Pavement Condition Report

Glencoe Municipal Airport (GYL)

December 2016

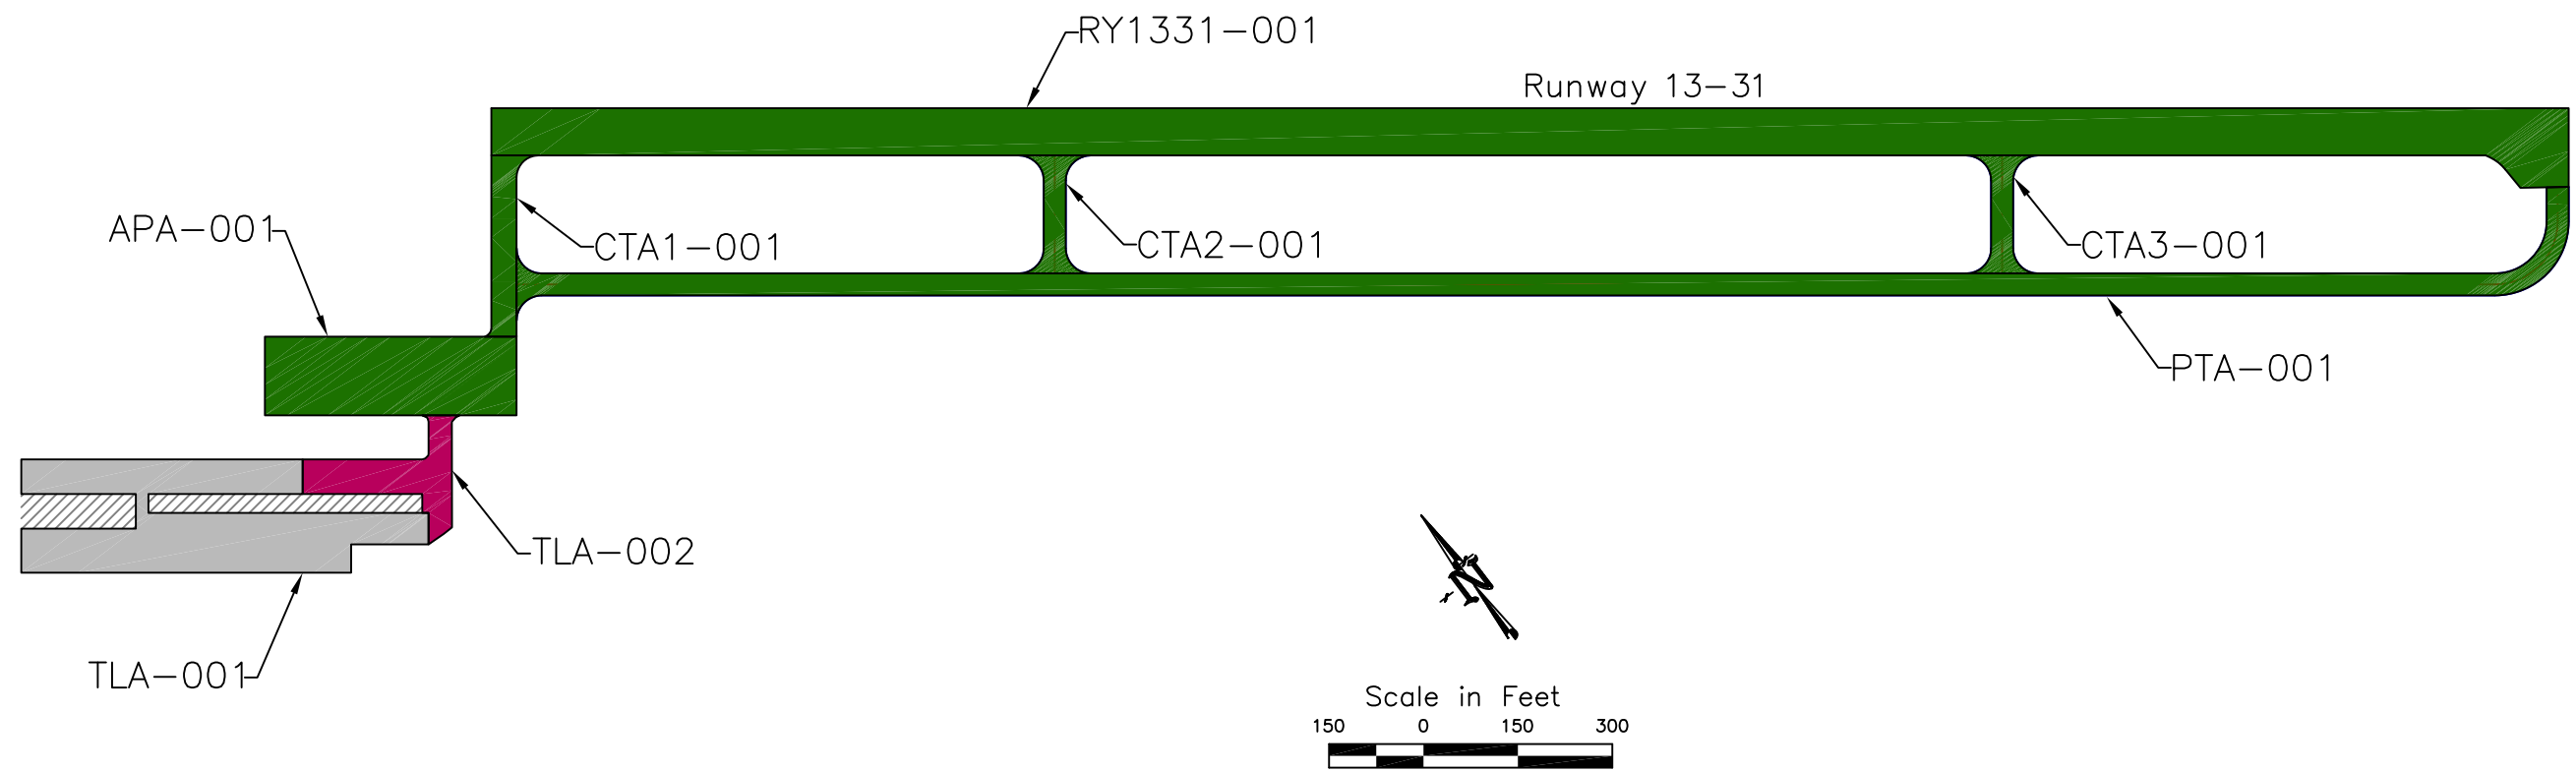
Figure 4. 2016 Pavement Condition Index Rating at Glencoe Municipal Airport (GYL).

Figures 5 and 6 present the overall PCI for GYL by area distribution and pavement use, respectively. Table 3 presents the PCI summary for each section at GYL, including the drop in PCI per year. Generally, pavement sections will deteriorate between 1 and 3 PCI points per year. Sections deteriorating at higher rates may need maintenance above the normal application rates and should be closely monitored in case major repairs become necessary earlier than expected.

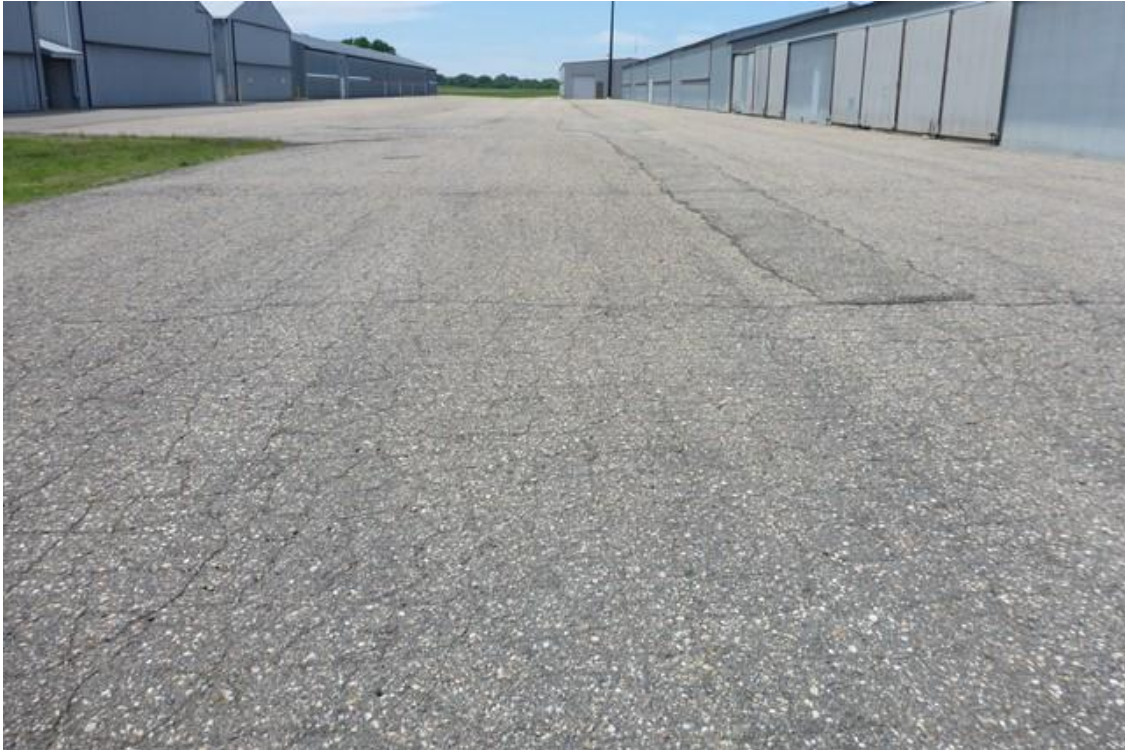
GYL TLA 001 (PCI = 0)

Section Comments: 2009 slurry seal masked true condition of pvmt.

Section / Work	Sum of Work Qty (Ft, SqFt)	Sum of Work Cost (\$)
TLA::001	Restorative: PCI Before 0 After: 57	748,294
Surface Treatment	3,139	1,569
Patching - AC Deep	65,388	746,724
TLA::002	Restorative: PCI Before 22 After: 55	17,227
Crack Sealing - AC	1,745	2,129
Surface Treatment	8,228	4,114
Patching - AC Deep	961	10,984
Grand Total		765,521
