Pavement Condition Report

Litchfield Municipal Airport (LJF)

December 2016

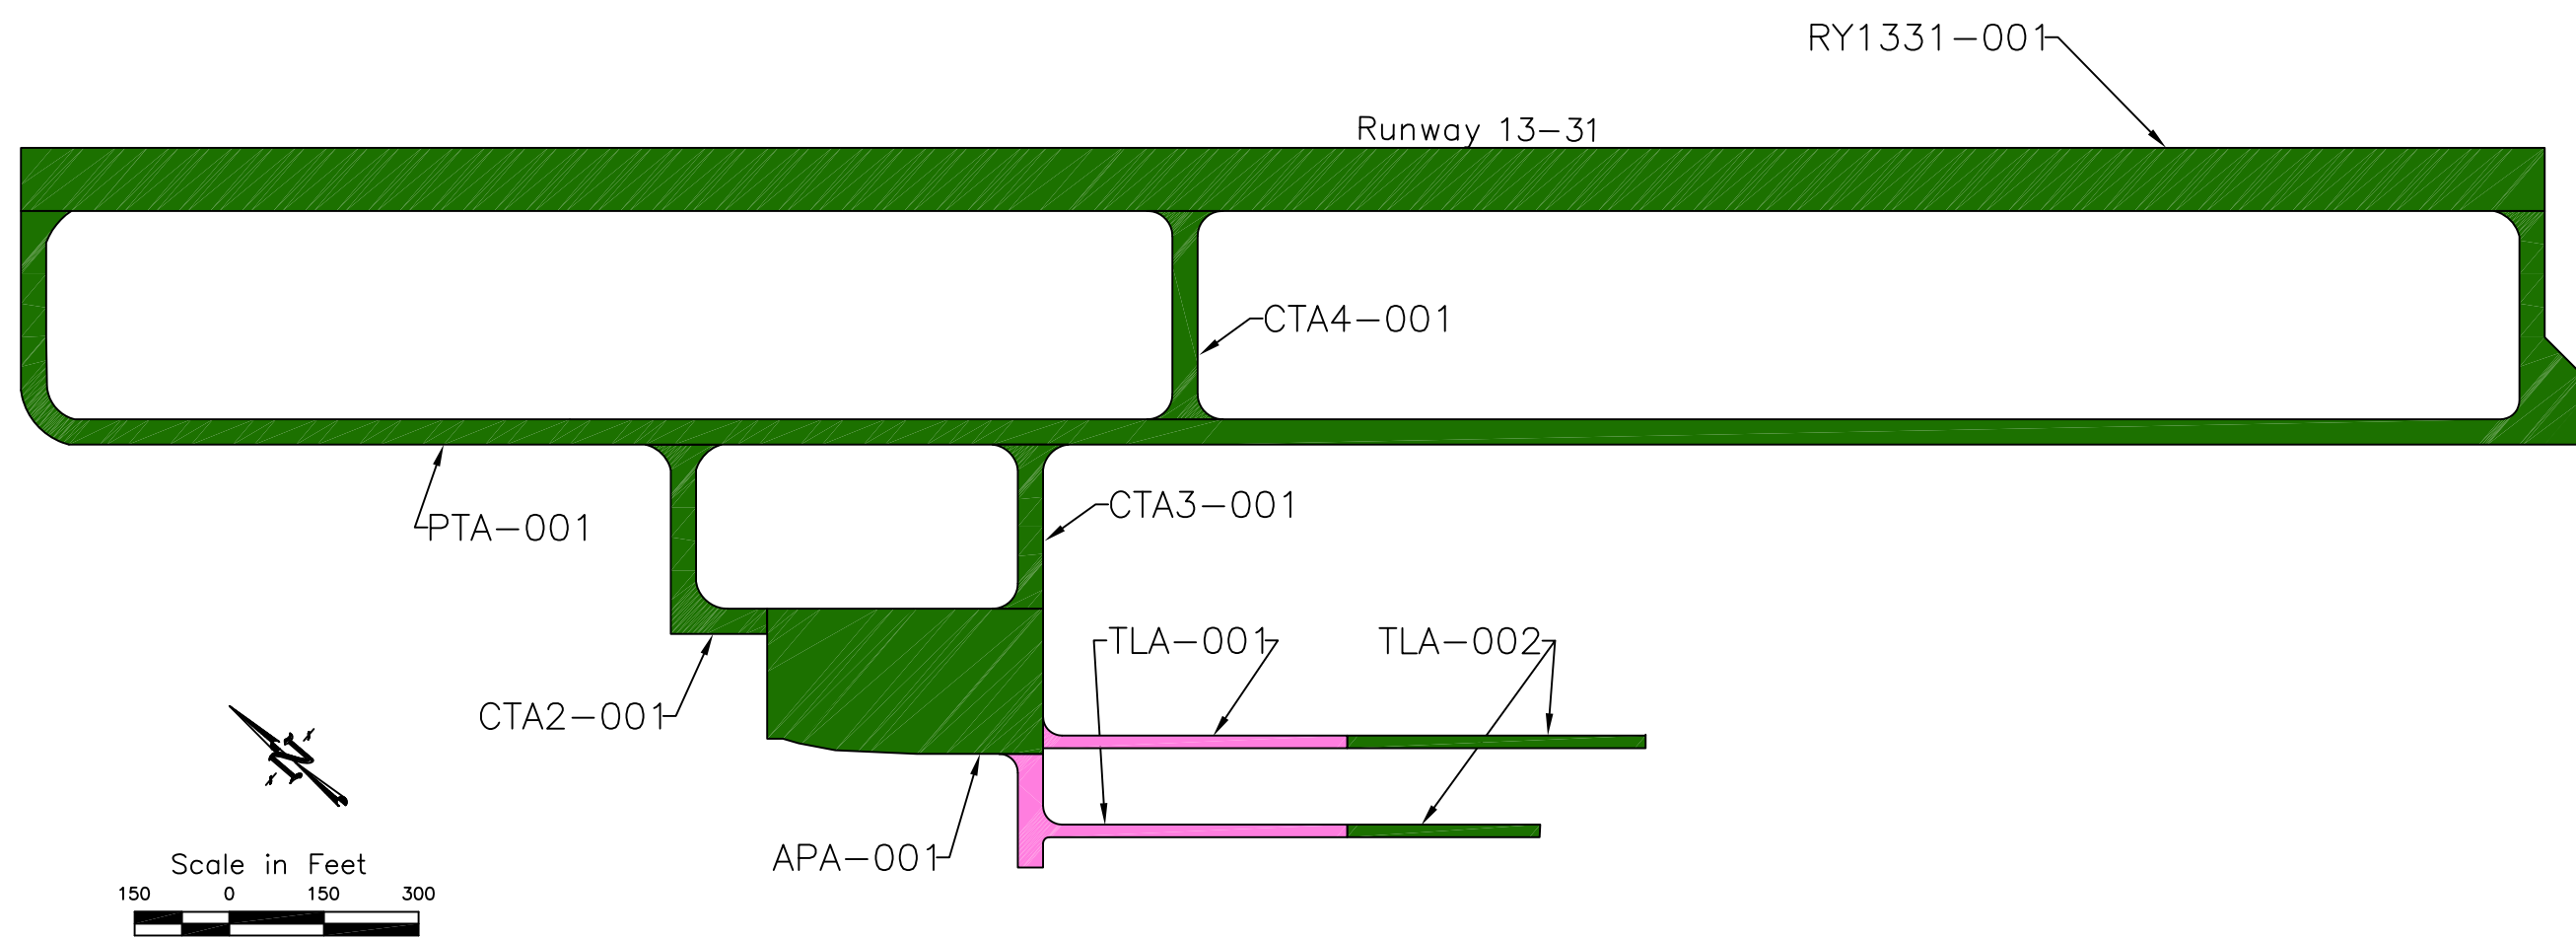
Figure 4. 2016 Pavement Condition Index Rating at Litchfield Municipal Airport (LJF).

Branch ID	Section ID	Surface type ¹	Section area (SF)	LCD ²	2013 PCI	2016 PCI	Drop in PCI/Yr ³	% Deduct due to		Distress types
								Load ⁴	Climate ⁵	
APA	001	AC	98,450	2016	66	100	-	-	-	-
CTA2	001	AC	18,060	2016	70	100	-	-	-	-
CTA3	001	AC	11,600	2016	70	100	-	-	-	-
CTA4	001	AC	14,580	2016	66	100	-	-	-	-
PTA	001	AC	195,130	2016	73	100	-	-	-	-
RY1331	001	AC	400,000	2016	67	100	-	-	-	-
TLA	001	AC	26,480	1989	53	53	2	54	46	Alligator cracking, Patching, L&T cracking, Rutting
TLA	002	AC	15,820	2008	100	96	1	-	100	L&T CR

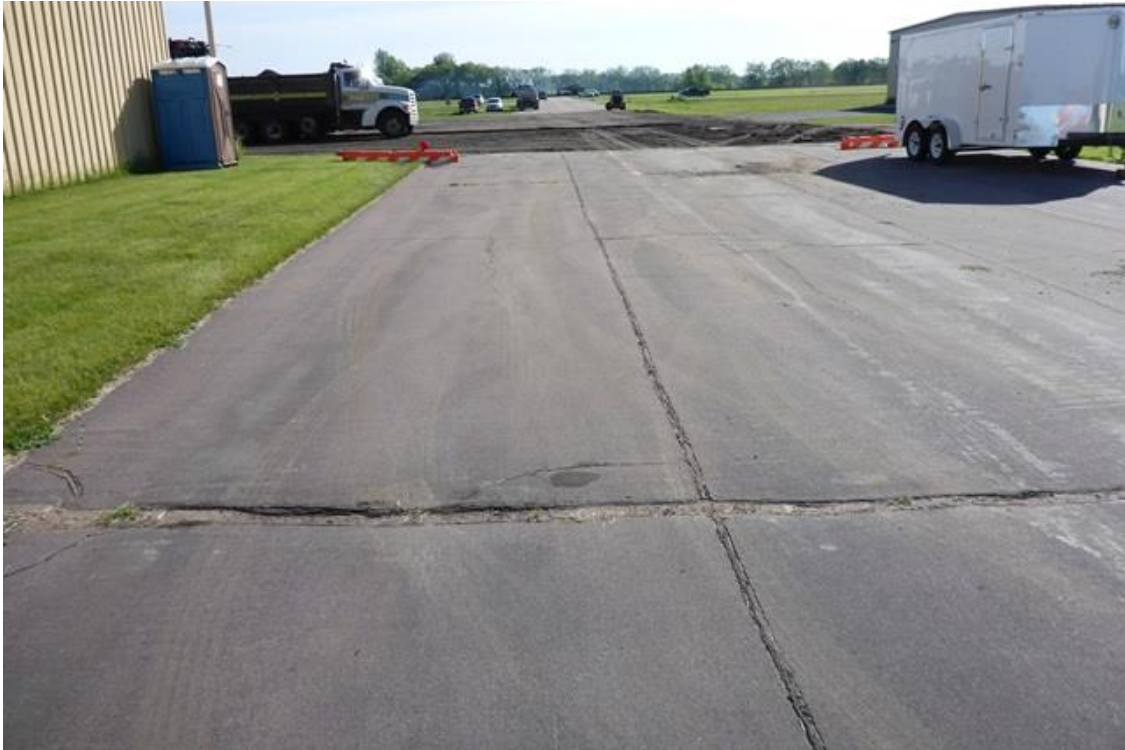
LJF TLA 001 (PCI = 53)

Conditions: PCI: 53

Section / Work	Sum of Work Qty (Ft, SqFt)	Sum of Work Cost (\$)
TLA::001	Preventative: PCI Before 53 After: 55	2,993
Crack Sealing - AC	1,562	1,906
Patching - AC Deep	95	1,087
Grand Total		2,993

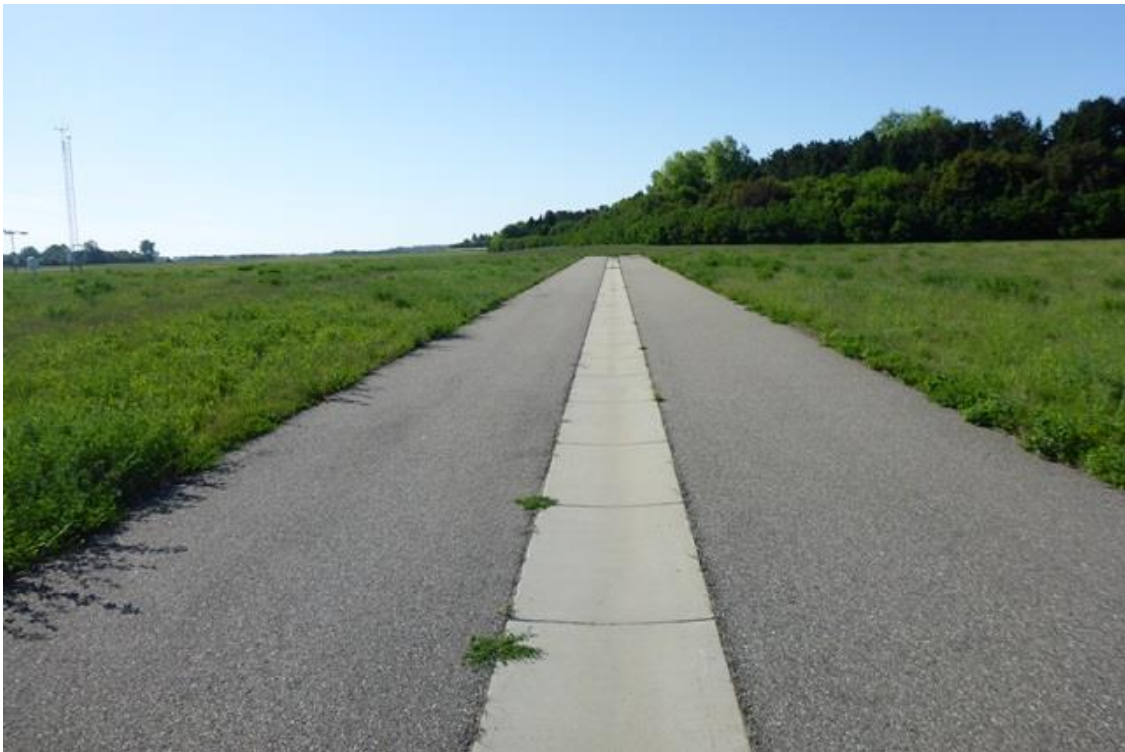
LJF TLA 002 (PCI = 96)

Network:	LJF	Name:	LITCHFIELD						
Branch:	TLA	Name:	Taxilane A	Use:	TAXILANE	Area:	42,300 SqFt		
Section:	002	of 2	From:	202	To:	304	Last Const.:	6/1/2008	
Surface:	AC	Family:	MN2013 Asphalt Taxilanes	Zone:	W	Category:	3	Rank:	T
Area:	15,820 SqFt	Length:	791 Ft	Width:	20 Ft				
Slabs:		Slab Length:	Ft	Slab Width:	Ft	Joint Length:	Ft		
Shoulder:		Street Type:		Grade:	0	Lanes:	0		
Section Comments:									
Last Insp. Date:	5/26/2016	TotalSamples:	4	Surveyed:	1				
Conditions:	PCI: 96								
Inspection Comments:									
Sample Number:	303	Type:	R	Area:	4000.00 SqFt	PCI:	96		
Sample Comments:									
48	L & T CR	L	22.00	Ft
