# Pavement Condition Report

## Pine River Regional Airport (PWC)

**December 2016**

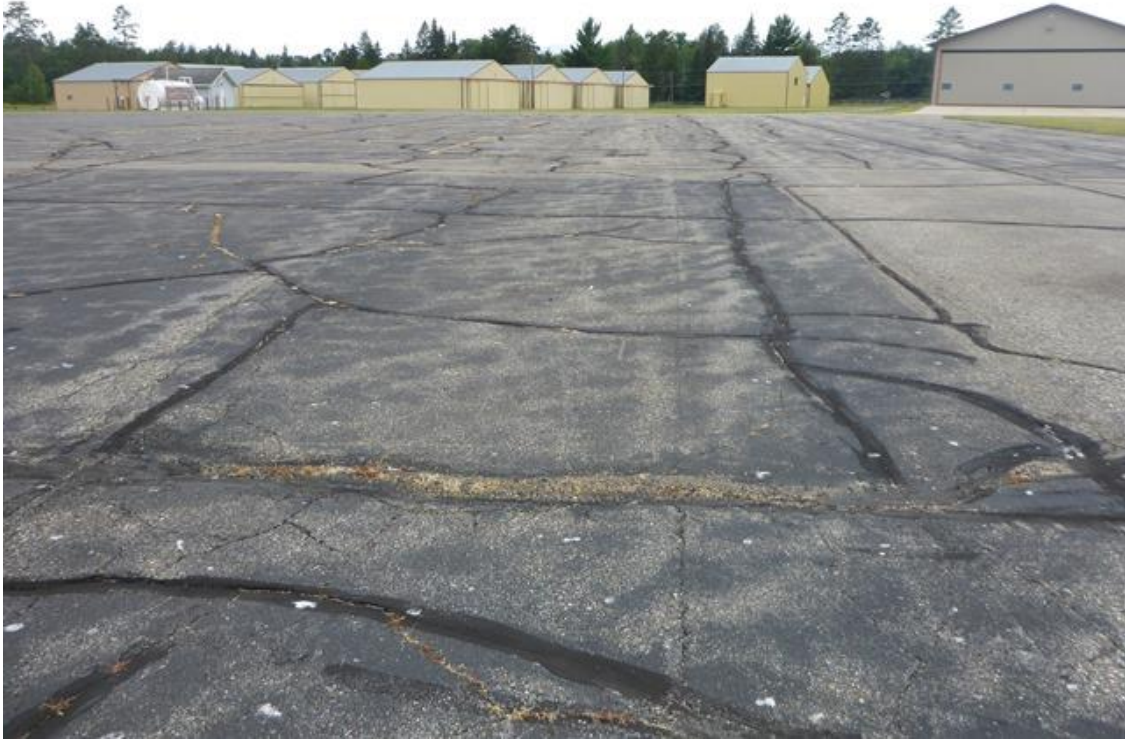
PWC APA 001 (PCI = 45)

**Conditions:** PCI: 45

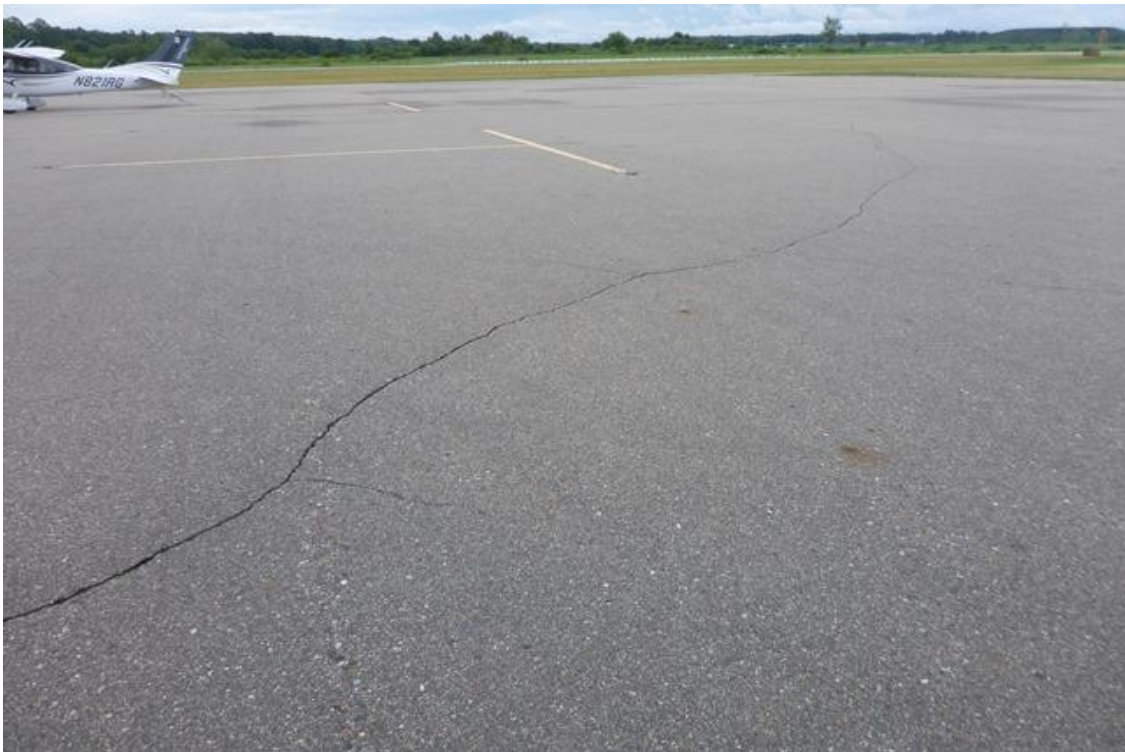
PWC APA 002 (PCI = 77)

**Conditions:** PCI: 77

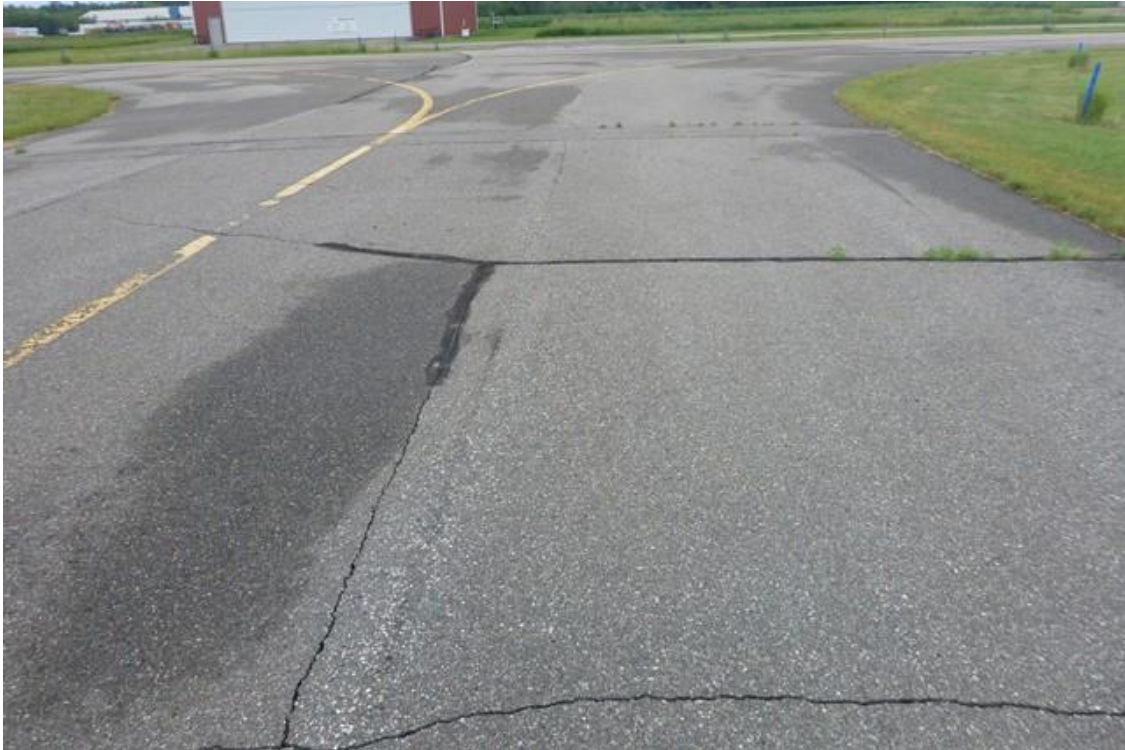
PWC CTA1 001 (PCI = 70)

**Conditions:** PCI: 70

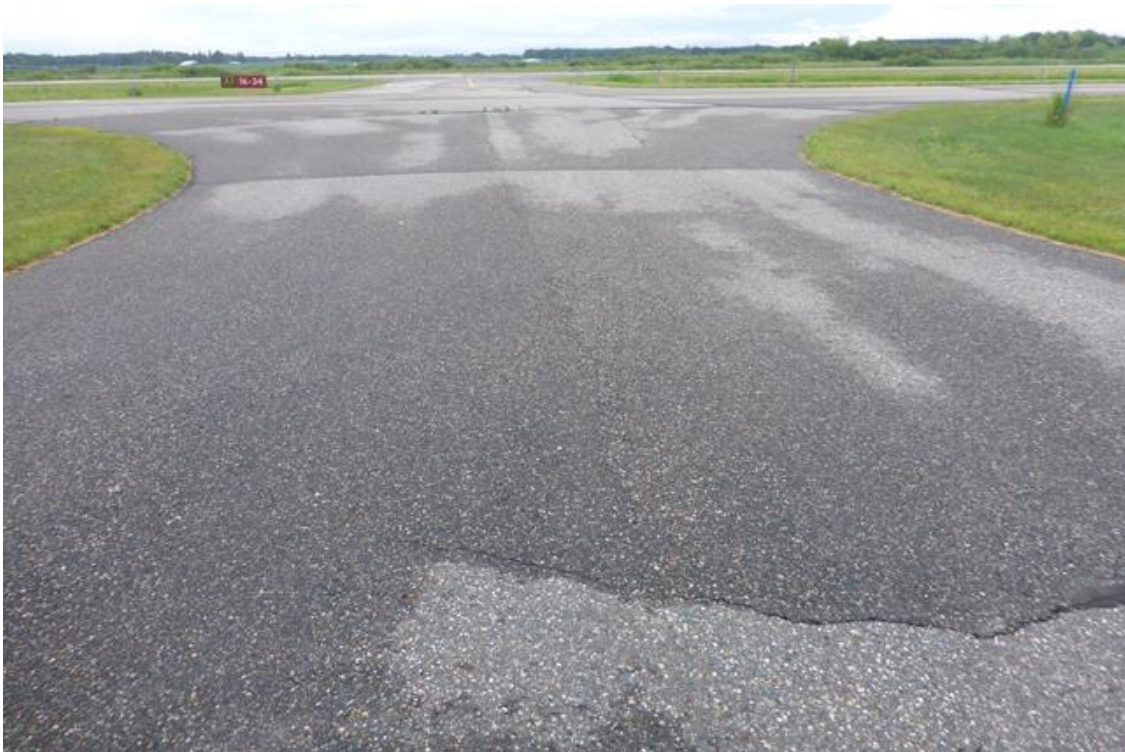
PWC CTA1X 001 (PCI = 76)

**Conditions:** PCI: 76

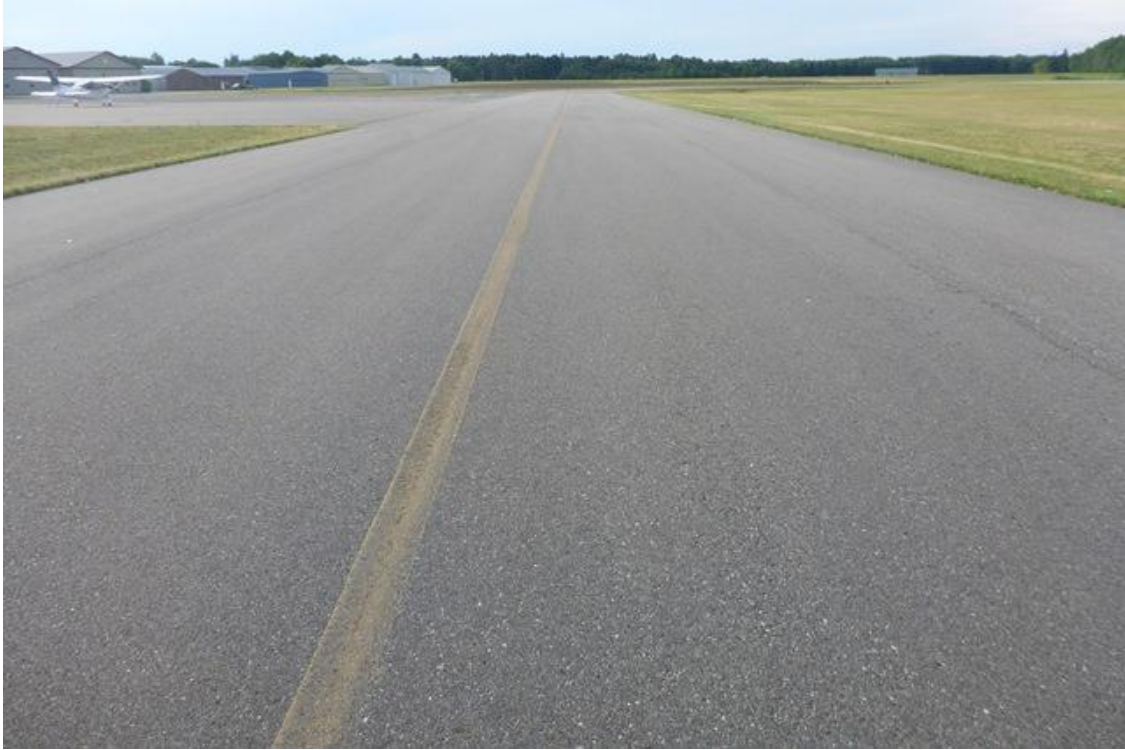
PWC PTA 003 (PCI = 88)

**Conditions:** PCI: 88

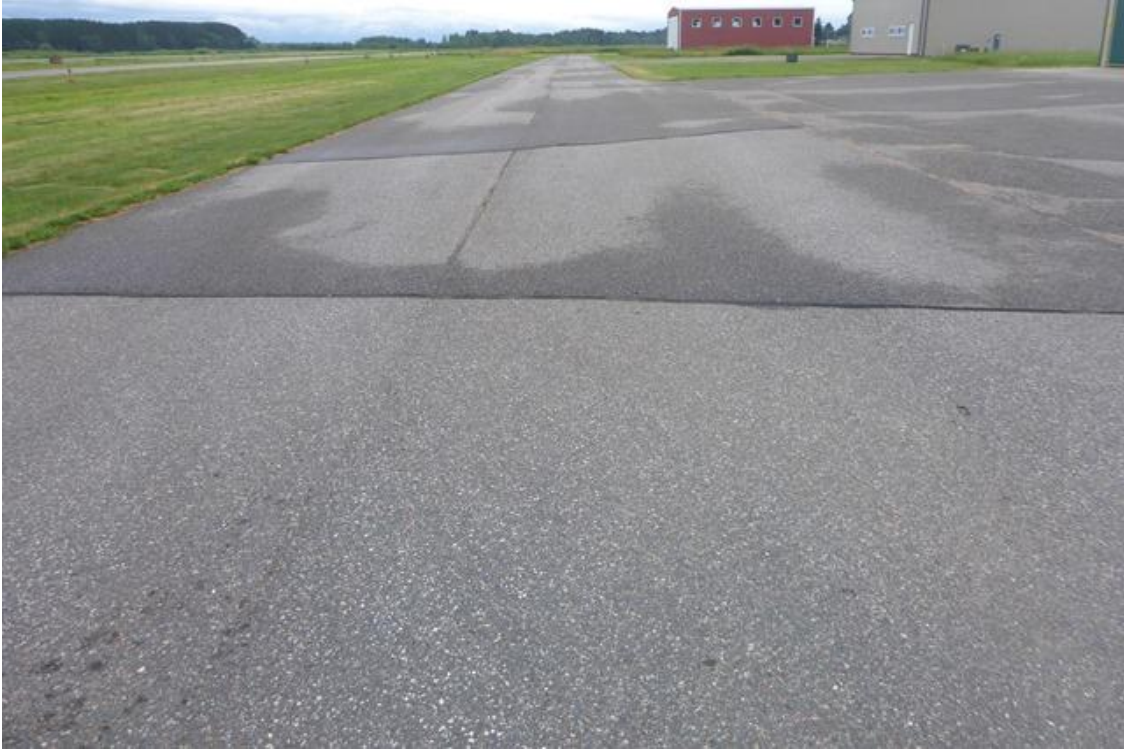
PWC TLB 001 (PCI = 68)

**Conditions:** PCI: 68

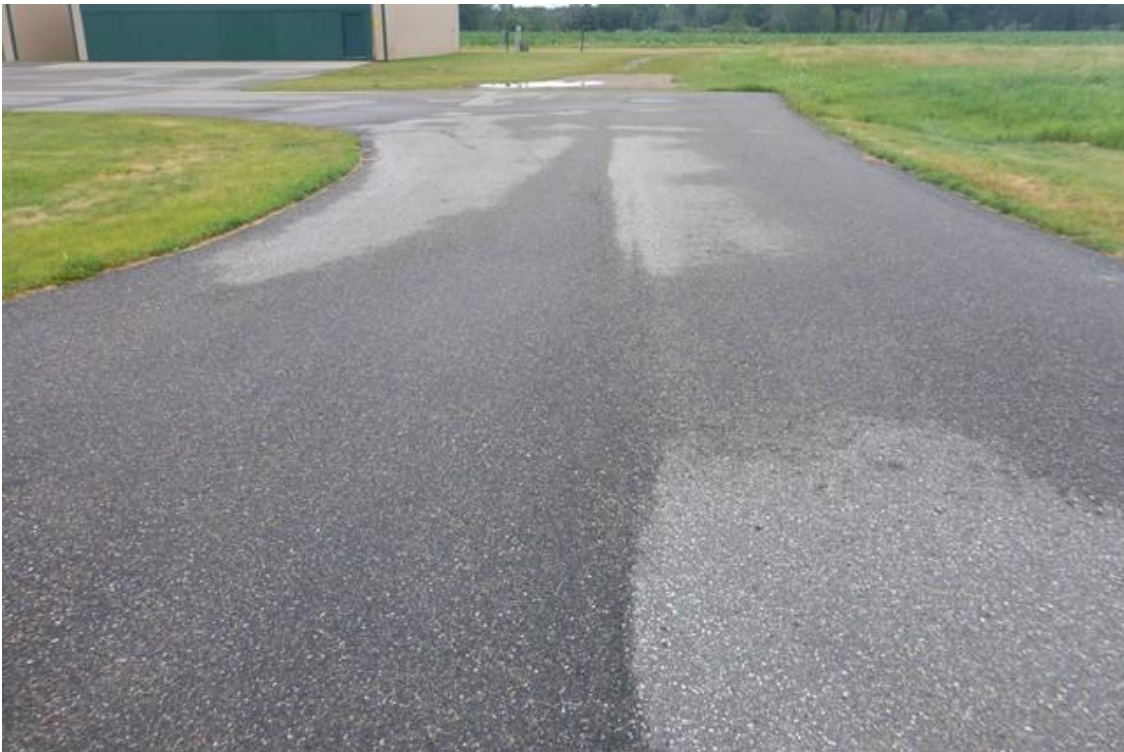
PWC TLB1 001 (PCI = 79)

**Conditions:** PCI: 79
