# Pavement Condition Report

## Baudette International Airport (BDE)

**December 2017**

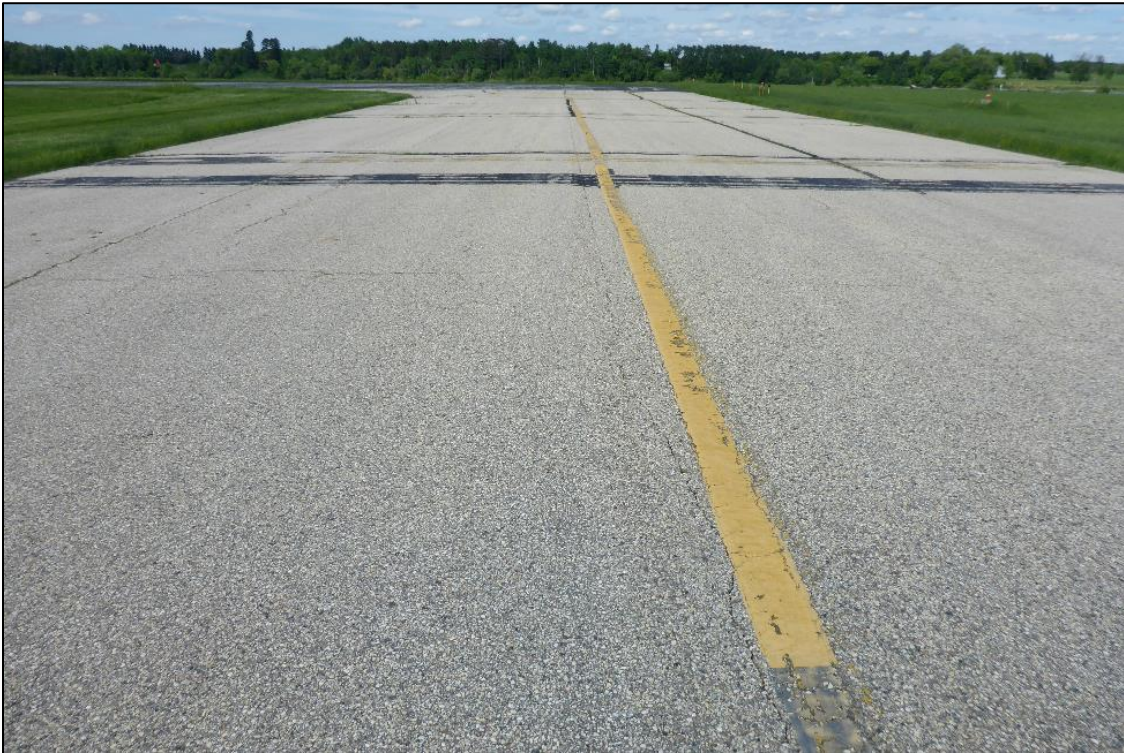
BDE CTA 001 (PCI = 62)

**Conditions:** PCI: 62

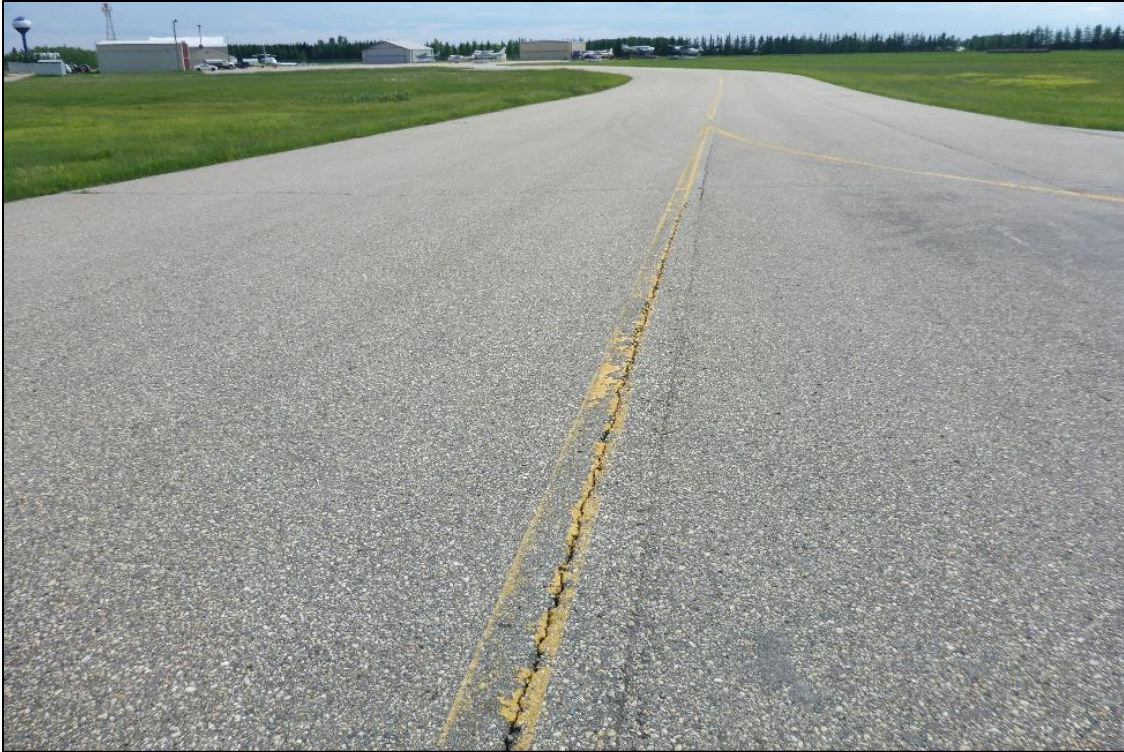
BDE CTAX 001 (PCI = 71)

**Conditions:** PCI: 71

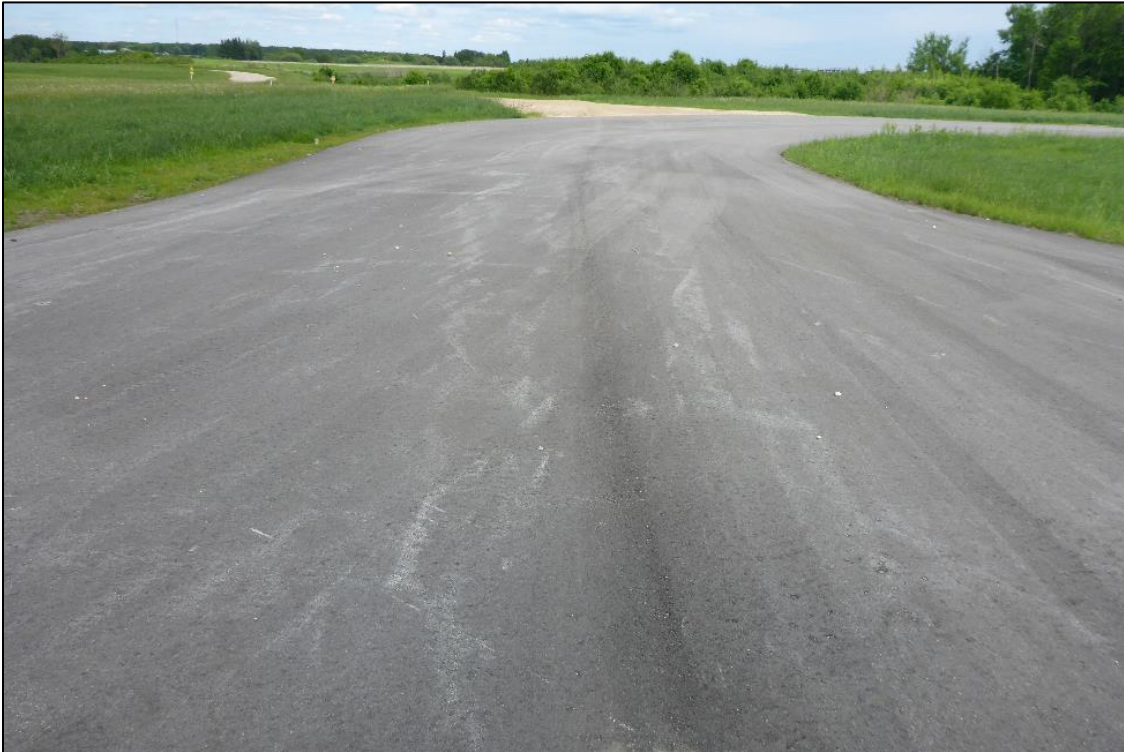
BDE CTAX 002 (PCI = 100)

**Conditions:** **PCI:** 100

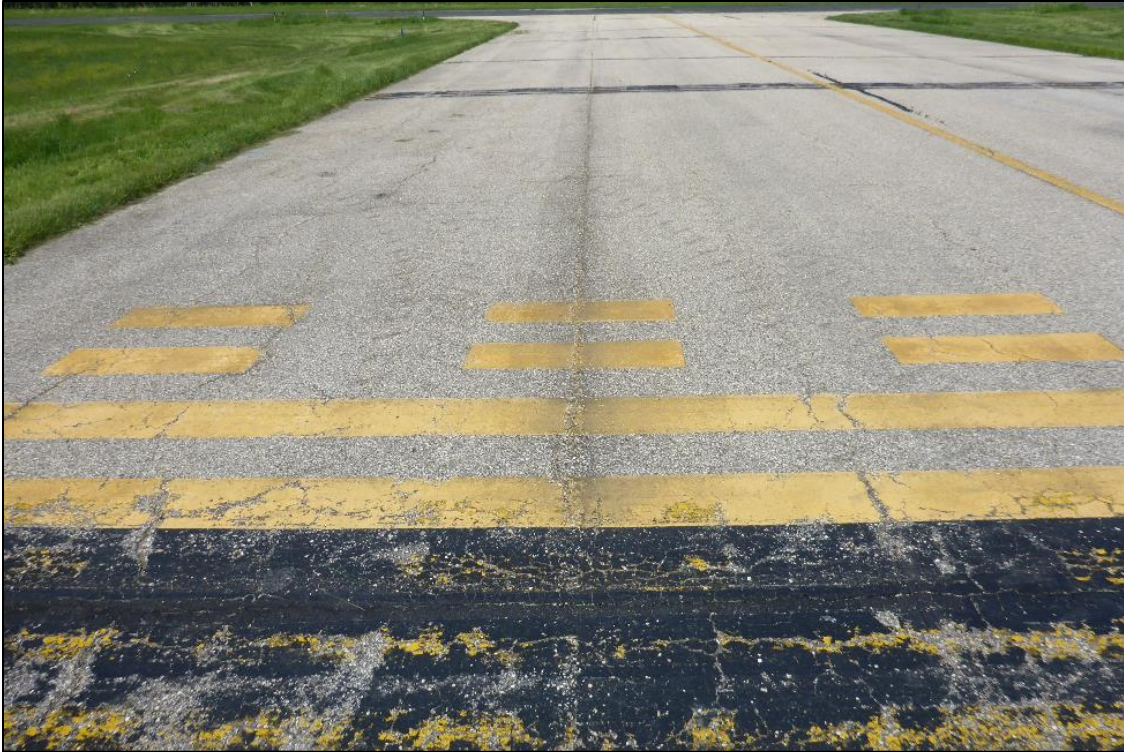
BDE CTB 001 (PCI = 46)

**Conditions:** PCI: 46
