Pavement Condition Report

Willmar Municipal Airport - John L. Rice Field (BDH)

December 2017

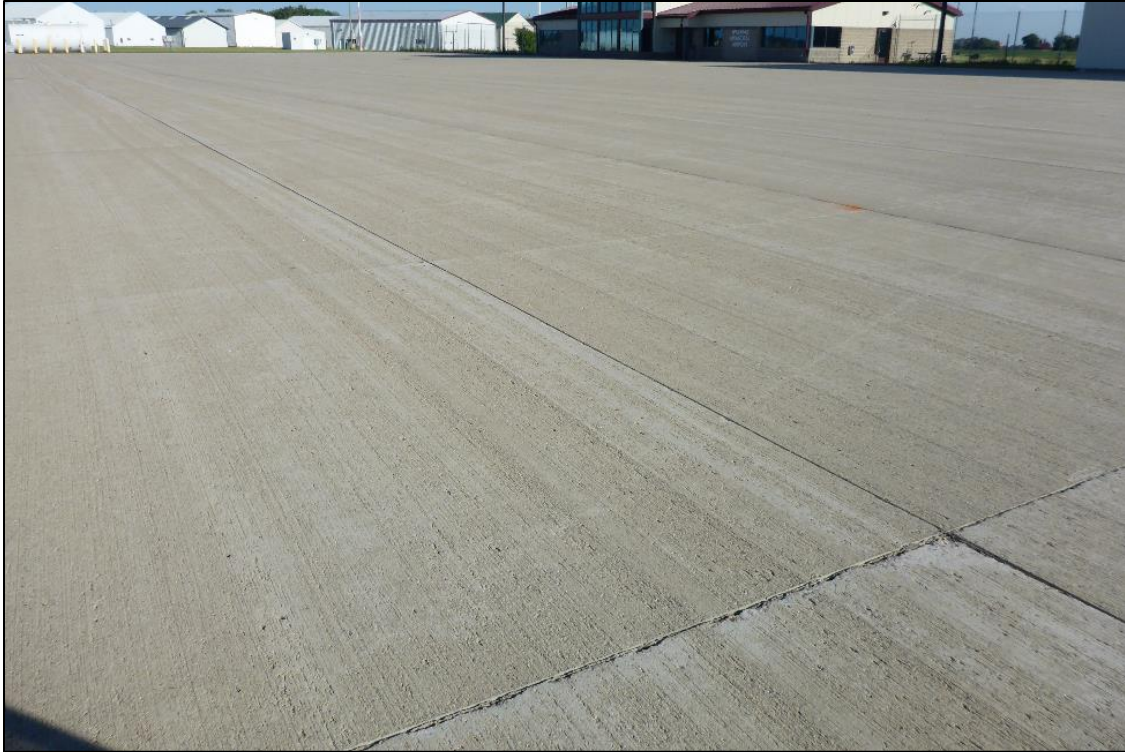
BDH APA 001 (PCI = 94)

Network:	BDH		Name:	WILLMAR					
Branch:	APA	Name:	Apron A	Use:	APRON	Area:	146,900 SqFt		
Section:	001	of 2	From:	100	To:	603	Last Const.:	9/27/2005	
Surface:	PCC	Family:	MN2013 PCC	Zone:	W	Category:	1	Rank:	S
Area:	137,500 SqFt	Length:	500 Ft	Width:	275 Ft				
Slabs:	880	Slab Length:	13 Ft	Slab Width:	13 Ft	Joint Length:	21,225 Ft		
Shoulder:		Street Type:		Grade:	0	Lanes:	0		
Section Comments:									
Last Insp. Date:	6/15/2017		TotalSamples:	44		Surveyed:	8		
Conditions:	PCI: 94								
Inspection Comments:									
Sample Number:	104	Type:	R	Area:	20.00 Slabs	PCI:	93		
Sample Comments:									
63	LINEAR CR		L	1.00	Slabs				
65	JT SEAL DMG		L	20.00	Slabs				
Sample Number:	107	Type:	R	Area:	20.00 Slabs	PCI:	93		
Sample Comments:									
63	LINEAR CR		L	1.00	Slabs				
65	JT SEAL DMG		L	20.00	Slabs				
Sample Number:	201	Type:	R	Area:	20.00 Slabs	PCI:	92		
Sample Comments:									
74	JOINT SPALL		M	1.00	Slabs

74	JOINT SPALL		L	1.00	Slabs				
65	JT SEAL DMG		L	20.00	Slabs				
Sample Number:	302	Type:	R	Area:	20.00 Slabs	PCI:	90		
Sample Comments:									
75	CORNER SPALL		L	1.00	Slabs				
74	JOINT SPALL		L	1.00	Slabs				
74	JOINT SPALL		M	1.00	Slabs				
65	JT SEAL DMG		L	20.00	Slabs				
Sample Number:	304	Type:	R	Area:	20.00 Slabs	PCI:	96		
Sample Comments:									
75	CORNER SPALL		L	1.00	Slabs				
65	JT SEAL DMG		L	20.00	Slabs				
Sample Number:	306	Type:	R	Area:	20.00 Slabs	PCI:	95		
Sample Comments:									
75	CORNER SPALL		L	1.00	Slabs				
65	JT SEAL DMG		L	20.00	Slabs				
73	SHRINKAGE CR		N	1.00	Slabs				
Sample Number:	501	Type:	R	Area:	20.00 Slabs	PCI:	96		
Sample Comments:									
75	CORNER SPALL		L	1.00	Slabs				
65	JT SEAL DMG		L	20.00	Slabs				
Sample Number:	504	Type:	R	Area:	20.00 Slabs	PCI:	93		
Sample Comments:									
63	LINEAR CR		L	1.00	Slabs				
65	JT SEAL DMG		L	20.00	Slabs

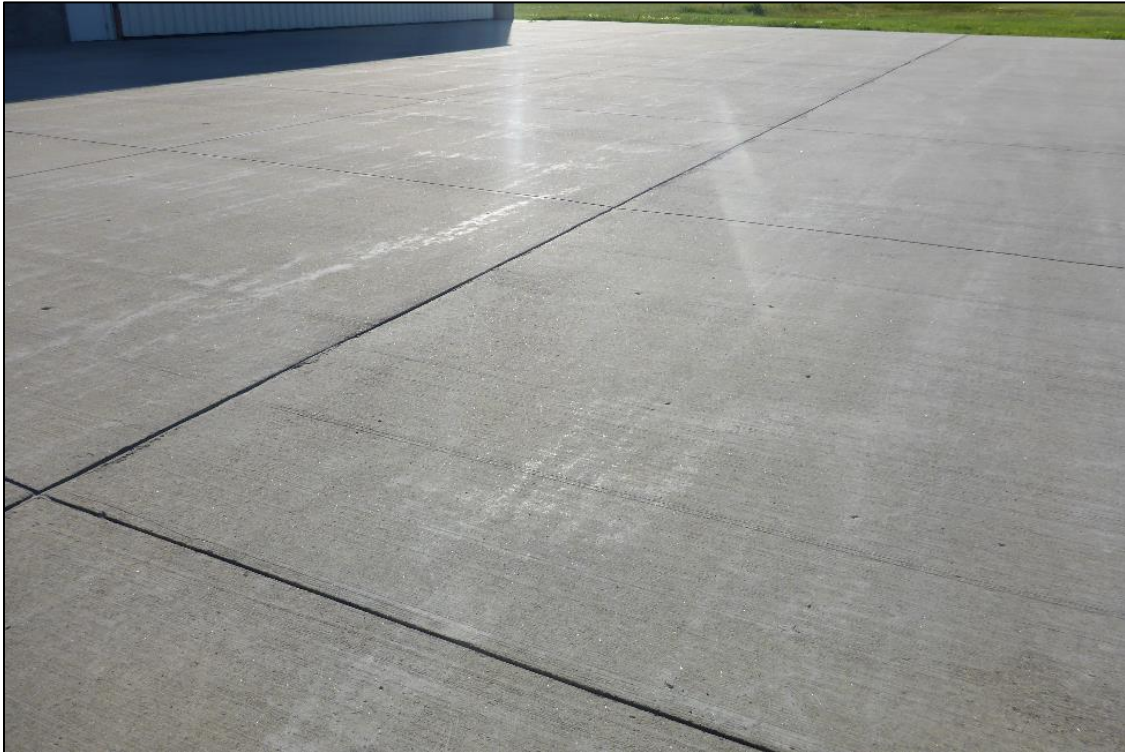
BDH APA 002 (PCI = 97)

Network:	BDH	Name:	WILLMAR						
Branch:	APA	Name:	Apron A	Use:	APRON	Area:	146,900 SqFt		
Section:	002	of 2	From:	100	To:	101	Last Const.:	10/1/2006	
Surface:	PCC	Family:	MN2013 PCC	Zone:	W	Category:	1	Rank:	S
Area:	9,400 SqFt	Length:	125 Ft	Width:	75 Ft				
Slabs:	60	Slab Length:	13 Ft	Slab Width:	13 Ft	Joint Length:	1,300 Ft		
Shoulder:		Street Type:		Grade:	0	Lanes:	0		
Section Comments:									
Last Insp. Date:	6/15/2017	TotalSamples:	3	Surveyed:	2				
Conditions:	PCI: 97								
Inspection Comments:									
Sample Number:	100	Type:	R	Area:	24.00 Slabs	PCI:	97		
Sample Comments:									
74	JOINT SPALL	L	1.00	Slabs					
65	JT SEAL DMG	L	24.00	Slabs					
Sample Number:	101	Type:	R	Area:	24.00 Slabs	PCI:	97		
Sample Comments:									
65	JT SEAL DMG	L	24.00	Slabs					
74	JOINT SPALL	L	1.00	Slabs

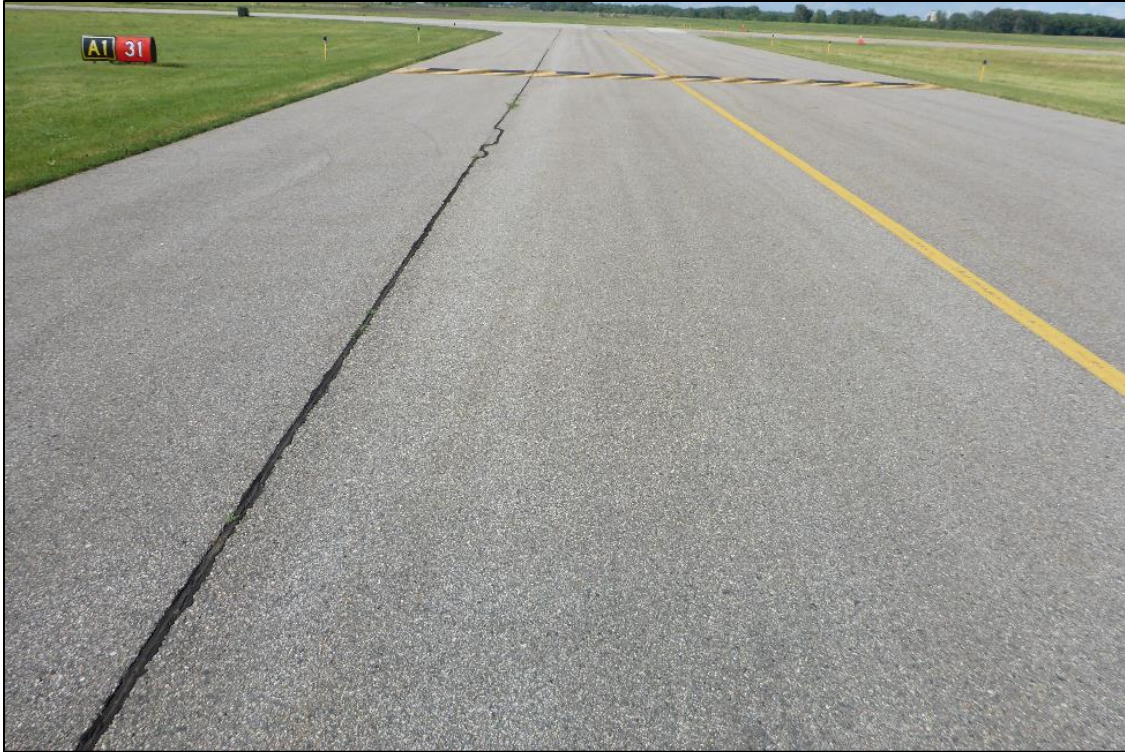
BDH CTA1 001 (PCI = 85)

Network:	BDH	Name:	WILLMAR						
Branch:	CTA1	Name:	Connecting Taxiway A1	Use:	TAXIWAY	Area:	17,900 SqFt		
Section:	001	of 1	From:	100	To:	102	Last Const.:	9/24/2005	
Surface:	AC	Family:	MN2013 Asphalt Taxiways	Zone:	W	Category:	1	Rank:	P
Area:	17,900 SqFt	Length:	341 Ft	Width:	50 Ft				
Slabs:		Slab Length:	Ft	Slab Width:	Ft	Joint Length:	Ft		
Shoulder:		Street Type:		Grade:	0	Lanes:	0		
Section Comments:									
Last Insp. Date:	6/15/2017	TotalSamples:	3	Surveyed:	2				
Conditions:	PCI: 85								
Inspection Comments:									
Sample Number:	101	Type:	R	Area:	5000.00 SqFt	PCI:	83		
Sample Comments:									
48	L & T CR	L	300.00	Ft					
Sample Number:	102	Type:	R	Area:	5000.00 SqFt	PCI:	86		
Sample Comments:									
48	L & T CR	L	172.00	Ft					
57	WEATHERING	L	1000.00	SqFt

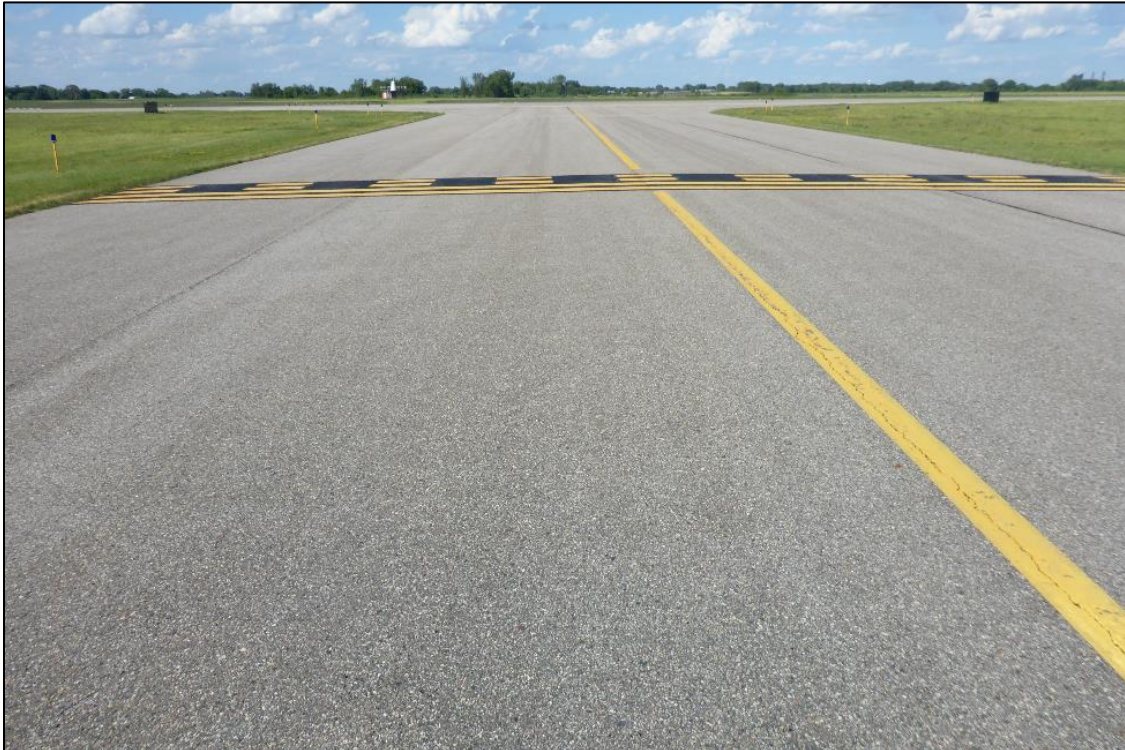
BDH CTA2 001 (PCI = 79)

Network:	BDH		Name:	WILLMAR					
Branch:	CTA2	Name:	Connecting Taxiway A2	Use:	TAXIWAY	Area:	23,050 SqFt		
Section:	001	of 1	From:	100	To:	103	Last Const.:	9/24/2005	
Surface:	AC	Family:	MN2013 Asphalt Taxiways	Zone:	W	Category:	1	Rank:	S
Area:	23,050 SqFt	Length:	385 Ft	Width:	50 Ft				
Slabs:		Slab Length:	Ft	Slab Width:	Ft	Joint Length:	Ft		
Shoulder:		Street Type:		Grade:	0	Lanes:	0		
Section Comments:									
Last Insp. Date:	6/15/2017		TotalSamples:	4	Surveyed:	2			
Conditions:	PCI:	79							
Inspection Comments:									
Sample Number:	101	Type:	R	Area:	5000.00 SqFt	PCI:	83		
Sample Comments:									
48	L & T CR	L	245.00	Ft					
57	WEATHERING	L	1000.00	SqFt					
Sample Number:	102	Type:	R	Area:	5000.00 SqFt	PCI:	74		
Sample Comments: SU in end in middle of utility cut patch									
50	PATCHING	L	50.00	SqFt					
48	L & T CR	L	236.00	Ft					
48	L & T CR	M	71.00	Ft					
57	WEATHERING	L	1000.00	SqFt

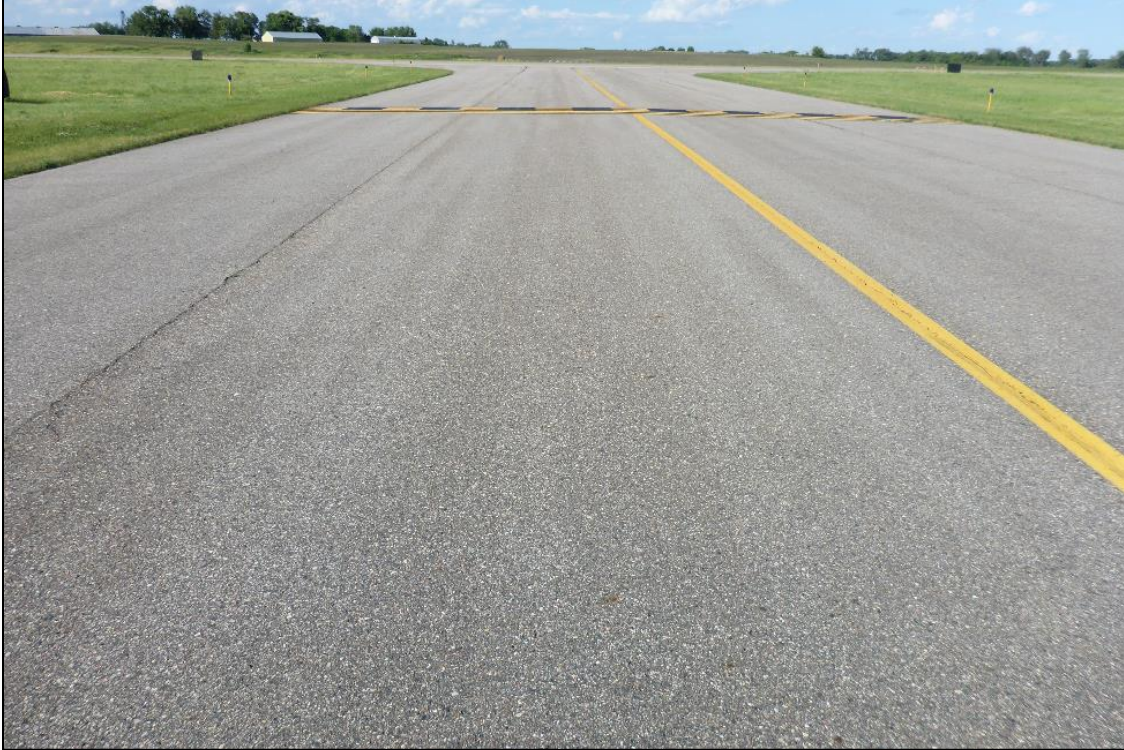
BDH CTA3 001 (PCI = 77)

Network:	BDH		Name:	WILLMAR					
Branch:	CTA3	Name:	Connecting Taxiway A3	Use:	TAXIWAY	Area:	23,050 SqFt		
Section:	001	of 1	From:	100	To:	103	Last Const.:	9/24/2005	
Surface:	AC	Family:	MN2013 Asphalt Taxiways	Zone:	W	Category:	1	Rank:	S
Area:	23,050 SqFt	Length:	385 Ft	Width:	50 Ft				
Slabs:		Slab Length:	Ft	Slab Width:	Ft	Joint Length:	Ft		
Shoulder:		Street Type:		Grade:	0	Lanes:	0		
Section Comments:									
Last Insp. Date:	6/15/2017	TotalSamples:	4	Surveyed:	2				
Conditions:	PCI: 77								
Inspection Comments:									
Sample Number:	101	Type:	R	Area:	5000.00 SqFt	PCI:	77		
Sample Comments:									
48	L & T CR	L	267.00	Ft					
48	L & T CR	M	82.00	Ft					
57	WEATHERING	L	1000.00	SqFt					
Sample Number:	102	Type:	R	Area:	5000.00 SqFt	PCI:	77		
Sample Comments:									
48	L & T CR	M	89.00	Ft					
57	WEATHERING	L	1000.00	SqFt					
48	L & T CR	L	223.00	Ft

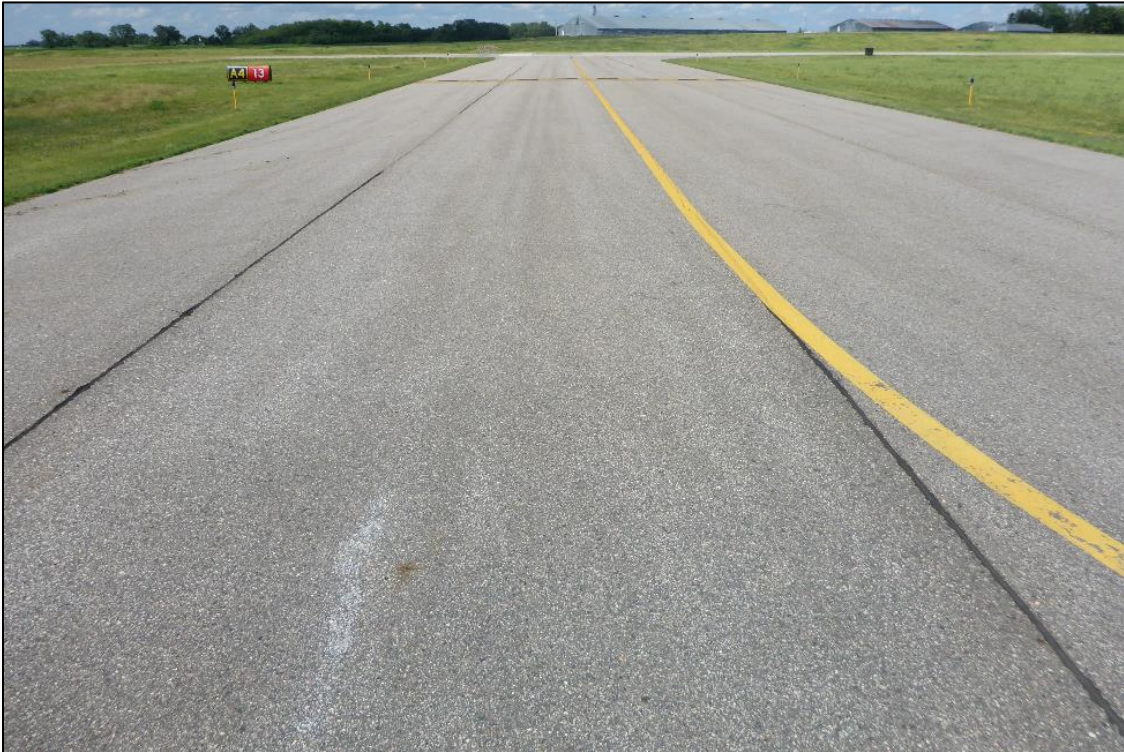
BDH CTA4 001 (PCI = 80)

Network:	BDH	Name:	WILLMAR						
Branch:	CTA4	Name:	Connecting Taxiway A4	Use:	TAXIWAY	Area:	21,250 SqFt		
Section:	001	of 1	From:	100	To:	103	Last Const.:	9/24/2005	
Surface:	AC	Family:	MN2013 Asphalt Taxiways	Zone:	W	Category:	1	Rank:	P
Area:	21,250 SqFt	Length:	385 Ft	Width:	50 Ft				
Slabs:		Slab Length:	Ft	Slab Width:	Ft	Joint Length:	Ft		
Shoulder:		Street Type:		Grade:	0	Lanes:	0		
Section Comments:									
Last Insp. Date:	6/15/2017	TotalSamples:	4	Surveyed:	2				
Conditions:	PCI: 80								
Inspection Comments:									
Sample Number:	101	Type:	R	Area:	5000.00 SqFt	PCI:	83		
Sample Comments:									
48	L & T CR	L	218.00	Ft					
57	WEATHERING	M	250.00	SqFt					
Sample Number:	102	Type:	R	Area:	5000.00 SqFt	PCI:	76		
Sample Comments:									
48	L & T CR	L	275.00	Ft					
48	L & T CR	M	67.00	Ft					
57	WEATHERING	L	1000.00	SqFt

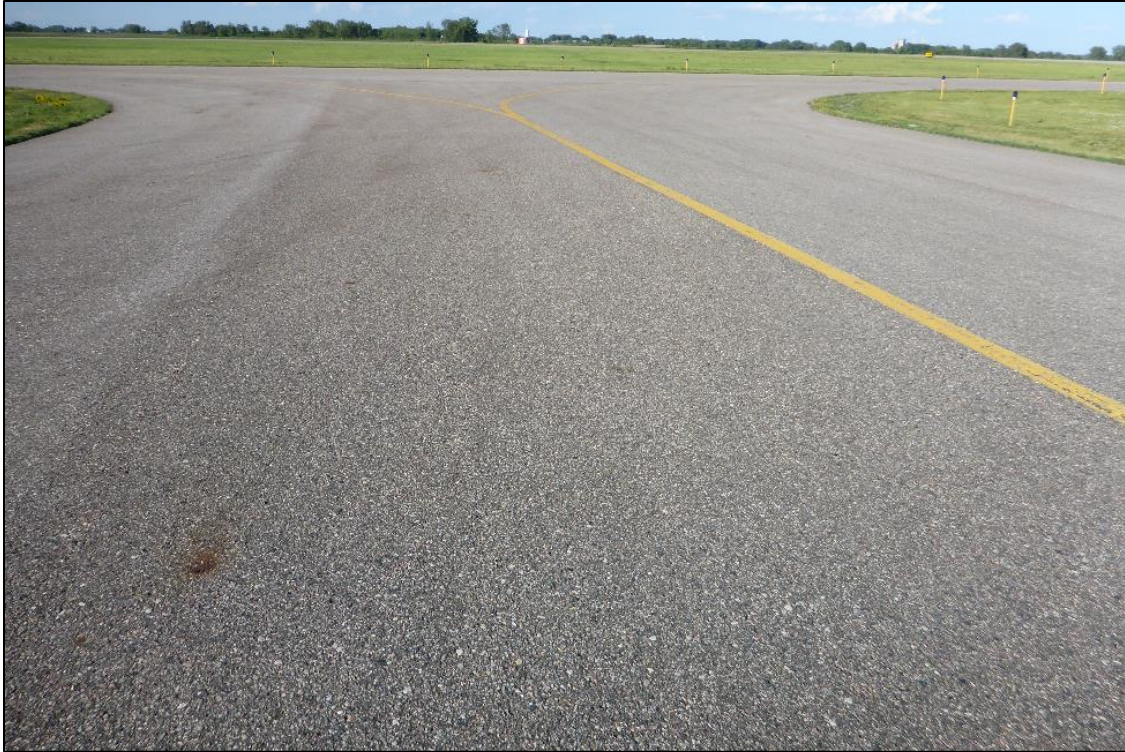
BDH CTC1 001 (PCI = 82)

Network:	BDH	Name:	WILLMAR						
Branch:	CTC1	Name:	Connecting Taxiway C1	Use:	TAXIWAY	Area:	7,200 SqFt		
Section:	001	of 1	From:	100	To:	100	Last Const.:	9/24/2005	
Surface:	AC	Family:	MN2013 Asphalt Taxiways	Zone:	W	Category:	1	Rank:	S
Area:	7,200 SqFt	Length:	118 Ft	Width:	50 Ft				
Slabs:	Slab Length:	Ft	Slab Width:	Ft	Joint Length:	Ft			
Shoulder:	Street Type:	Grade:	0	Lanes:	0				
Section Comments:									
Last Insp. Date:	6/15/2017	TotalSamples:	2	Surveyed:	1				
Conditions:	PCI: 82								
Inspection Comments:									
Sample Number:	100	Type:	R	Area:	5335.00 SqFt	PCI:	82		
Sample Comments:									
48	L & T CR	M	45.00	Ft					
48	L & T CR	L	123.00	Ft					
57	WEATHERING	L	1000.00	SqFt
