Pavement Condition Report

Richard B. Helgeson Airport (TWM)

December 2017

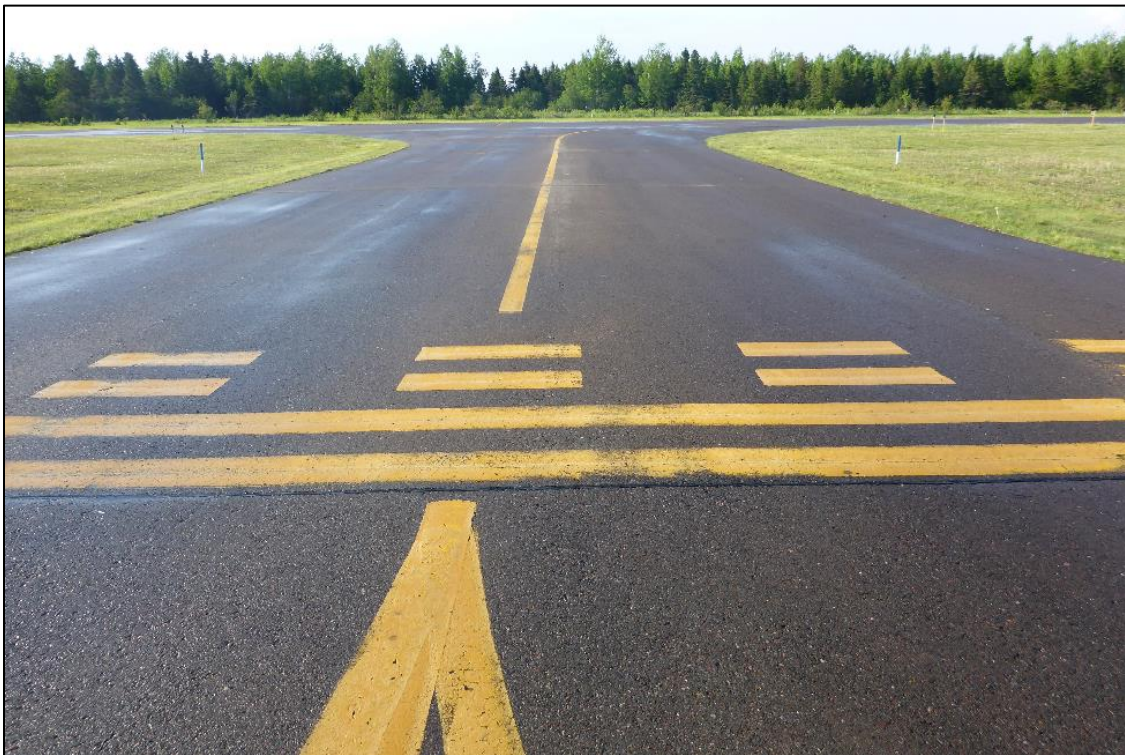
TWM CTB 001 (PCI = 90)

Network:	TWM	Name:	TWO HARBORS						
Branch:	CTB	Name:	CONNECTING TAXIWAY B	Use:	TAXIWAY	Area:	9,150 SqFt		
Section:	001	of 1	From:	200	To:	201	Last Const.:	10/1/2011	
Surface:	AC	Family:	MN2013 Asphalt Taxiways	Zone:	N	Category:	1	Rank:	P
Area:	9,150 SqFt	Length:	195 Ft	Width:	40 Ft				
Slabs:		Slab Length:	Ft	Slab Width:	Ft	Joint Length:	Ft		
Shoulder:		Street Type:		Grade:	0	Lanes:	0		
Section Comments:									
Last Insp. Date:	6/10/2017	TotalSamples:	2	Surveyed:	1				
Conditions:	PCI: 90								
Inspection Comments:									
Sample Number:	200	Type:	R	Area:	3500.00 SqFt	PCI:	90		
Sample Comments:									
48	L & T CR	L	80.00	Ft					
57	WEATHERING	L	500.00	SqFt

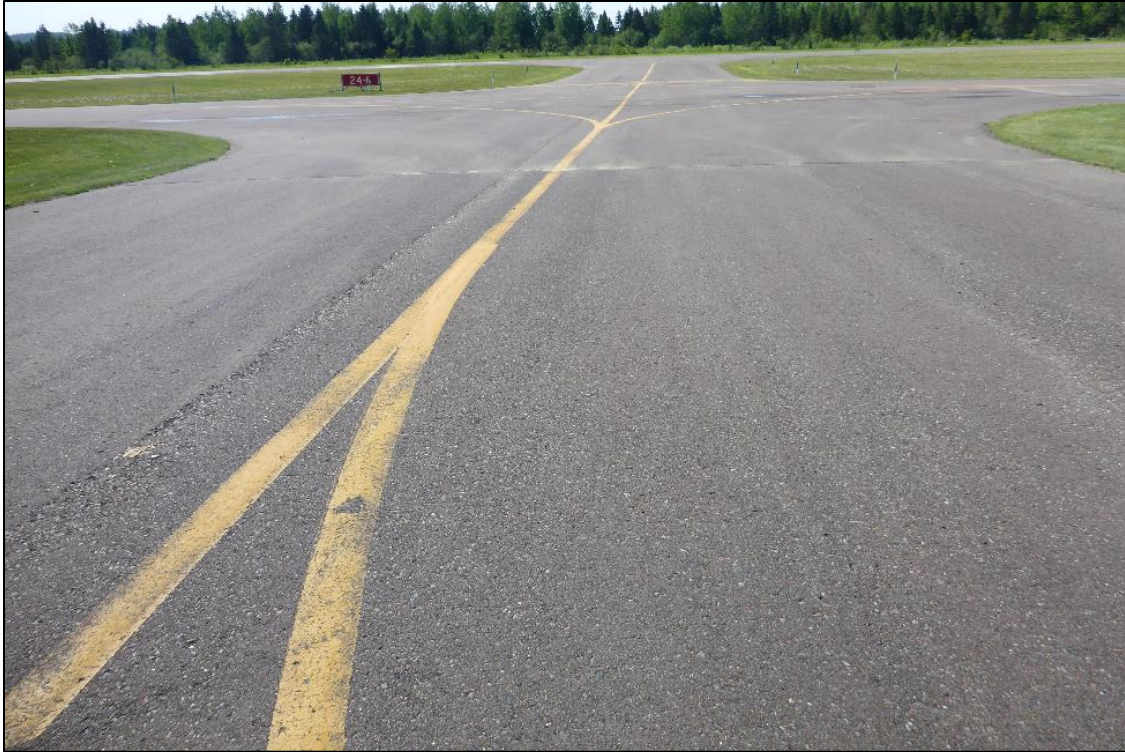
TWM CTBX 001 (PCI = 93)

Network:	TWM	Name:	TWO HARBORS						
Branch:	CTBX	Name:	Connecting Taxiway B Ext.	Use:	TAXIWAY	Area:	5,000 SqFt		
Section:	001	of	1	From:	202	To:	202	Last Const.:	10/1/2011
Surface:	AC	Family:	MN2013 Asphalt Taxiways	Zone:	N	Category:	1	Rank:	P
Area:	5,000 SqFt	Length:	100 Ft	Width:	40 Ft				
Slabs:		Slab Length:	Ft	Slab Width:	Ft	Joint Length:	Ft		
Shoulder:		Street Type:		Grade:	0	Lanes:	0		
Section Comments:									
Last Insp. Date:	6/10/2017	TotalSamples:	1	Surveyed:	1				
Conditions:	PCI: 93								
Inspection Comments:									
Sample Number:	202	Type:	R	Area:	3500.00 SqFt	PCI:	93		
Sample Comments:									
48	L & T CR	L	38.00	Ft					
57	WEATHERING	M	80.00	SqFt

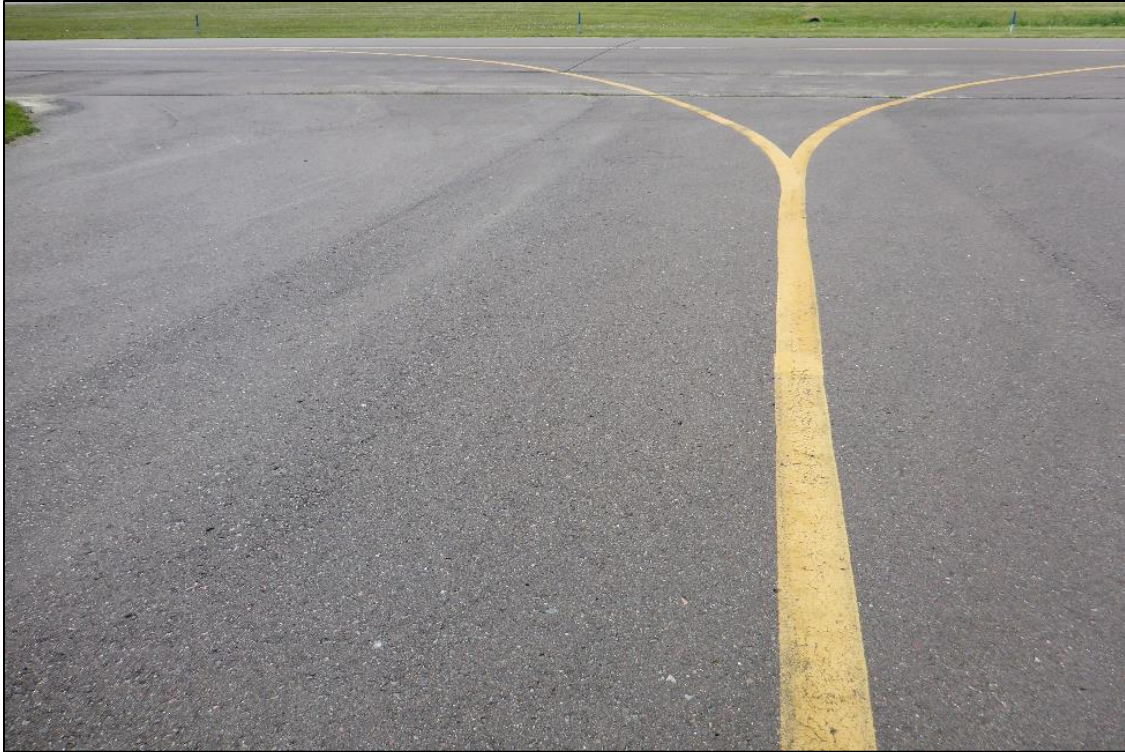
TWM CTD 001 (PCI = 91)

Network:	TWM	Name:	TWO HARBORS						
Branch:	CTD	Name:	CONNECTING TAXIWAY D	Use:	TAXIWAY	Area:	5,050 SqFt		
Section:	001	of 1	From:	100	To:	100	Last Const.:	10/1/2011	
Surface:	AC	Family:	MN2013 Asphalt Taxiways	Zone:	N	Category:	1	Rank:	S
Area:	5,050 SqFt	Length:	100 Ft	Width:	40 Ft				
Slabs:		Slab Length:	Ft	Slab Width:	Ft	Joint Length:	Ft		
Shoulder:		Street Type:		Grade:	0	Lanes:	0		
Section Comments:									
Last Insp. Date:	6/10/2017	TotalSamples:	1	Surveyed:	1				
Conditions:	PCI: 91								
Inspection Comments:									
Sample Number:	100	Type:	R	Area:	5010.00 SqFt	PCI:	91		
Sample Comments:									
48	L & T CR	L	130.00	Ft

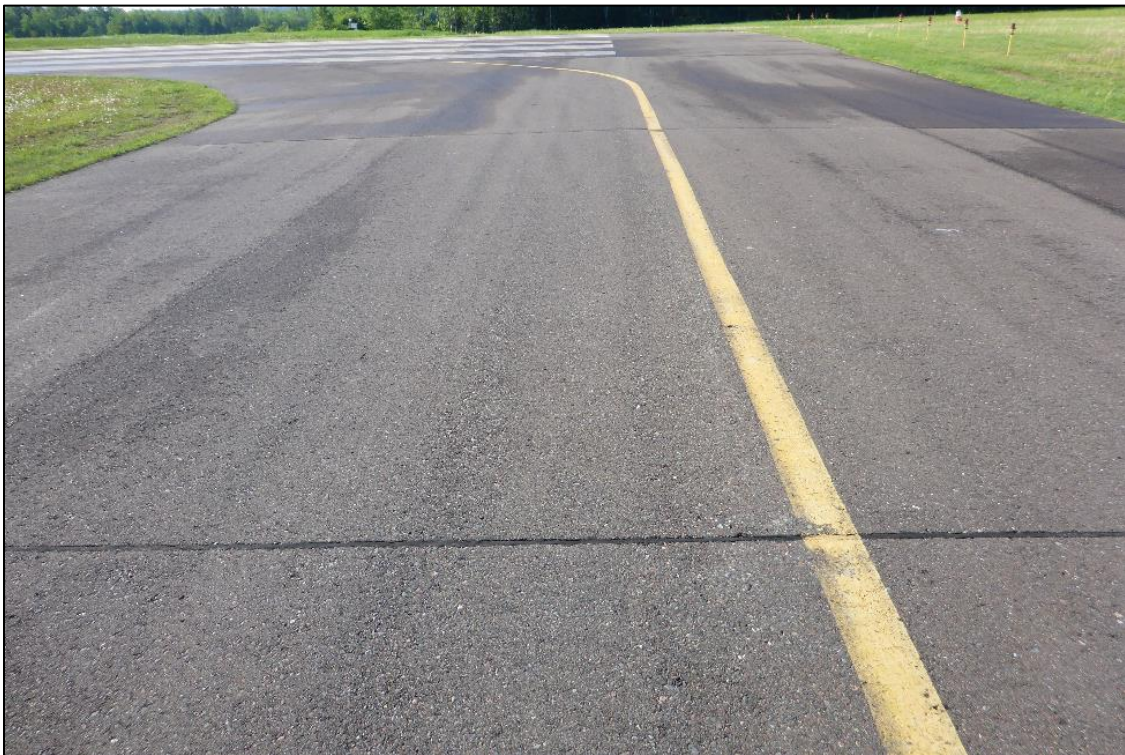
TWM CTF 001 (PCI = 87)

Network:	TWM	Name:	TWO HARBORS						
Branch:	CTF	Name:	CONNECTING TAXIWAY F	Use:	TAXIWAY	Area:	12,050 SqFt		
Section:	001	of 2	From:	100	To:	100	Last Const.:	10/1/2011	
Surface:	AC	Family:	MN2013 Asphalt Taxiways	Zone:	N	Category:	1	Rank:	P
Area:	4,600 SqFt	Length:	107 Ft	Width:	40 Ft				
Slabs:		Slab Length:	Ft	Slab Width:	Ft	Joint Length:	Ft		
Shoulder:		Street Type:		Grade:	0	Lanes:	0		
Section Comments:									
Last Insp. Date:	6/10/2017	TotalSamples:	1	Surveyed:	1				
Conditions:	PCI: 87								
Inspection Comments:									
Sample Number:	100	Type:	R	Area:	4615.00 SqFt	PCI:	87		
Sample Comments:									
48	L & T CR	L	112.00	Ft					
48	L & T CR	M	8.00	Ft

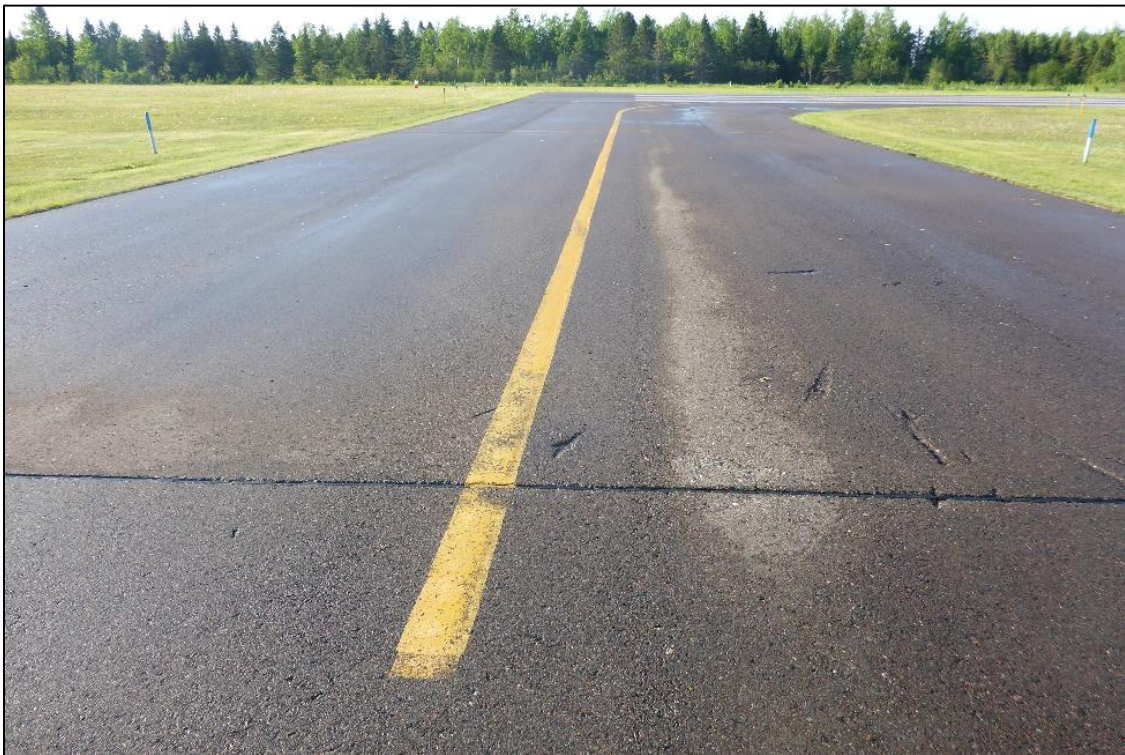
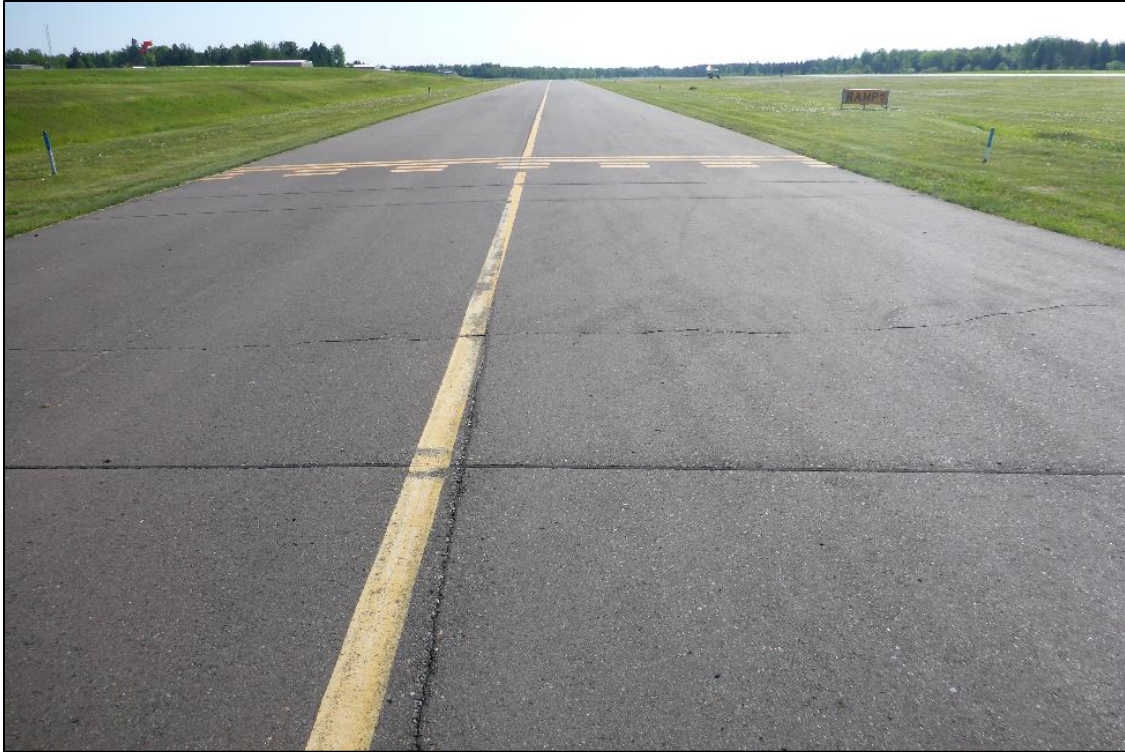
TWM PTA 001 (PCI = 84)

Network:	TWM	Name:	TWO HARBORS						
Branch:	PTA	Name:	PARALLEL TAXIWAY A	Use:	TAXIWAY	Area:	182,950 SqFt		
Section:	001	of 2	From:	100	To:	130	Last Const.:	10/1/2011	
Surface:	AC	Family:	MN2013 Asphalt Taxiways	Zone:	N	Category:	1	Rank:	P
Area:	119,450 SqFt	Length:	2,755 Ft	Width:	35 Ft				
Slabs:		Slab Length:	Ft	Slab Width:	Ft	Joint Length:	Ft		
Shoulder:		Street Type:		Grade:	0	Lanes:	0		
Section Comments:									
Last Insp. Date:	6/10/2017	TotalSamples:	31	Surveyed:	6				
Conditions:	PCI: 84								
Inspection Comments:									
Sample Number:	104	Type:	R	Area:	3500.00 SqFt	PCI:	77		
Sample Comments:									
48	L & T CR	L		226.00	Ft				
48	L & T CR	M		31.00	Ft				
Sample Number:	111	Type:	R	Area:	3500.00 SqFt	PCI:	75		
Sample Comments:									
48	L & T CR	L		278.00	Ft				
48	L & T CR	M		11.00	Ft				
Sample Number:	118	Type:	R	Area:	3500.00 SqFt	PCI:	90		
Sample Comments:									
48	L & T CR	L		103.00	Ft

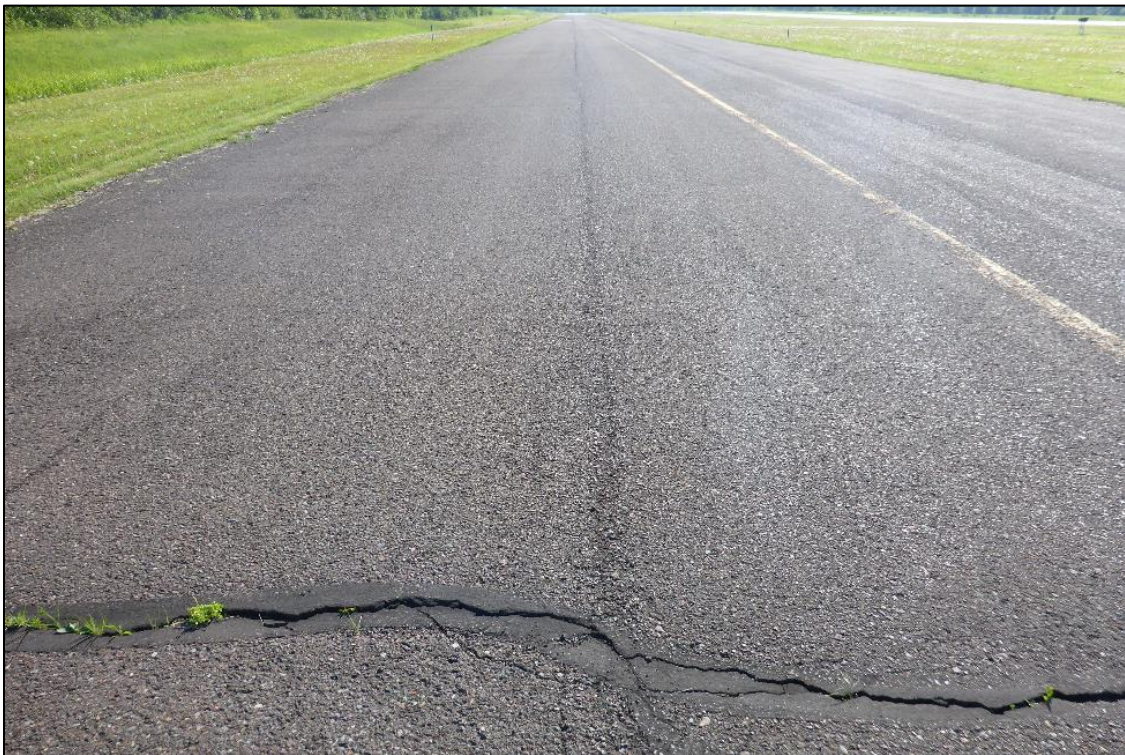
TWM PTA 002 (PCI = 67)

Network:	TWM	Name:	TWO HARBORS						
Branch:	PTA	Name:	PARALLEL TAXIWAY A	Use:	TAXIWAY	Area:	182,950 SqFt		
Section:	002	of 2	From:	100	To:	115	Last Const.:	9/20/2005	
Surface:	AC	Family:	MN2013 Asphalt Taxiways	Zone:	N	Category:	1	Rank:	P
Area:	63,500 SqFt	Length:	1,560 Ft	Width:	40 Ft				
Slabs:		Slab Length:	Ft	Slab Width:	Ft	Joint Length:	Ft		
Shoulder:		Street Type:		Grade:	0	Lanes:	0		
Section Comments:									
Last Insp. Date:	6/10/2017	TotalSamples:	16	Surveyed:	4				
Conditions:	PCI: 67								
Inspection Comments:									
Sample Number:	101	Type:	R	Area:	4000.00 SqFt	PCI:	70		
Sample Comments:									
48	L & T CR	L	143.00	Ft					
48	L & T CR	M	44.00	Ft					
57	WEATHERING	M	3000.00	SqFt					
57	WEATHERING	L	1000.00	SqFt					
Sample Number:	103	Type:	R	Area:	4000.00 SqFt	PCI:	70		
Sample Comments:									
48	L & T CR	L	213.00	Ft					
48	L & T CR	M	38.00	Ft					
57	WEATHERING	M	2500.00	SqFt					
57	WEATHERING	L	1500.00	SqFt

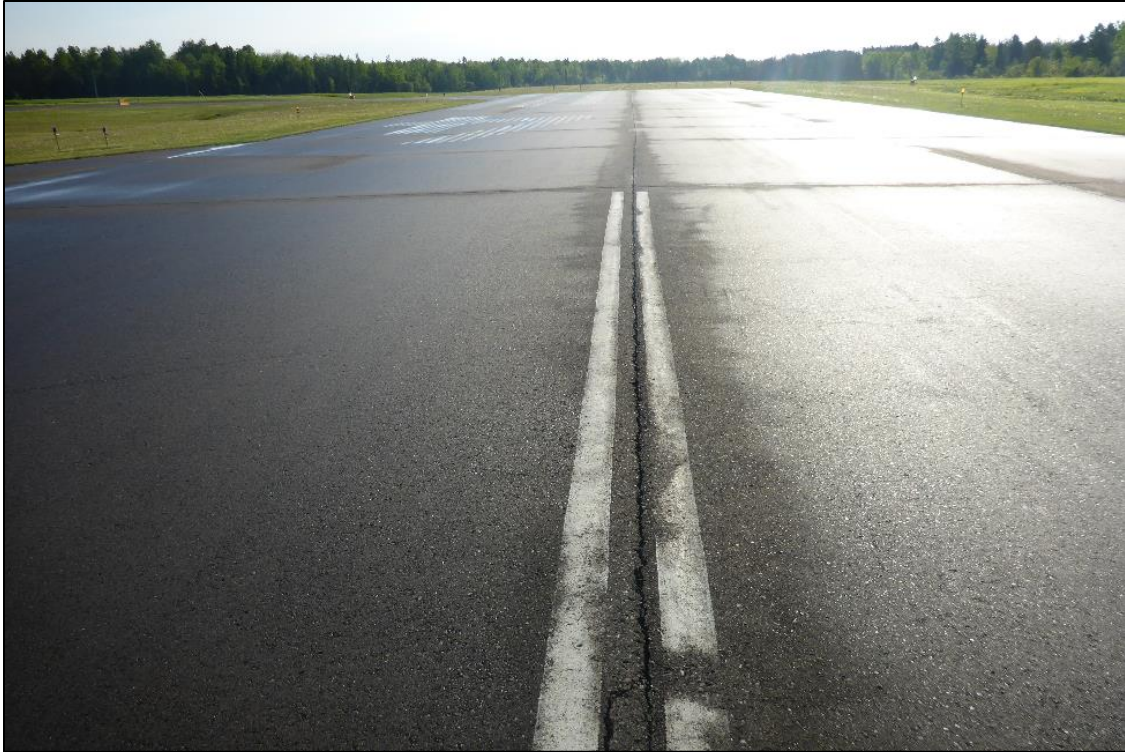
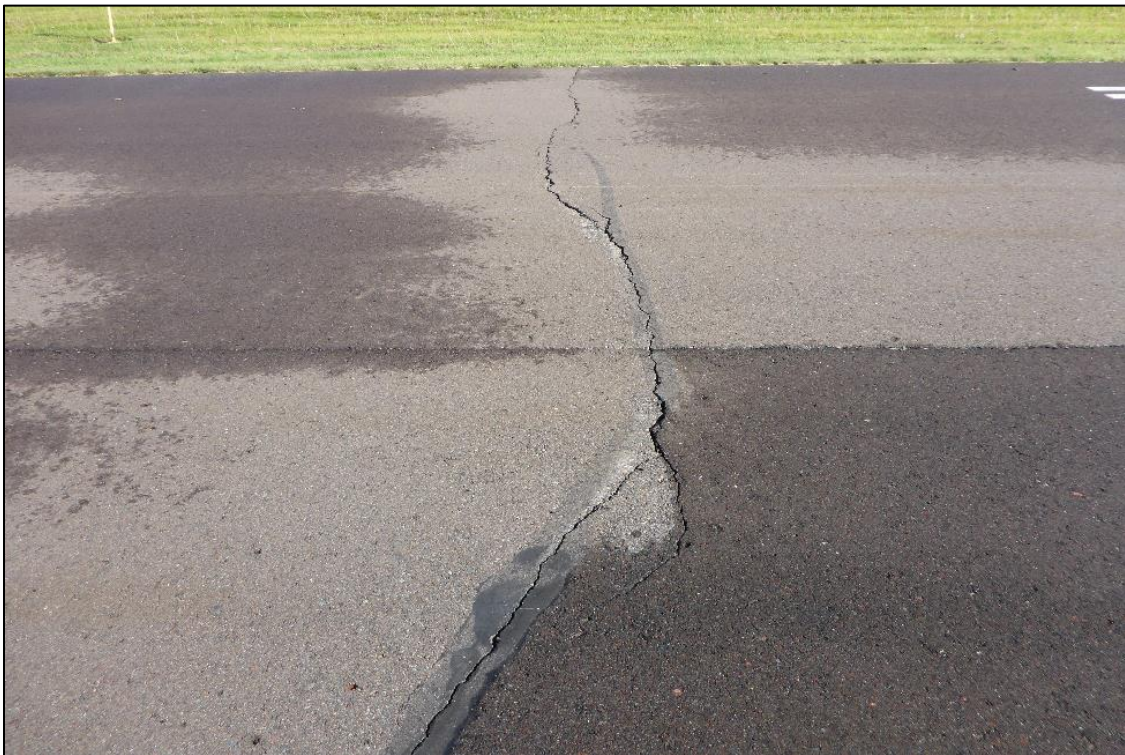
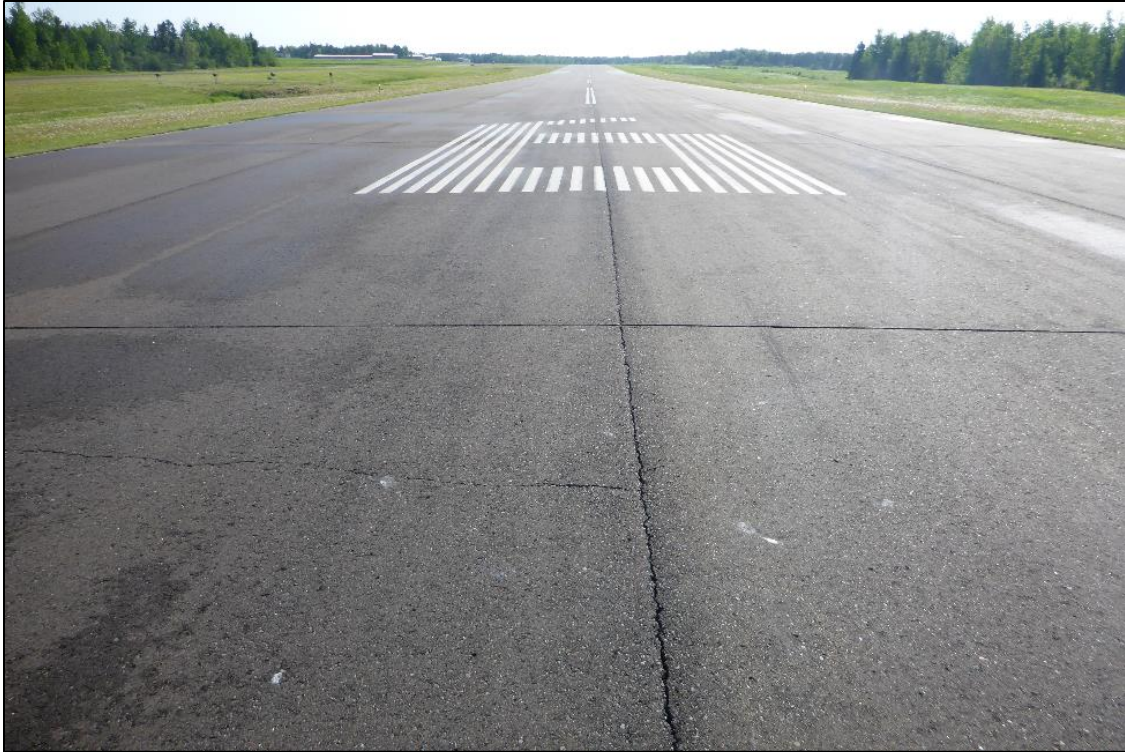
TWM RY624 001 (PCI = 83)

Network:	TWM	Name:	TWO HARBORS						
Branch:	RY624	Name:	RUNWAY 6-24	Use:	RUNWAY	Area:	330,000 SqFt		
Section:	001	of 1	From:	100	To:	187	Last Const.:	10/1/2011	
Surface:	AC	Family:	MN2013 Asphalt Runways	Zone:	N	Category:	1	Rank:	P
Area:	330,000 SqFt	Length:	4,400 Ft	Width:	75 Ft				
Slabs:		Slab Length:	Ft	Slab Width:	Ft	Joint Length:	Ft		
Shoulder:		Street Type:		Grade:	0	Lanes:	0		
Section Comments:									
Last Insp. Date:	6/10/2017	TotalSamples:	88	Surveyed:	9				
Conditions:	PCI: 83								
Inspection Comments:									
Sample Number:	108	Type:	R	Area:	3750.00 SqFt	PCI:	78		
Sample Comments:									
48	L & T CR	L	223.00	Ft					
48	L & T CR	M	8.00	Ft					
Sample Number:	117	Type:	R	Area:	3750.00 SqFt	PCI:	79		
Sample Comments:									
48	L & T CR	L	215.00	Ft					
48	L & T CR	M	16.00	Ft					
Sample Number:	126	Type:	R	Area:	3750.00 SqFt	PCI:	81		
Sample Comments:									
48	L & T CR	L	171.00	Ft					
48	L & T CR	M	36.00	Ft

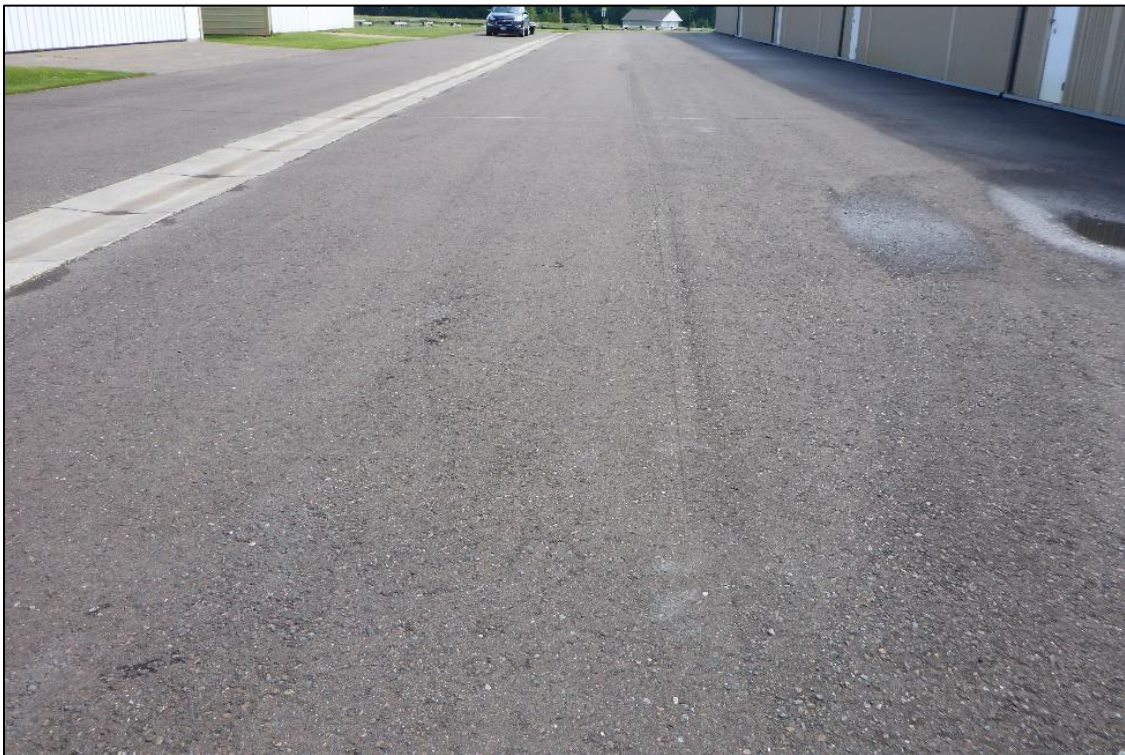
TWM TLA 001 (PCI = 94)

Network:	TWM	Name:	TWO HARBORS						
Branch:	TLA	Name:	TAXILANE A	Use:	TAXILANE	Area:	25,600 SqFt		
Section:	001	of 1	From:	100	To:	201	Last Const.:	10/1/2011	
Surface:	AC	Family:	MN2013 Asphalt Taxilanes	Zone:		Category:		Rank:	T
Area:	25,600 SqFt	Length:	280 Ft	Width:	153 Ft				
Slabs:		Slab Length:	Ft	Slab Width:	Ft	Joint Length:	Ft		
Shoulder:		Street Type:		Grade:	0	Lanes:	0		
Section Comments:	est LCD								
Last Insp. Date:	6/10/2017	TotalSamples:	4	Surveyed:	1				
Conditions:	PCI: 94								
Inspection Comments:									
Sample Number:	100	Type:	R	Area:	5000.00 SqFt	PCI:	94		
Sample Comments:									
48	L & T CR	L	45.00	Ft					
57	WEATHERING	L	500.00	SqFt

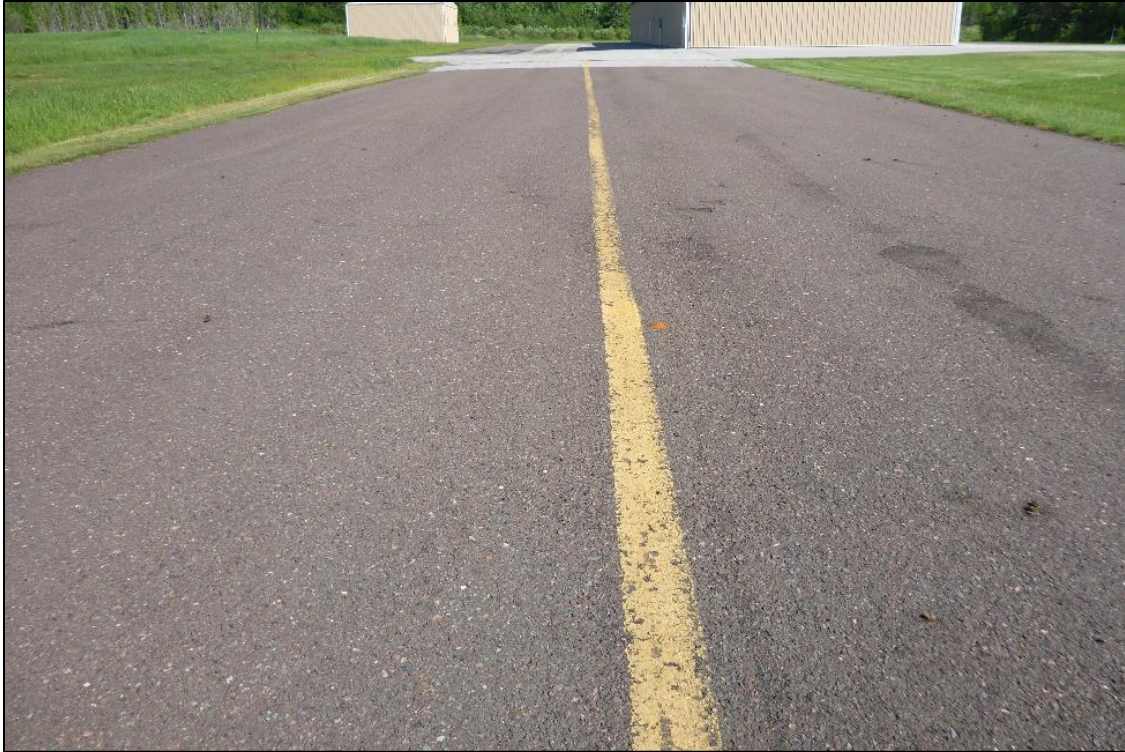
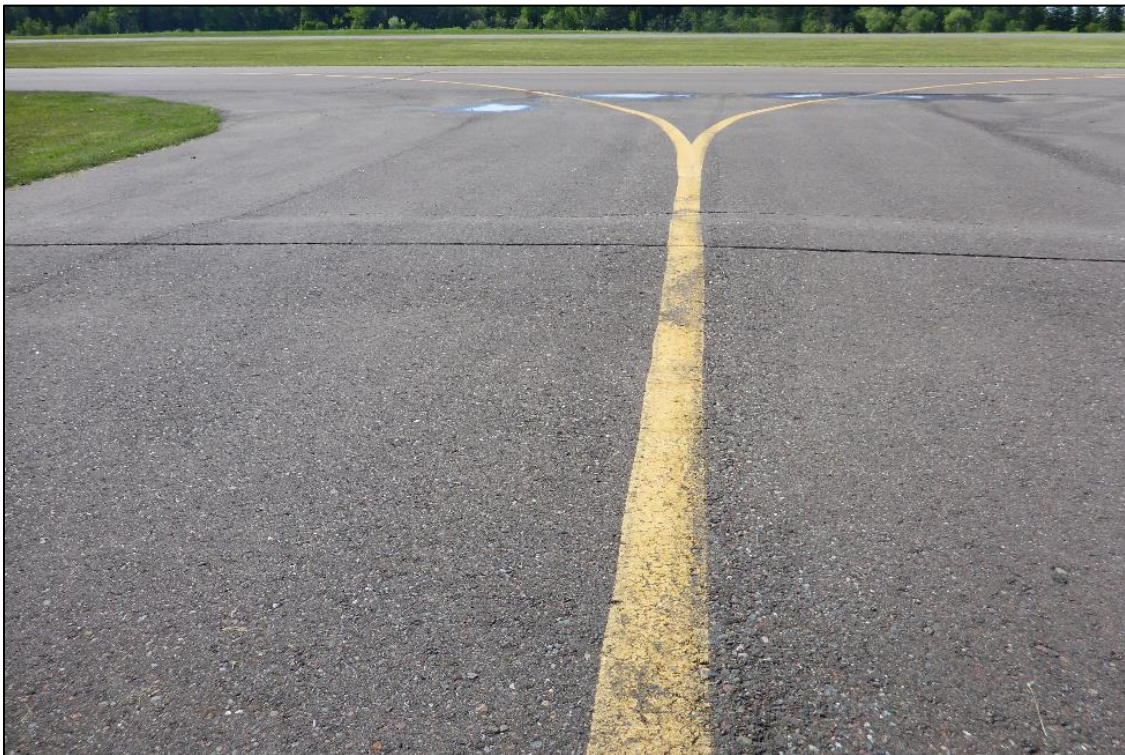
TWM TLC 001 (PCI = 72)

Network:	TWM	Name:	TWO HARBORS						
Branch:	TLC	Name:	TAXILANE C	Use:	TAXILANE	Area:	50,650 SqFt		
Section:	001	of 2	From:	100	To:	102	Last Const.:	9/30/2005	
Surface:	AC	Family:	MN2013 Asphalt Taxilanes	Zone:	N	Category:	1	Rank:	T
Area:	5,450 SqFt	Length:	140 Ft	Width:	40 Ft				
Slabs:		Slab Length:	Ft	Slab Width:	Ft	Joint Length:	Ft		
Shoulder:		Street Type:		Grade:	0	Lanes:	0		
Section Comments:									
Last Insp. Date:	6/10/2017	TotalSamples:	2	Surveyed:	1				
Conditions:	PCI: 72								
Inspection Comments:									
Sample Number:	101	Type:	R	Area:	4000.00 SqFt	PCI:	72		
Sample Comments:									
48	L & T CR	L	218.00	Ft					
50	PATCHING	L	32.00	SqFt					
57	WEATHERING	M	4000.00	SqFt
