Pavement Condition Report

Longville Municipal Airport (XVG)

December 2019

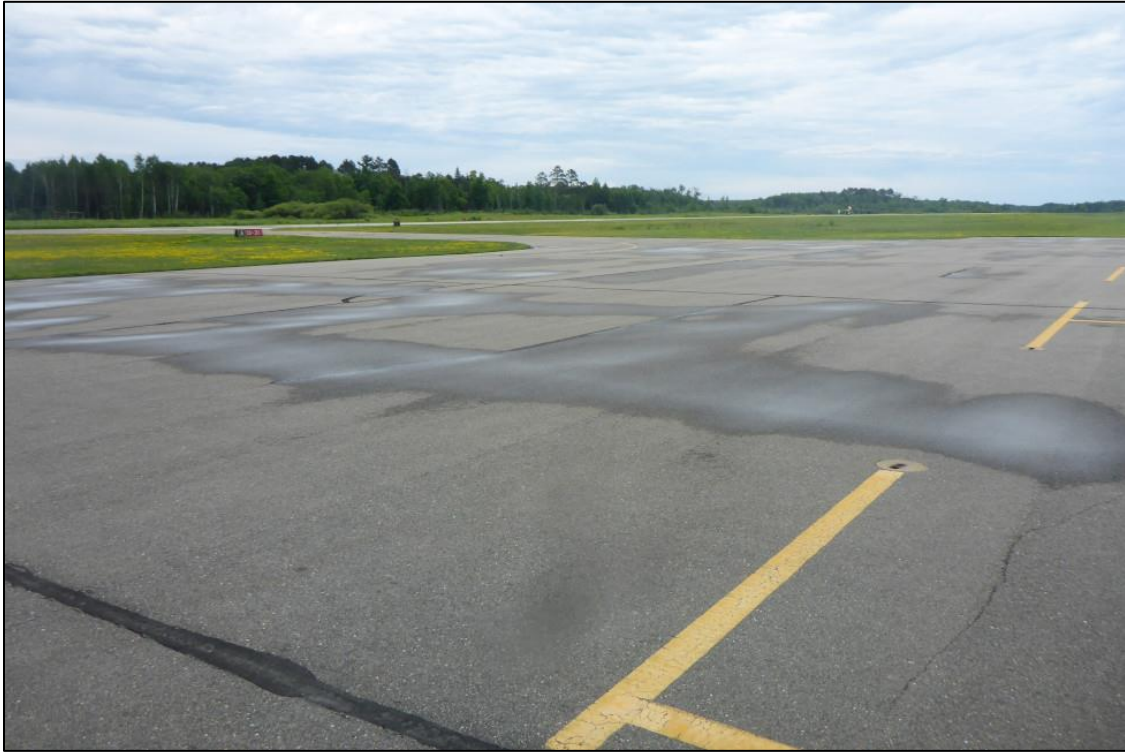
XVG APA 001 (PCI = 78)

Conditions: PCI: 78

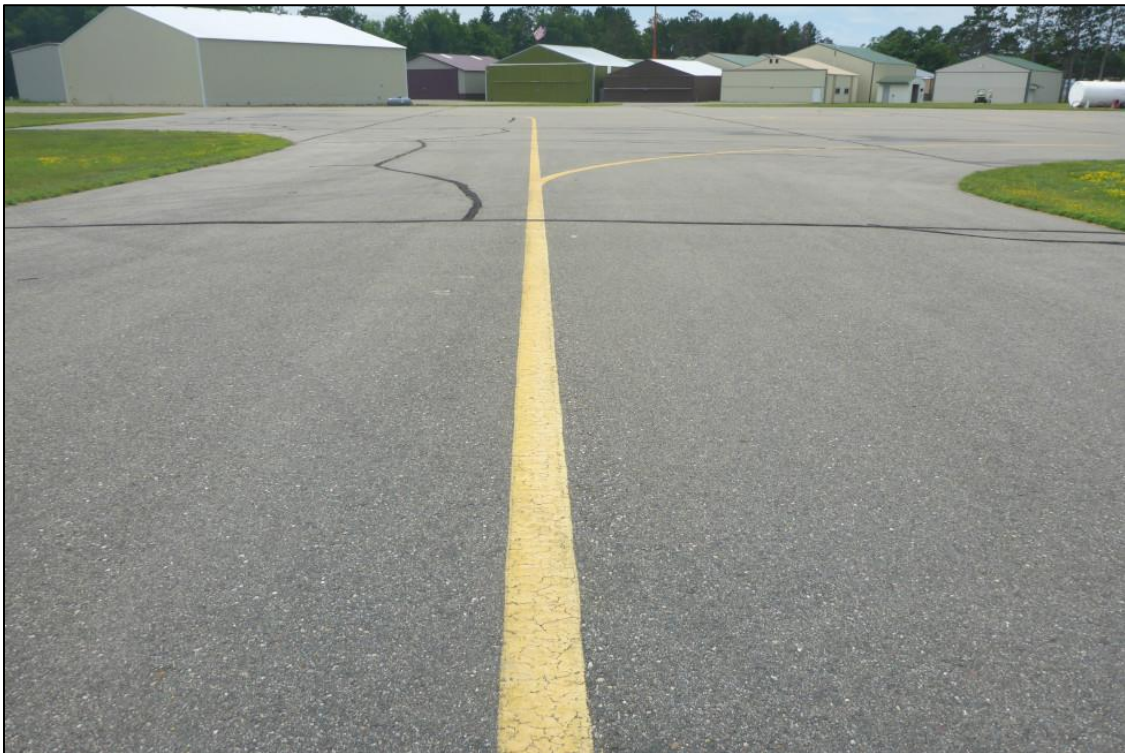
XVG CTA 001 (PCI = 86)

Network:	XVG	Name:	LONGVILLE						
Branch:	CTA	Name:	CONNECTING TAXIWAY A	Use:	TAXIWAY	Area:	7,870 SqFt		
Section:	001	of 2	From:	101	To:	101	Last Const.:	10/1/2014	
Surface:	AC	Family:	MN2018 Asphalt Runway- Taxiways	Zone:	N	Category:	3	Rank:	P
Area:	3,370 SqFt	Length:	81 Ft	Width:	40 Ft				
Slabs:		Slab Length:	Ft	Slab Width:	Ft	Joint Length:	Ft		
Shoulder:		Street Type:		Grade:	0	Lanes:	0		
Section Comments:									
Last Insp. Date:	7/16/2019	TotalSamples:	1	Surveyed:	1				
Conditions:	PCI: 86								
Inspection Comments:									
Sample Number:	101	Type:	R	Area:	3370.00 SqFt	PCI:	86		
Sample Comments:	pic 587								
48	L & T CR	L	146.00 Ft						
57	WEATHERING	L	50.00 SqFt

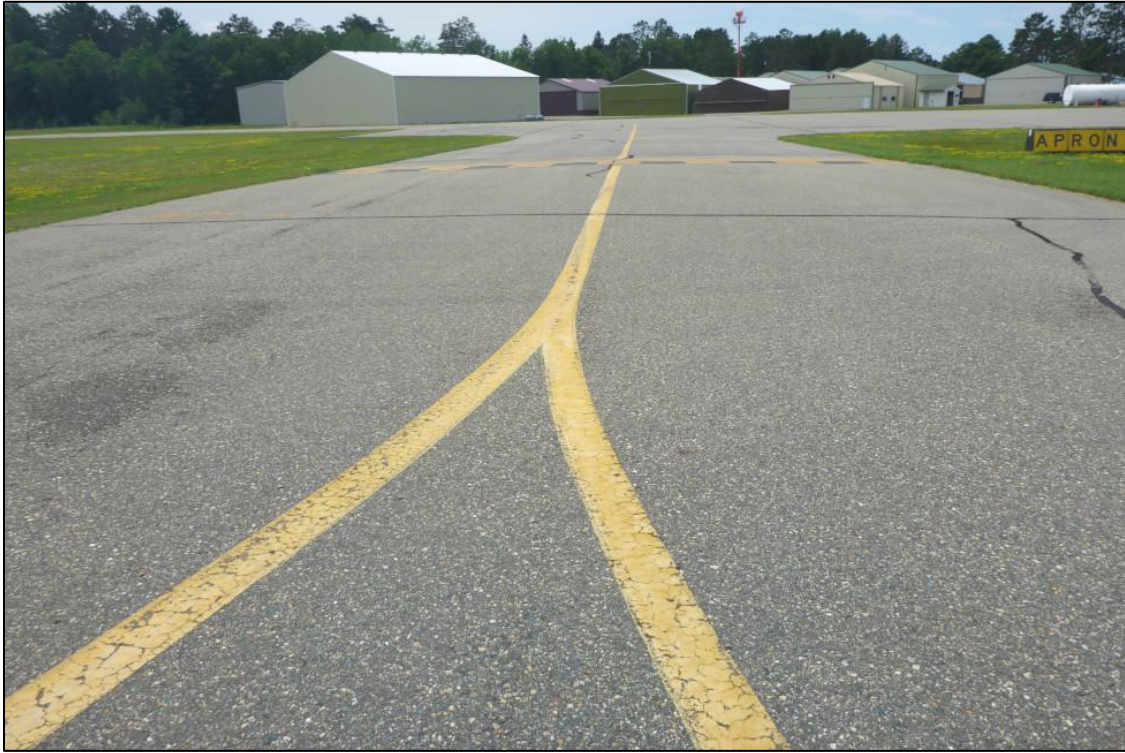
XVG CTA 002 (PCI = 80)

Network:	XVG	Name:	LONGVILLE						
Branch:	CTA	Name:	CONNECTING TAXIWAY A	Use:	TAXIWAY	Area:	7,870 SqFt		
Section:	002	of 2	From:	100	To:	100	Last Const.:	10/1/2009	
Surface:	AAC	Family:	MN2018 Asphalt Runway- Taxiways	Zone:	N	Category:	3	Rank:	P
Area:	4,500 SqFt	Length:	100 Ft	Width:	40 Ft				
Slabs:		Slab Length:	Ft	Slab Width:	Ft	Joint Length:	Ft		
Shoulder:		Street Type:		Grade:	0	Lanes:	0		
Section Comments:									
Last Insp. Date:	7/16/2019	TotalSamples:	1	Surveyed:	1				
Conditions:	PCI: 80								
Inspection Comments:									
Sample Number:	100	Type:	R	Area:	4500.00 SqFt	PCI:	80		
Sample Comments: pic 586									
48	L & T CR	L	213.00	Ft					
57	WEATHERING	L	3000.00	SqFt					
57	WEATHERING	M	10.00	SqFt

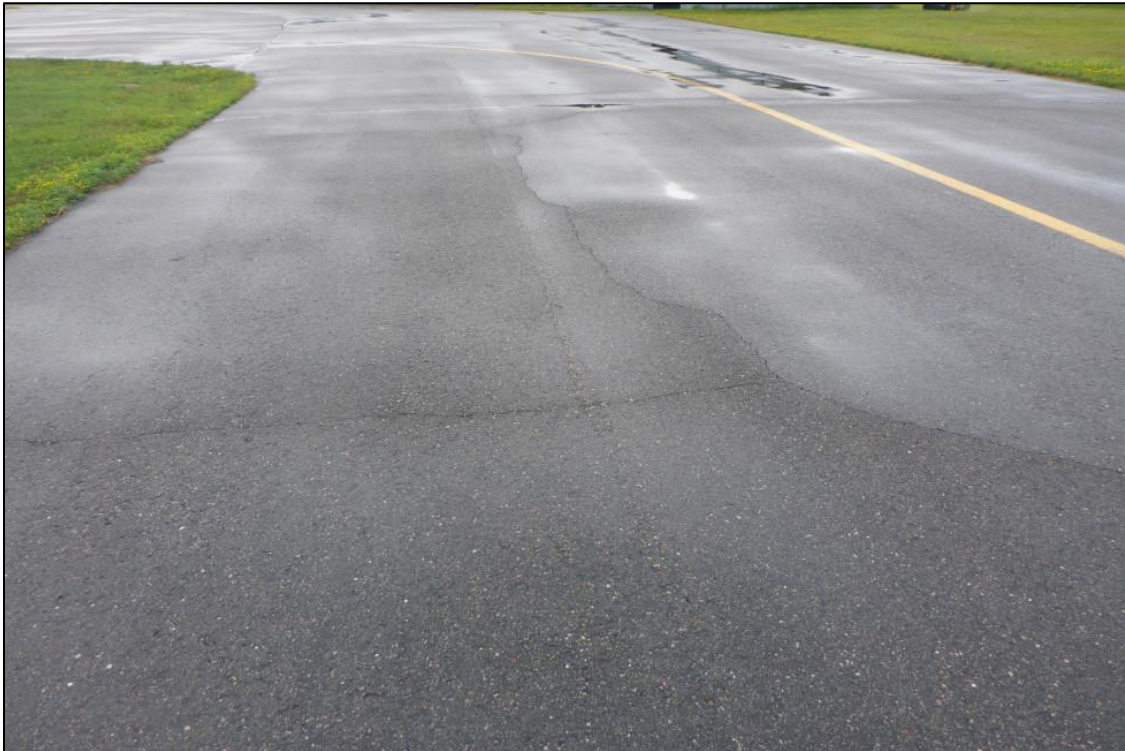
XVG CTB 001 (PCI = 83)

Network:	XVG	Name:	LONGVILLE						
Branch:	CTB	Name:	CONNECTING TAXIWAY B	Use:	TAXIWAY	Area:	7,620 SqFt		
Section:	001	of 2	From:	201	To:	201	Last Const.:	10/1/2014	
Surface:	AC	Family:	MN2018 Asphalt Runway- Taxiways	Zone:	N	Category:	3	Rank:	P
Area:	3,370 SqFt	Length:	81 Ft	Width:	40 Ft				
Slabs:		Slab Length:	Ft	Slab Width:	Ft	Joint Length:	Ft		
Shoulder:		Street Type:		Grade:	0	Lanes:	0		
Section Comments:									
Last Insp. Date:	7/16/2019	TotalSamples:	1	Surveyed:	1				
Conditions:	PCI: 83								
Inspection Comments:									
Sample Number:	201	Type:	R	Area:	3370.00 SqFt	PCI:	83		
Sample Comments:	pic 581								
48	L & T CR	L	164.00 Ft						
56	SWELLING	L	20.00 SqFt

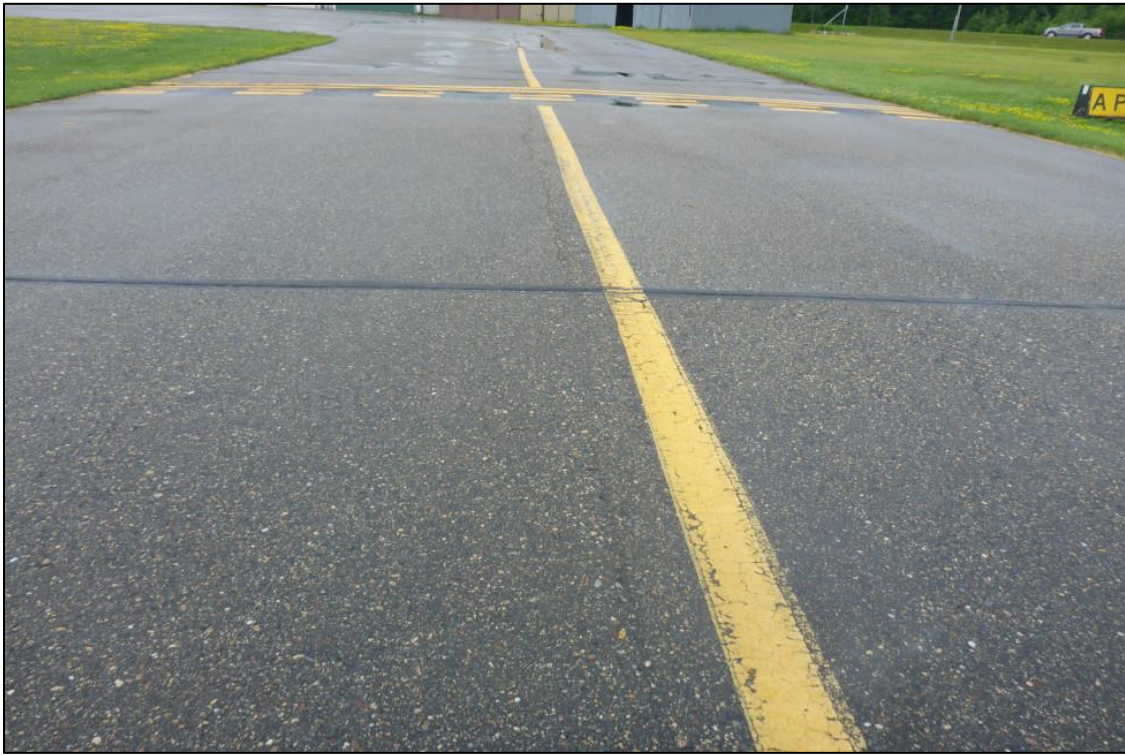
XVG CTB 002 (PCI = 78)

Conditions: PCI: 78

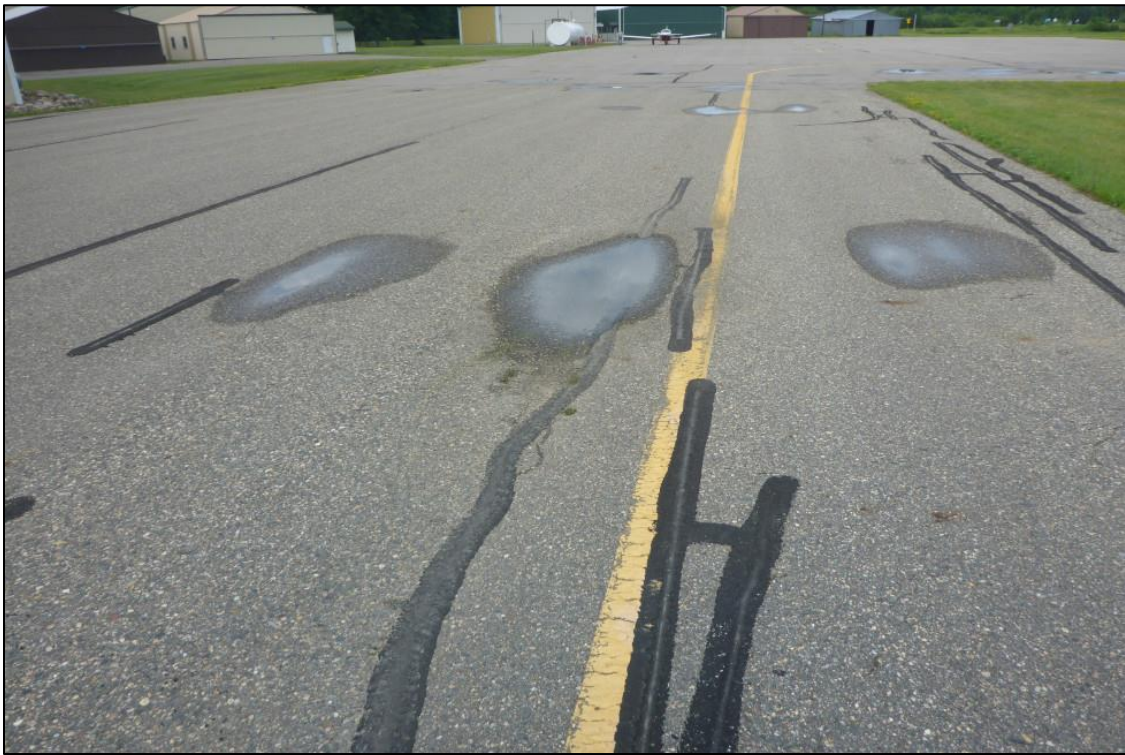
XVG CTC 001 (PCI = 42)

Conditions: PCI: 42

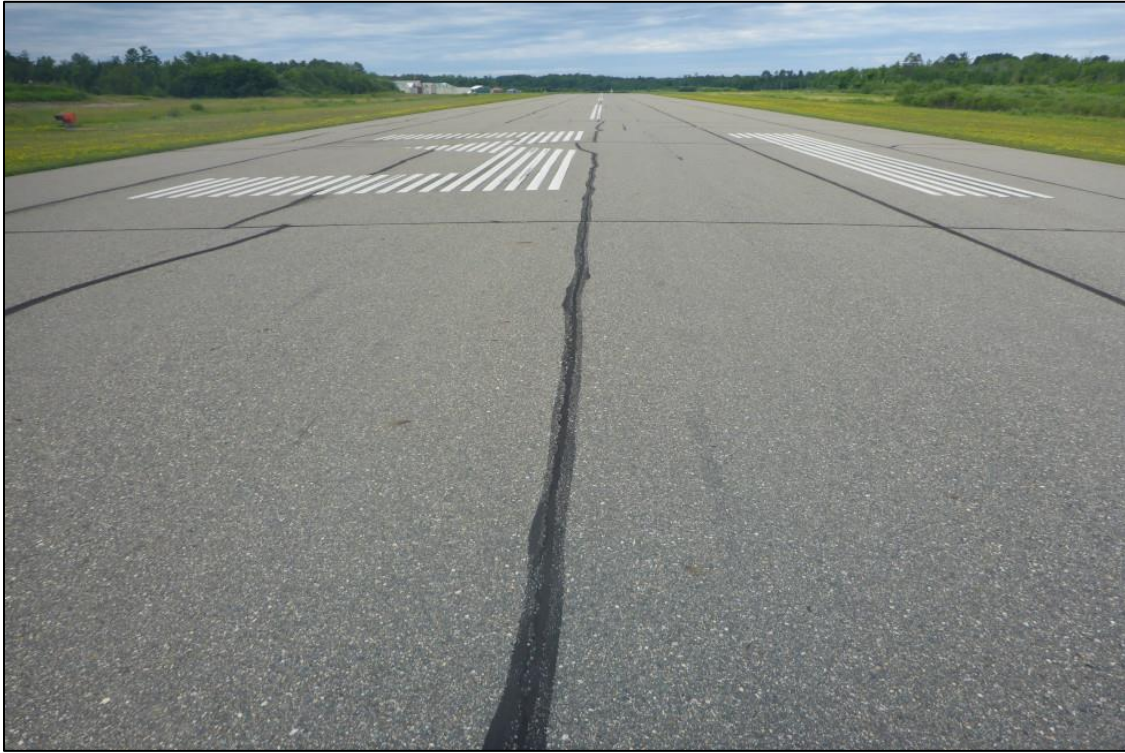
XVG RY1331 001 (PCI = 69)

Network:	XVG	Name:	LONGVILLE						
Branch:	RY1331	Name:	RUNWAY 13-31	Use:	RUNWAY	Area:	266,250 SqFt		
Section:	001	of 1	From:	100	To:	170	Last Const.:	10/1/2009	
Surface:	AC	Family:	MN2018 Asphalt Runway- Taxiways	Zone:	N	Category:	3	Rank:	P
Area:	266,250 SqFt	Length:	3,550 Ft	Width:	75 Ft				
Slabs:		Slab Length:	Ft	Slab Width:	Ft	Joint Length:	Ft		
Shoulder:		Street Type:		Grade:	0	Lanes:	0		
Section Comments:									
Last Insp. Date:	7/16/2019	TotalSamples:	71	Surveyed:	8				
Conditions:	PCI: 69								
Inspection Comments:									
Sample Number:	106	Type:	R	Area:	3750.00 SqFt	PCI:	65		
Sample Comments:	pic 582								
48	L & T CR	L	370.00	Ft					
48	L & T CR	M	13.00	Ft					
56	SWELLING	L	8.00	SqFt					
57	WEATHERING	L	2000.00	SqFt					
Sample Number:	115	Type:	R	Area:	3750.00 SqFt	PCI:	72		
Sample Comments:									
48	L & T CR	L	241.00	Ft					
48	L & T CR	M	29.00	Ft					
57	WEATHERING	L	3500.00	SqFt

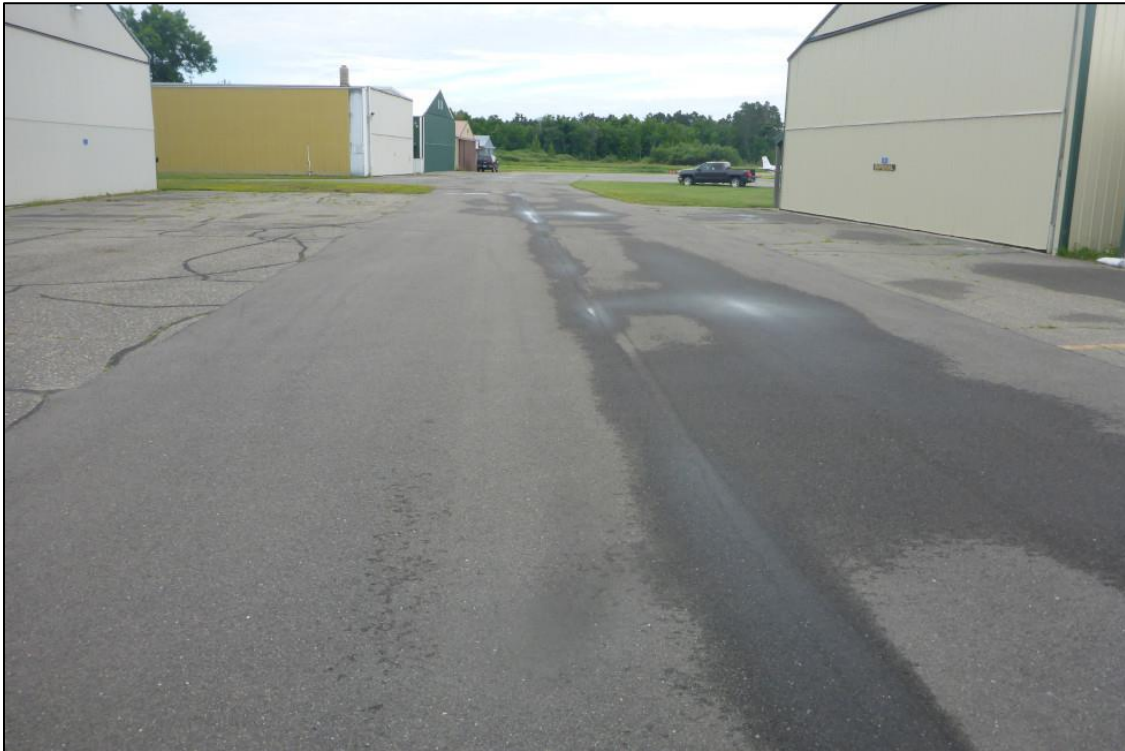
XVG TLA 001 (PCI = 89)

Network:	XVG	Name:	LONGVILLE						
Branch:	TLA	Name:	Taxilane A	Use:	TAXILANE	Area:	7,175 SqFt		
Section:	001	of 1	From:	100	To:	102	Last Const.:	6/1/2016	
Surface:	AAC	Family:	MN2018 Asphalt Taxilanes	Zone:	N	Category:	3	Rank:	T
Area:	7,175 SqFt	Length:	287 Ft	Width:	25 Ft				
Slabs:	Slab Length:	Ft	Slab Width:	Ft	Joint Length:	Ft			
Shoulder:	Street Type:	Grade:	0	Lanes:	0				
Section Comments:									
Last Insp. Date:	7/16/2019	TotalSamples:	3	Surveyed:	2				
Conditions:	PCI: 89								
Inspection Comments:									
Sample Number:	101	Type:	R	Area:	2600.00 SqFt	PCI:	85		
Sample Comments: p119									
48	L & T CR	L	86.00	Ft					
48	L & T CR	M	3.00	Ft					
Sample Number:	102	Type:	R	Area:	2600.00 SqFt	PCI:	93		
Sample Comments: p118									
48	L & T CR	L	43.00	Ft

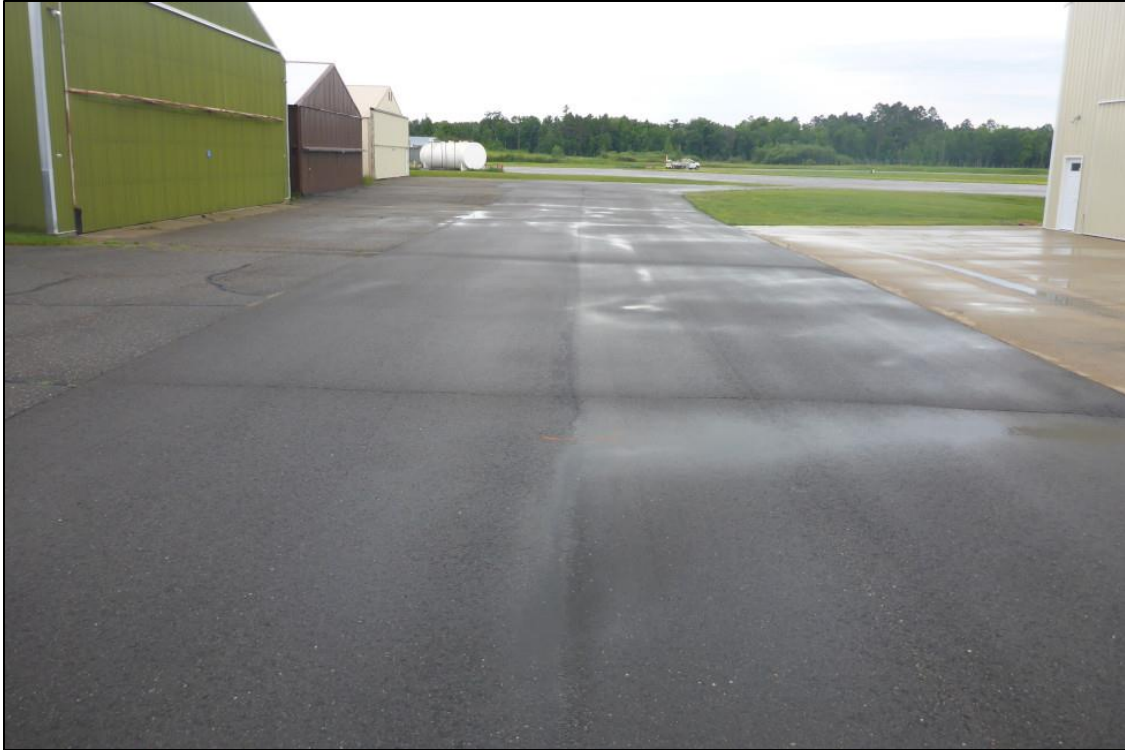
XVG TLB 001 (PCI = 84)

Network:	XVG	Name:	LONGVILLE						
Branch:	TLB	Name:	Taxilane B	Use:	TAXILANE	Area:	5,750 SqFt		
Section:	001	of 1	From:	100	To:	102	Last Const.: 6/1/2016		
Surface:	AAC	Family:	MN2018 Asphalt Taxilanes	Zone:	N	Category:	3	Rank:	T
Area:	5,750 SqFt	Length:	290 Ft	Width:	25 Ft				
Slabs:	Slab Length:	Ft	Slab Width:	Ft	Joint Length:	Ft			
Shoulder:	Street Type:		Grade:	0	Lanes:	0			
Section Comments:									
Last Insp. Date:	7/16/2019	TotalSamples:	2	Surveyed:	1				
Conditions:	PCI: 84								
Inspection Comments:									
Sample Number:	101	Type:	R	Area:	2500.00 SqFt	PCI:	84		
Sample Comments:	p116,117								
48	L & T CR	L	120.00	Ft					
56	SWELLING	L	15.00	SqFt

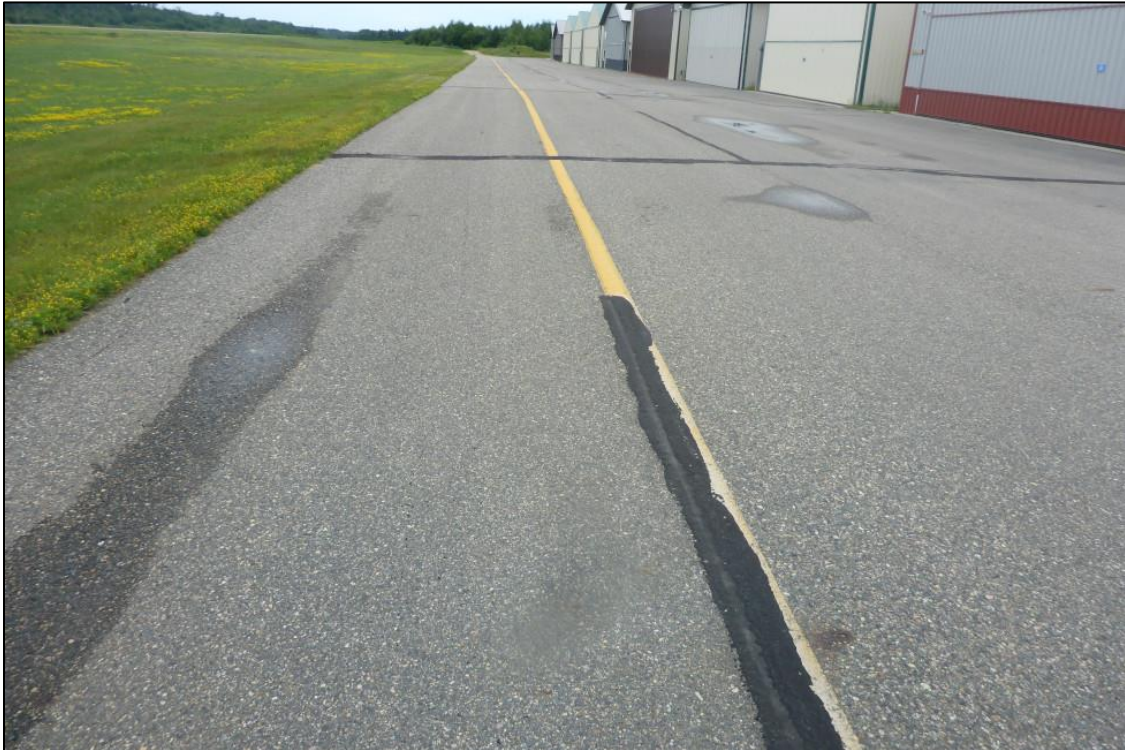
XVG TLC 001 (PCI = 67)

Conditions: PCI: 67

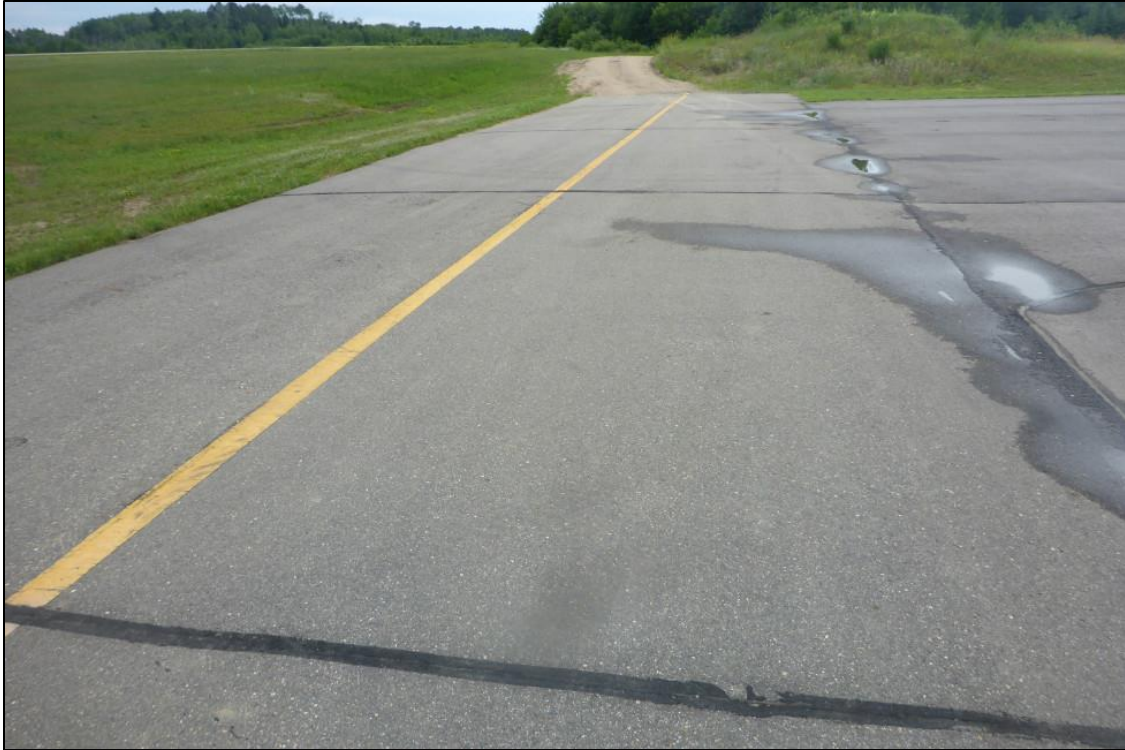
XVG TLC 002 (PCI = 87)

Conditions: PCI: 87
