Special Bridge Inspection Report

Bridge #38010

Mn Hwy 61 over the Gooseberry River (Gooseberry Falls)
(Mn/DOT District D1-A - Duluth)

Inspection Date: August 6, 2007

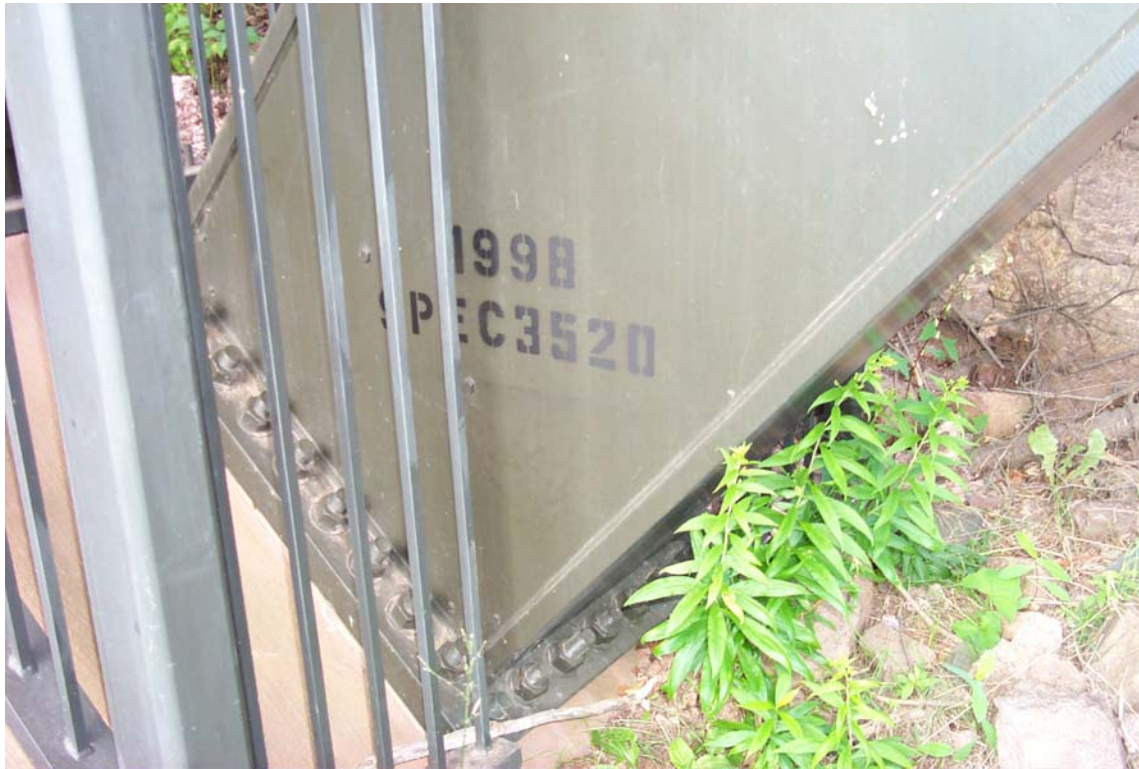
Photo #1: Typical arch footing

The truss spans were accessed using a Reachall UB-50 "snooper" - a shoulder closure and flagging was required. Approximately six hours were required for the inspection. The superstructure, substructure, and bridge deck were visually inspected. Ultrasonic testing was performed on the arch bearing anchor bolts at all four arch footings (see photo #1).

Each arch footing has 34 threaded steel anchor bolts imbedded in the concrete footings - the plans show these bolts as being 38mm in diameter and 1,250 mm (50.4") long, with a minimum embedment length of 1,000 mm (39.4"). Ultrasonic examination of the arch footing anchor bolts indicated that the anchor bolts generally had a length 48", and 16 of the anchor bolts had a length of only 19". These were found on the southwest, northwest, and northeast arch footings (see diagrams at end of report). These findings will be reviewed by the Mn/DOT Bridge Office.

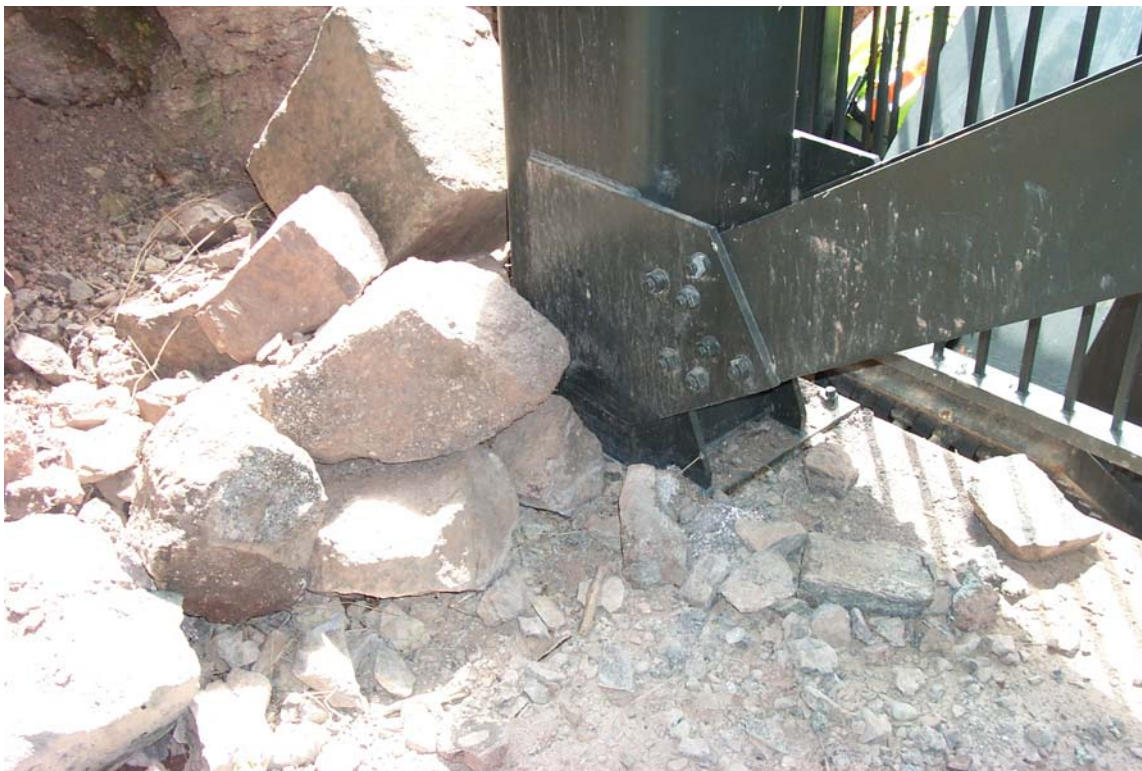
Some large rocks have fallen near the east footing of Pier #4 (near the northeast arch footing). While it does not appear that the pier column has been damaged, the rocks and debris should be removed to prevent corrosion and allow easier inspection (see photo #2).

Photo #2: Debris at Pier #4 (east column)

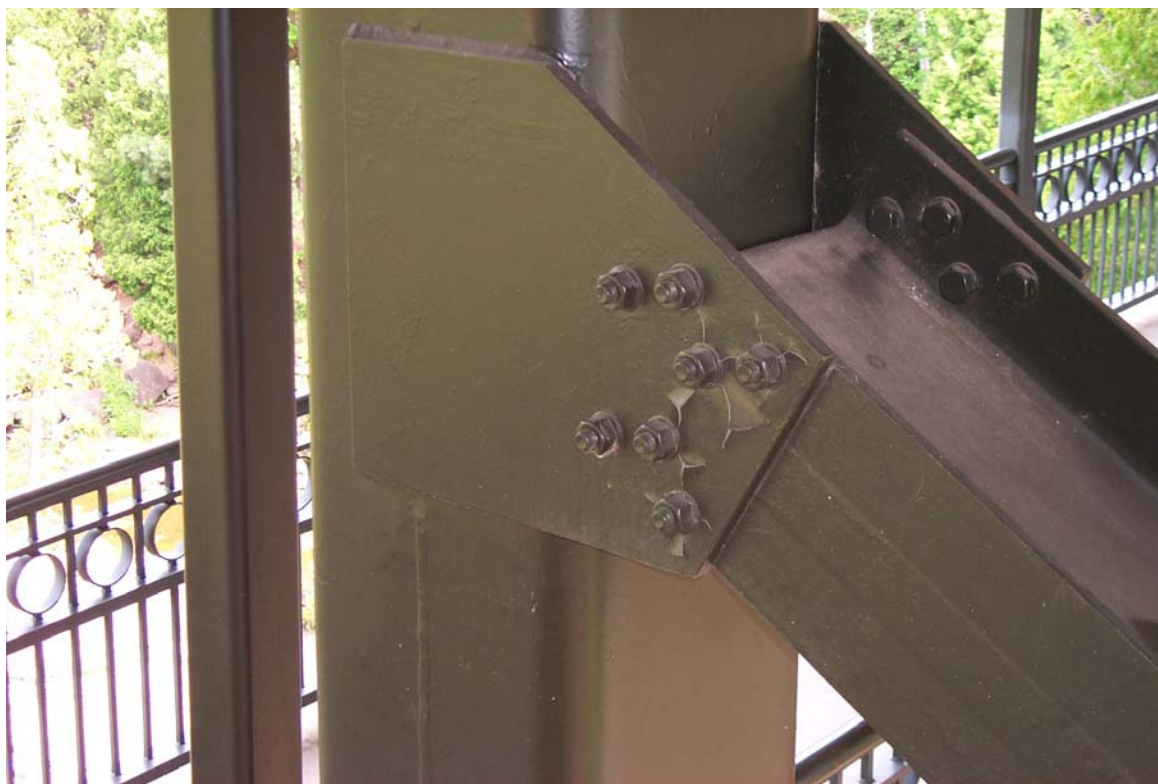
There are some isolated areas of paint failure and superficial corrosion on the superstructure (see photos #3 & 4) - this should probably warrant a slightly lower NBI superstructure condition rating (8 - Very Good Condition).

Photo #3: Paint failure on pier bracing connection (typical)

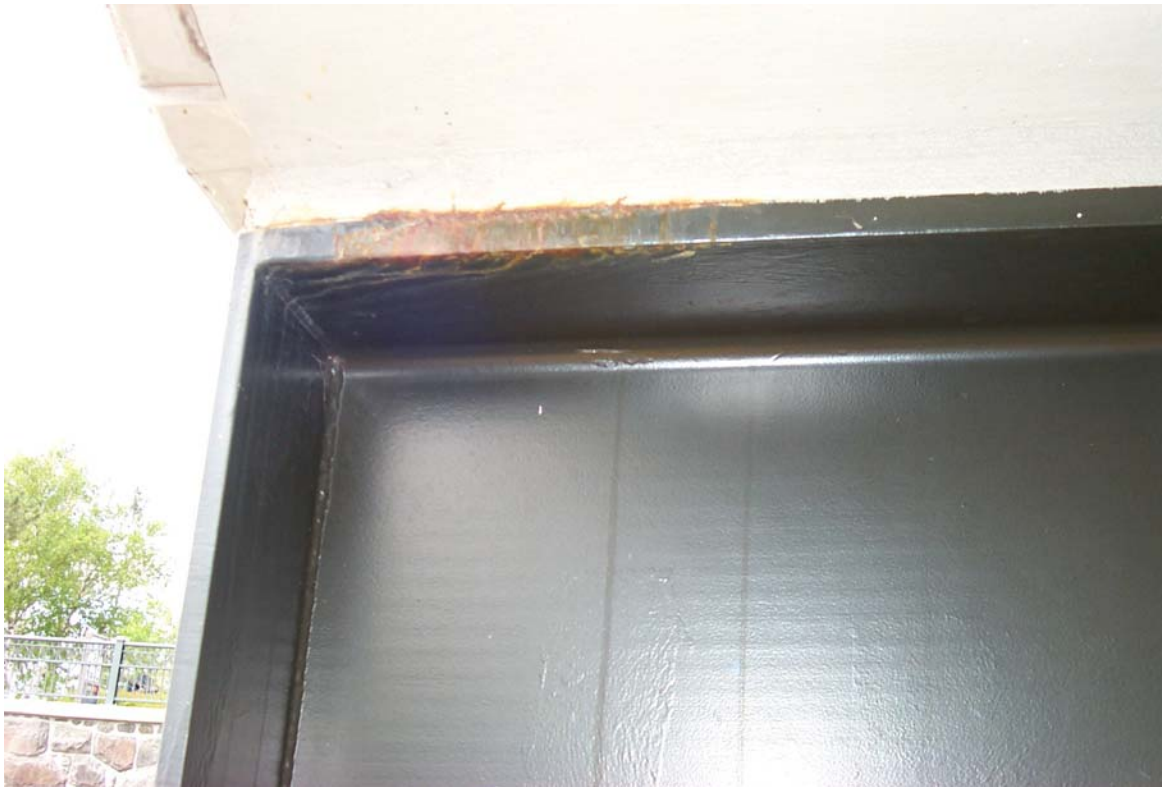
Photo #4: Minor corrosion on floorbeam end (typical)

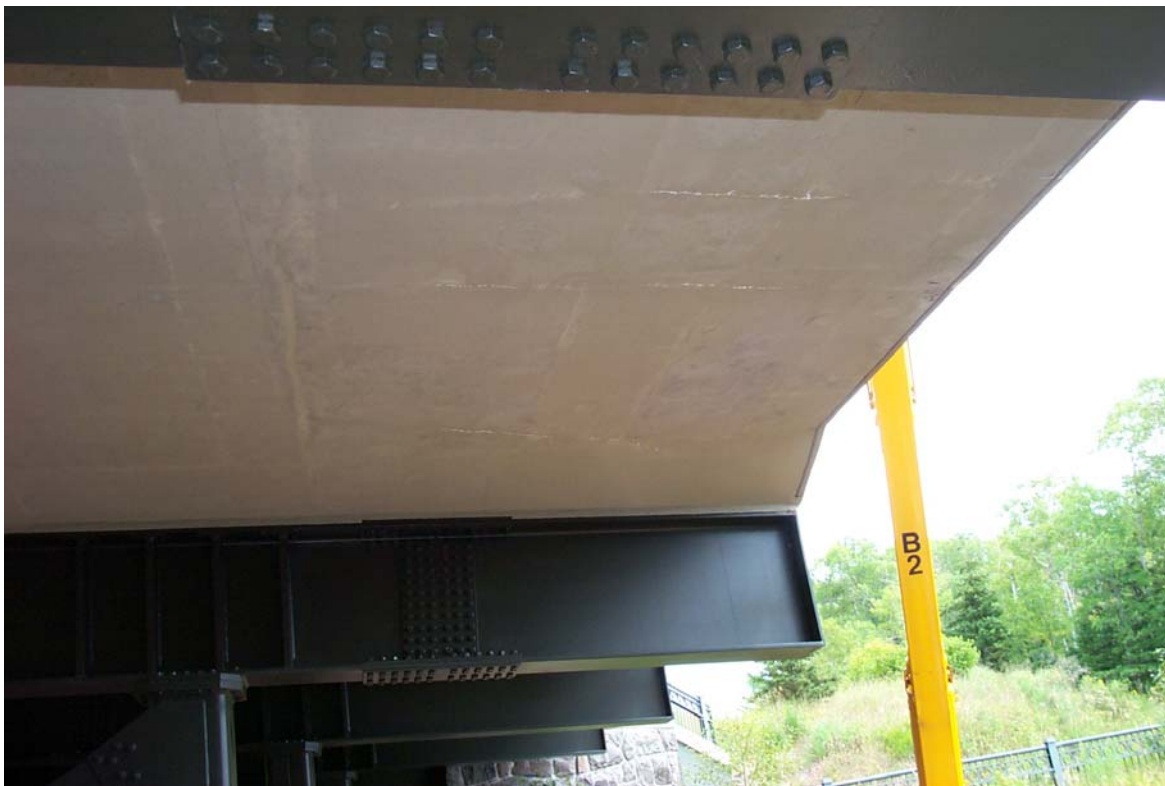
There are some isolated light leaching cracks on the underside of the deck (see photo #5) - this should probably warrant a slightly lower NBI deck condition rating (8 - Very Good Condition).

Photo #5: Light leaching cracks on underside of deck

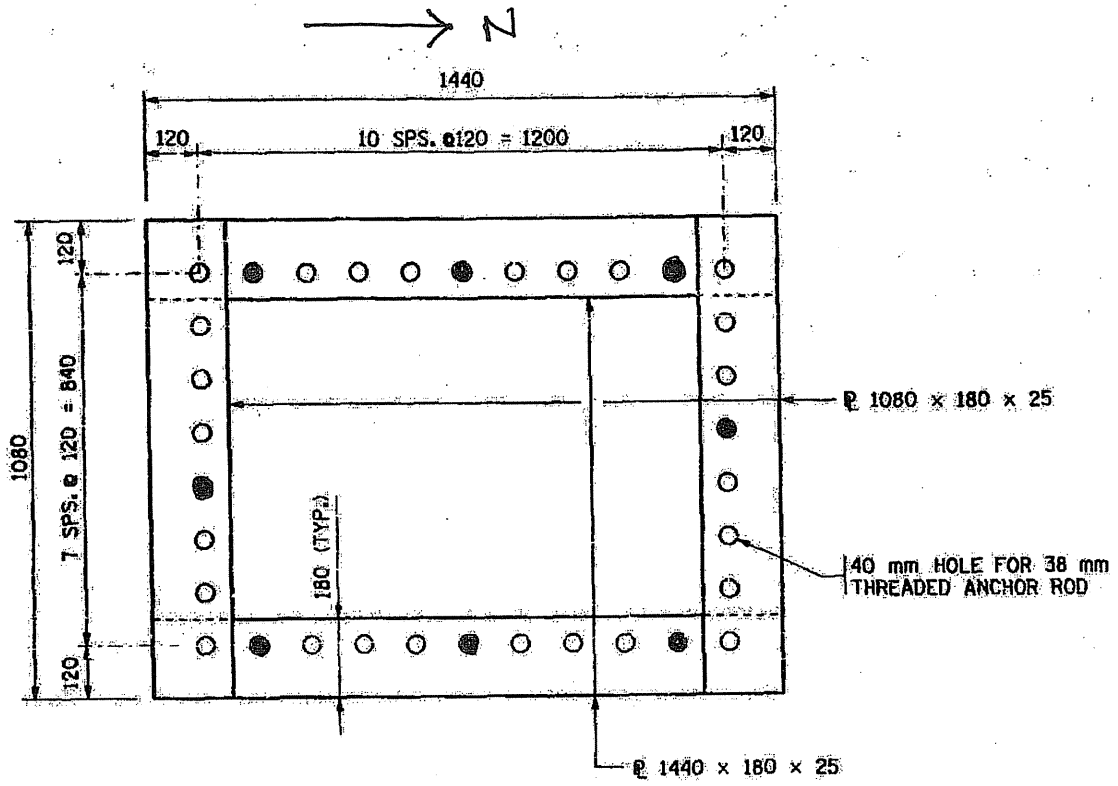
SOUTH WEST ARCH FOOTING
LOCATIONS WITH UT LENGTH OF 19" ARE
INDICATED BY A SOLID ●

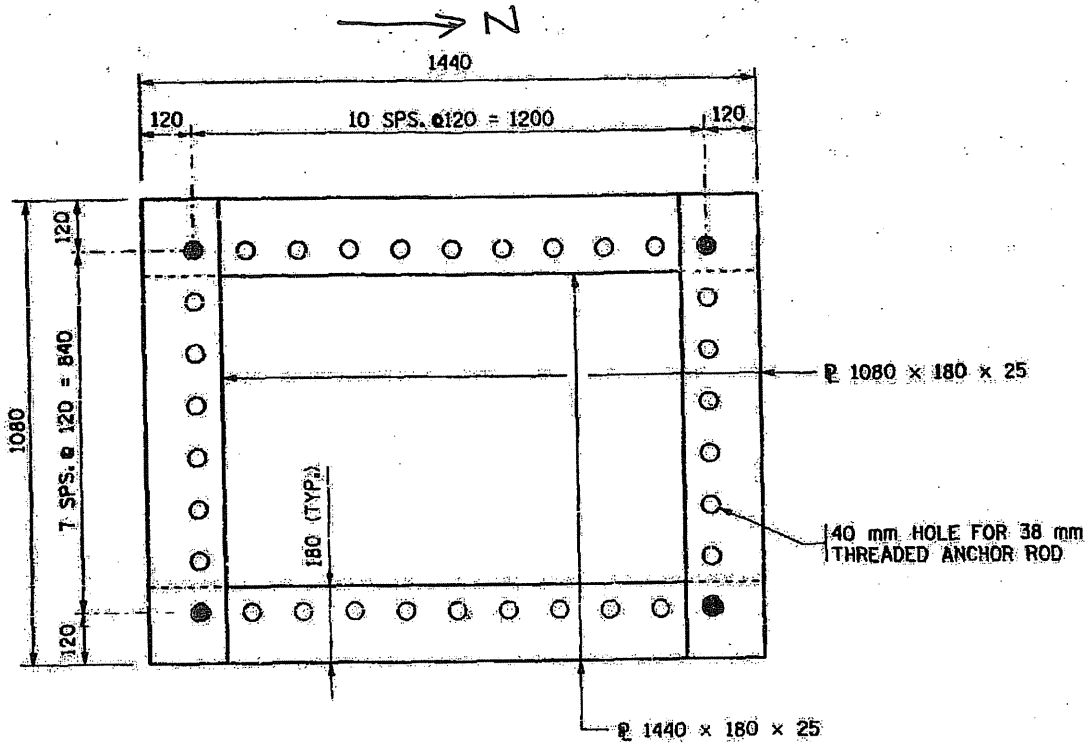
NORTHWEST ARCH FOOTING
LOCATIONS WITH A UT LENGTH OF 19" ARE
INDICATED BY A SOLID ●

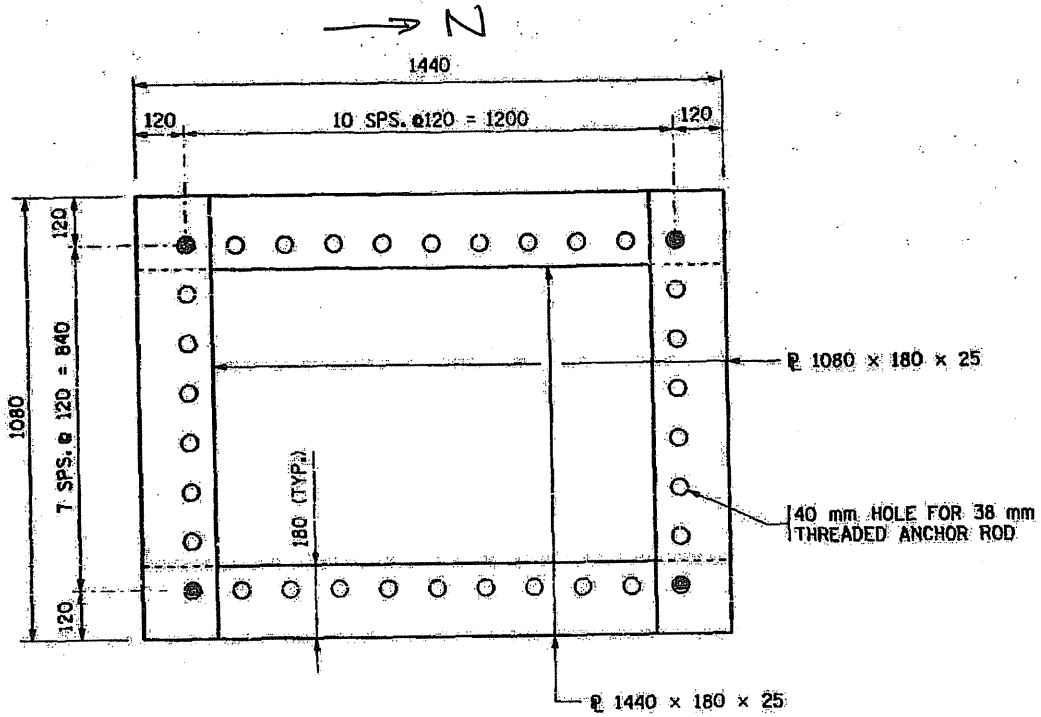
BR # 38010
NORTHEAST ARCH FOOTING
LOCATIONS WITH A UT LENGTH OF 19" ARE
INDICATED BY A SOLID ●

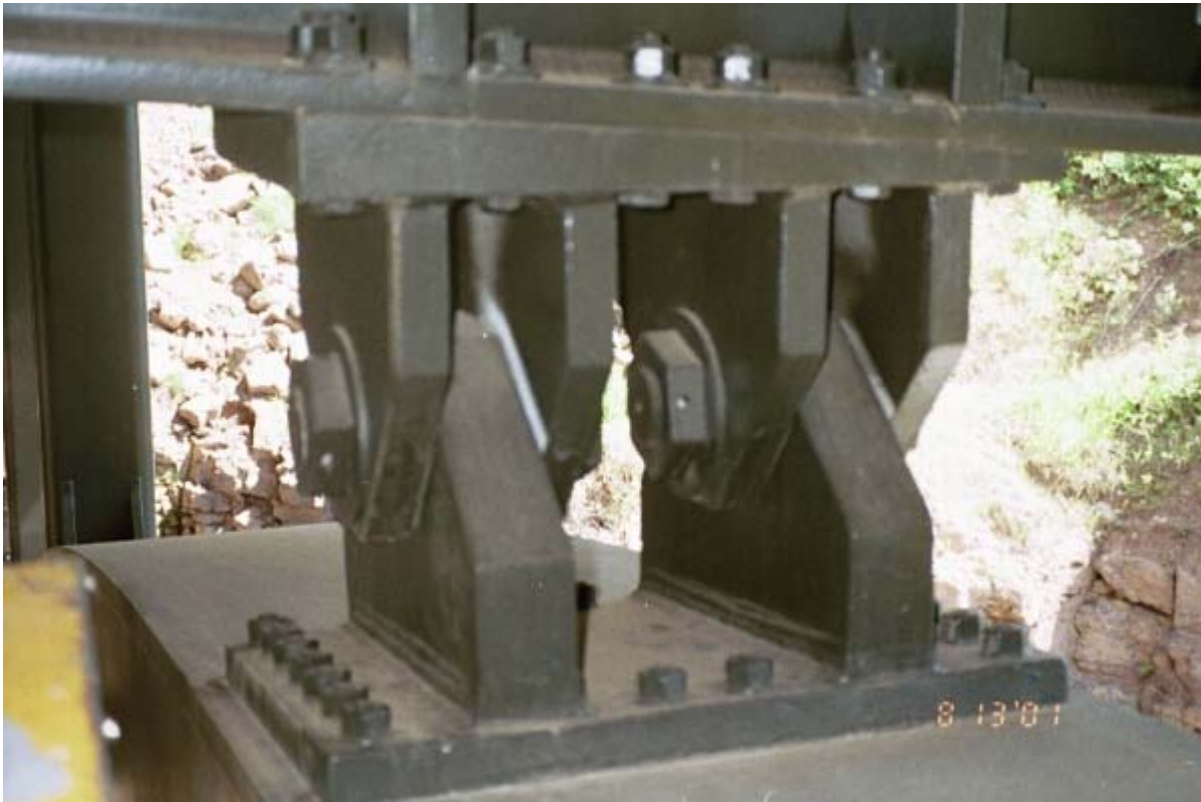
Pin Assemblies (Spandrels #3 & 4): Near the top of the arch, the spandrel caps are connected directly to the arch ribs with pinned bearings (two at each connection), to allow some rotational movement. The cotter pins (on the cap nuts) shown in the plans were never installed - the holes were never drilled through the pin ends.

Pinned connection between arch rib & spandrel cap

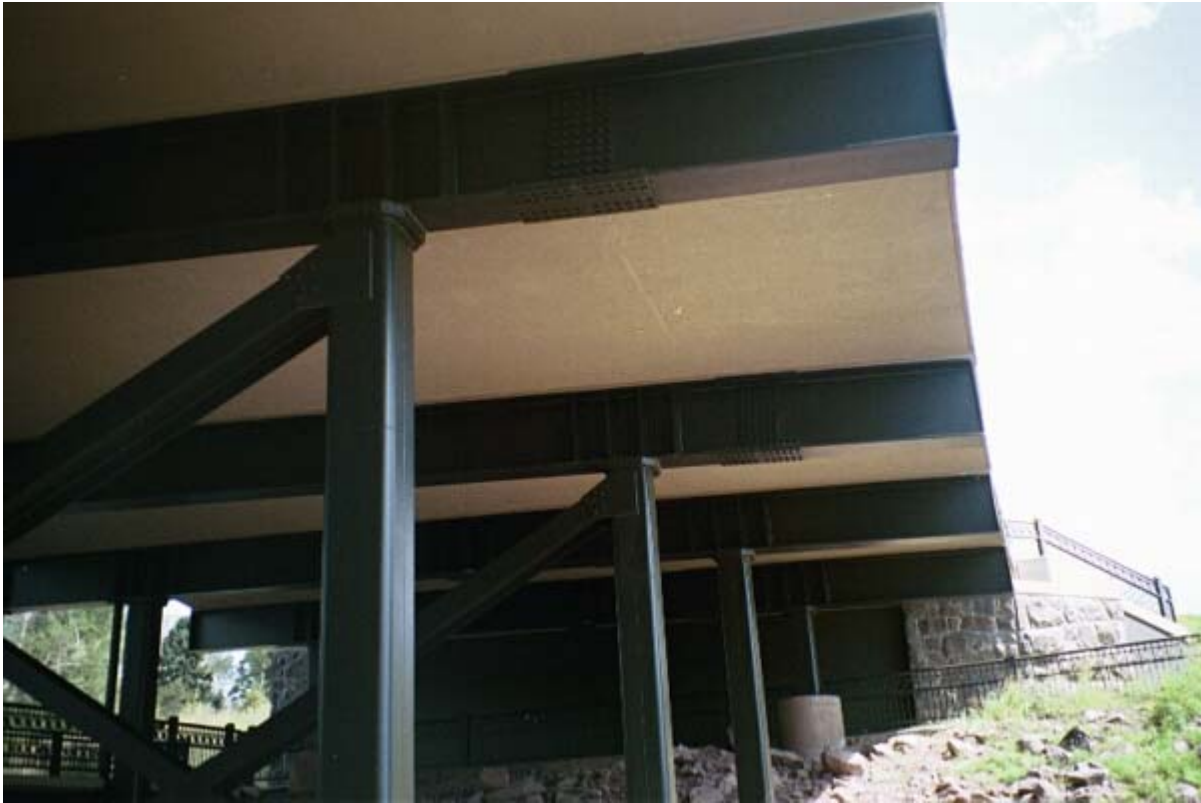
View of north approach spans - note pier cap splices due to staged construction.

Pier Caps: The pier caps on the approach spans are the same as the arch spandrel caps (36" deep rolled beams). They have web stiffeners at the column connections. Due to the staged construction, Piers #4-6 have splices, and Piers #5 & 6 have additional web stiffeners (where the temporary supports were located). In some locations, the welds on these extra stiffeners are now located in tension zones.

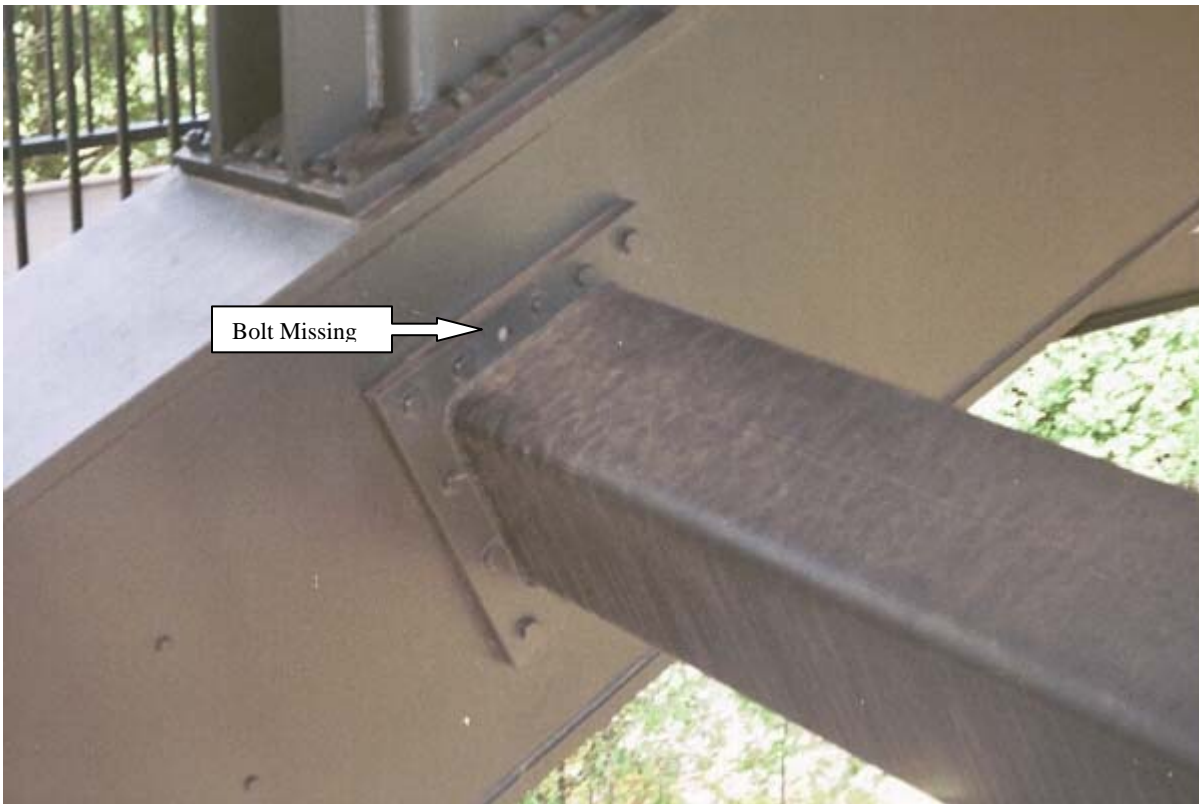
Spandrel #2: The west arch strut connection has missing bolt (never installed, as the internal arch stiffener plate interfered).

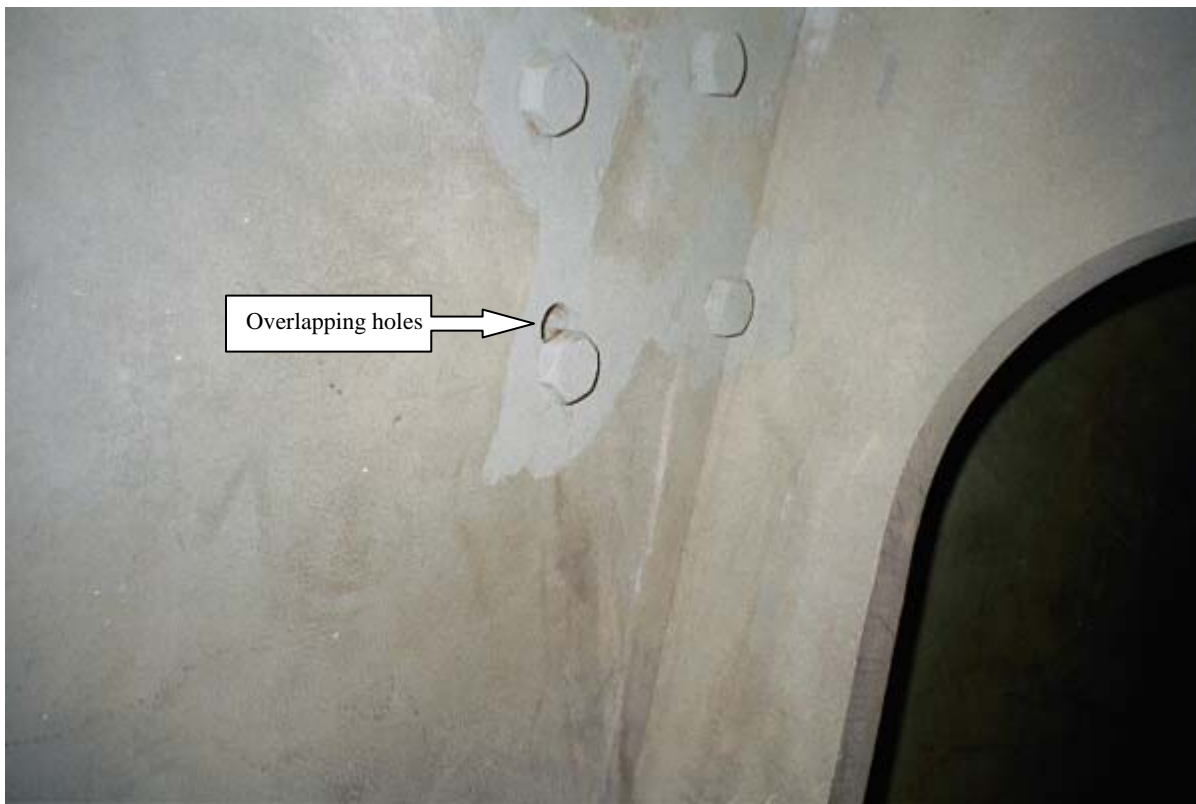
Spandrel #5: The sidewalk support connection on the west truss was drilled improperly (overlapping holes). [1998] The sidewalk floorbeam support is slightly buckled (at the west arch connection).

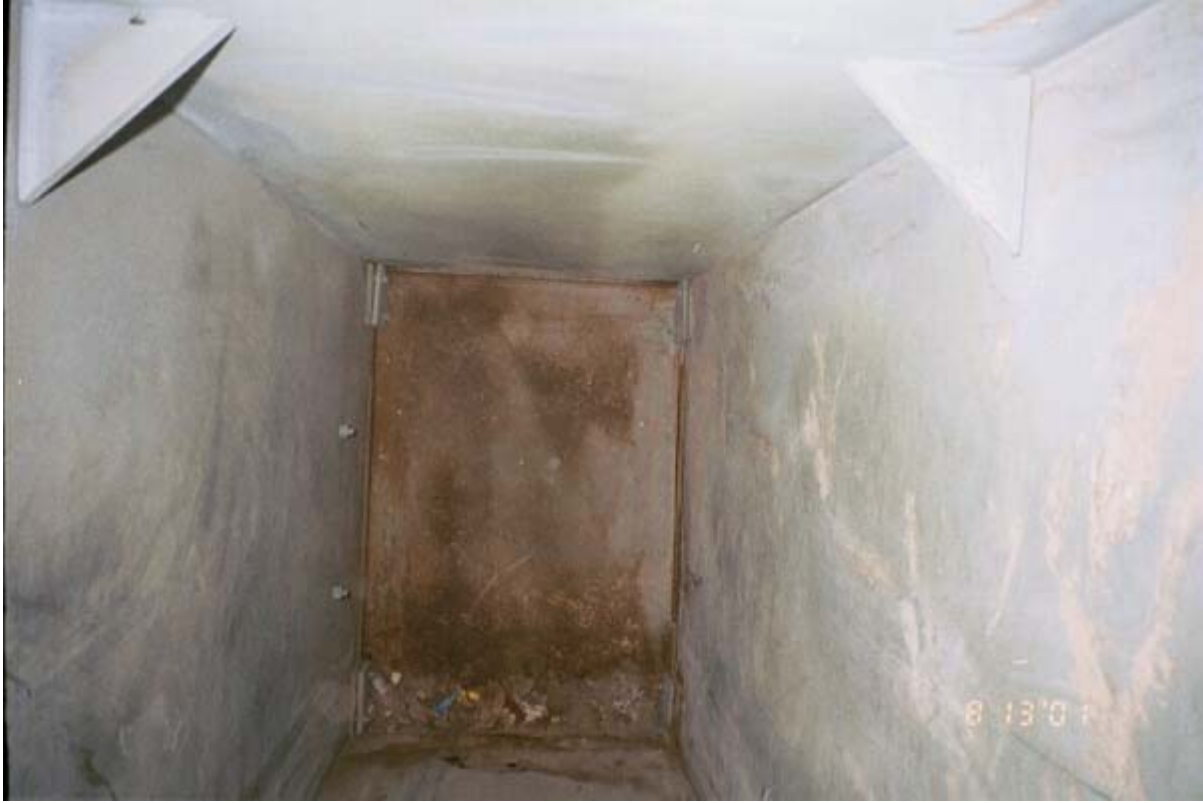
Arch Rib Interior Inspection: Access hatches can just barely be reached with Reach-all UB-50 snoopers. The internal surfaces are in good condition (primer coated). There is some minor surface rust at the arch ends.

Arch rib interiors - typical surface rust at arch ends
