# Evaluation of the SafeLane™ Overlay System for Crash Reduction on Bridge Deck Surfaces

Minnesota  
Department of  
Transportation

John F. Evans, Principal Investigator  
Department of Chemistry and Biochemistry  
University of Minnesota Duluth

Research Project  
Final Report #2010-13

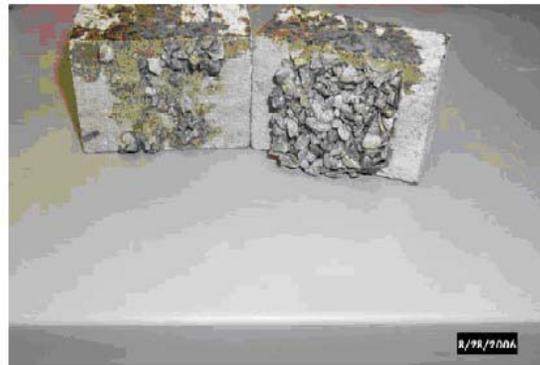
As shown in the following figure, bond rupture was observed at the SafeLane™ - concrete interface.

Figure 3.3. Failure of bonding.

Specimen 1 (7 day strength) failed mainly by de-bonding at the interface. Specimen 2 (7 day strength not shown) failed by a combination of de-bonding and tension within the overlay in the overlay. Specimen 3 (28 day strength) failed by de-bonding. Failure loads are shown in the following table.

The tests above do not have a published reference with which one can compare results. Compared to bond strength requirements of ASTM C-882, which is a different procedure, these results are low.

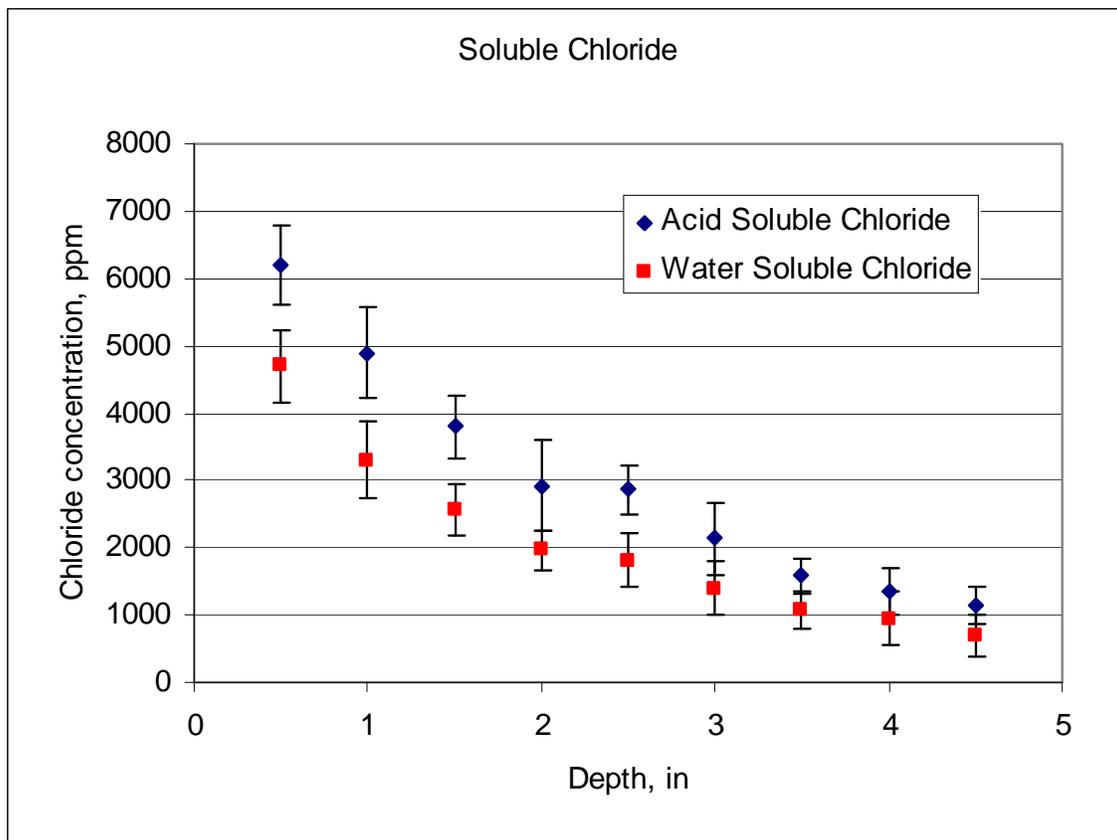
Unfortunately, this installation was made on a deck that had been in service for some time, so that there was significant chloride content already present in the deck. Figure 4.1 shows the pre-installation water and acid soluble chloride profile for the southbound lanes. The data were subjected to statistical analysis, and plotted as a function of depth for the six samples. The error bars give a 95% confidence level for each depth for each type of analysis. Because both the water and acid soluble data have similar depth dependencies, yet the values for the latter are larger, further comparisons have been limited to the results for acid soluble chloride.

Figure 4.1. Pre-installation chloride concentration variation with depth, southbound lanes. Error bars are at the 95% confidence level for six samples taken at each depth.

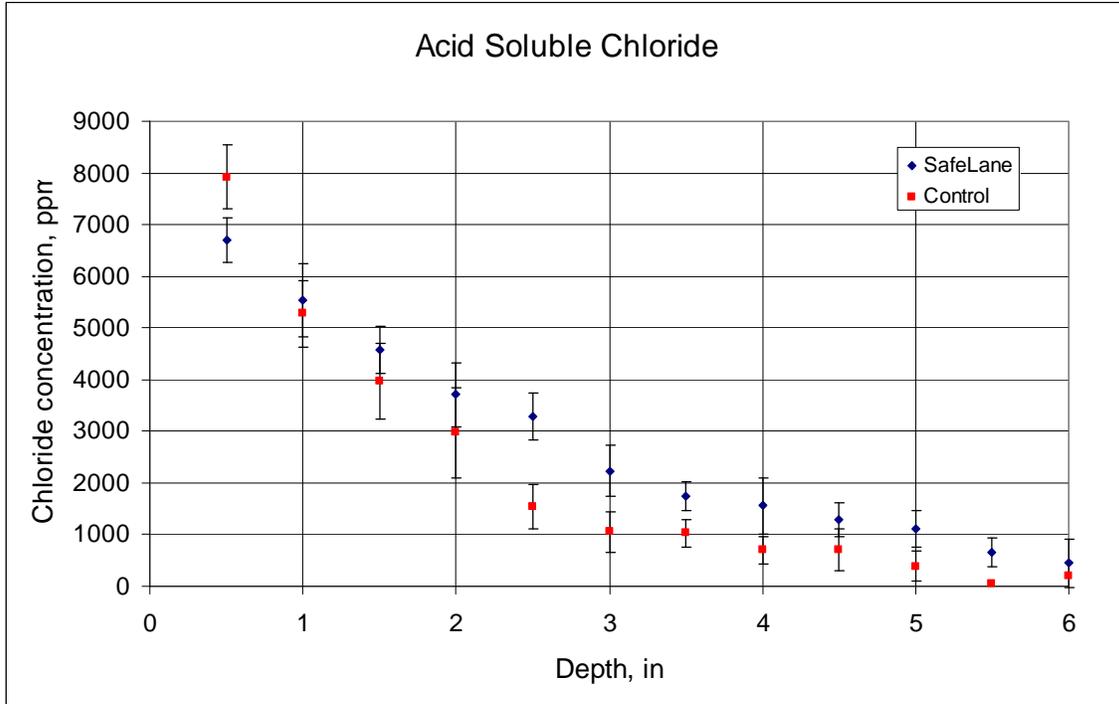
Figure 4.2 compares the acid soluble chloride for the SafeLane™ installation (southbound lanes) to that from the northbound control lanes (no overlay) for core samples taken two years after installation. Clearly, the SafeLane™ overlay has provided significant protection against chloride intrusion on the southbound decks.

Figure 4.2. Comparison of SafeLane™ (southbound) and control (northbound) lanes for acid soluble chloride content as a function of depth two years after installation (2008). Error bars are at the 95% confidence level for nine samples taken at each depth.

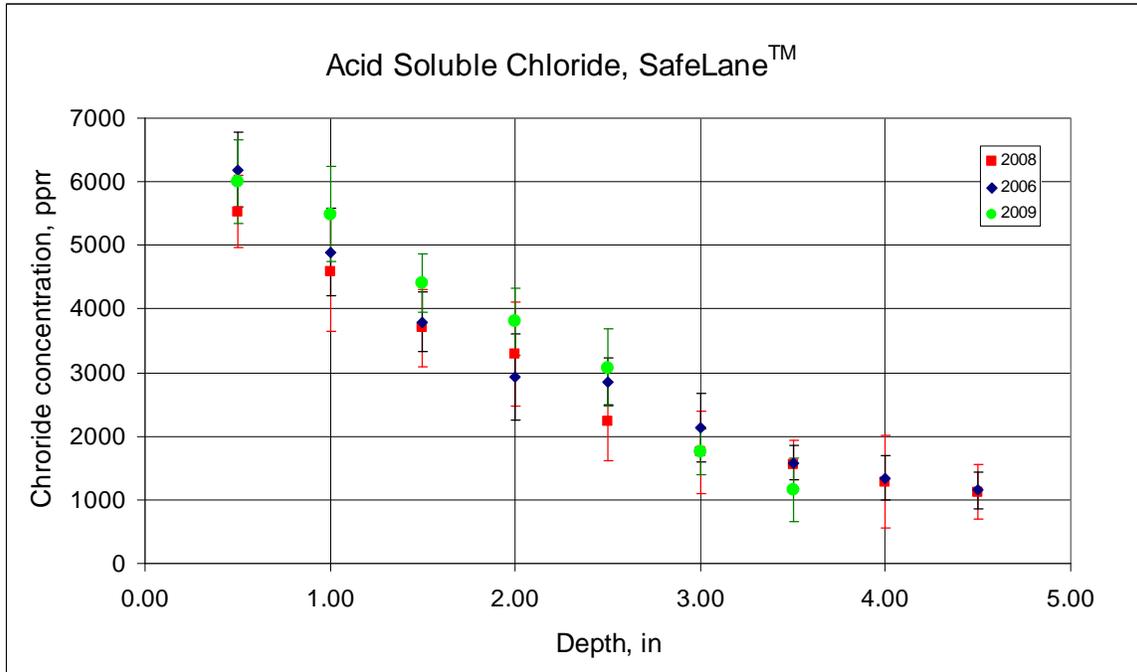
The plot on the following page (Fig. 4.3) shows a comparison of the acid soluble chloride data for pre-installation (2006), after two years of service (2008), and after three years of service life (2009). There are no statistically significant differences between these data sets, further confirming the efficacy of the SafeLane™ overlay from the perspective of its performance as a sealcoat.

Figure 4.3. Comparison of pre-installation (2006) and post-installation (2008, 2009) chloride concentration profiles. Error bars are at the 95% confidence levels. Data sets ranged in size from three samples to nine samples at each depth.

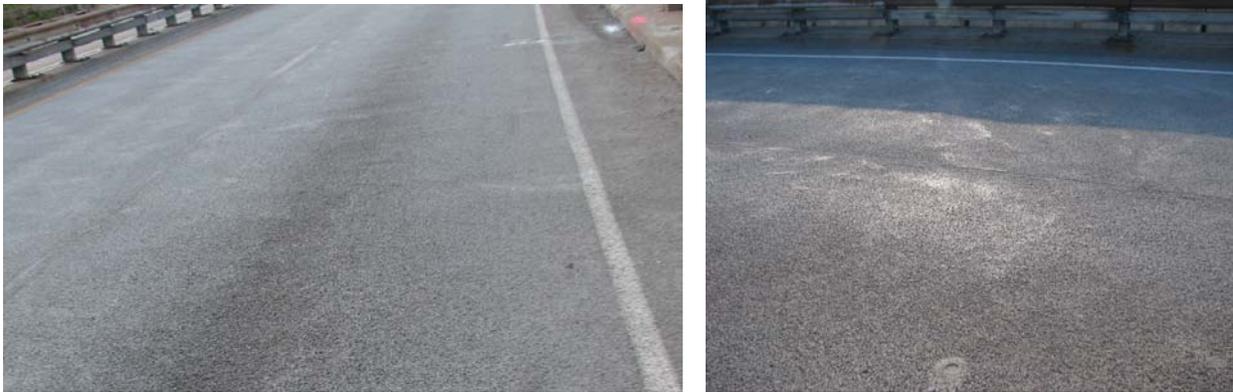
More qualitative observations of the sealcoat performance of the SafeLane™ overlay at this site are consistent with the performance inferred from the chloride data presented above. In general the lanes were found to be almost crack-free throughout the three-year span of this study (Fig. 4.4). Bonding integrity for this time span was outstanding with evidence of de-bonding found only at expansion joints that experienced extreme plow shear forces (Fig. 4.5), and one area where the overlay was placed over top of an asphalt repair patch (Fig. 4.6). However, it should be noted that the manufacturer recommends this overlay not be used over asphalt.

Figure 4.4. Photographs showing general overall integrity of the Hibbing SafeLane™ installation after two years (left: September, 2008) and three years (right: July, 2009).

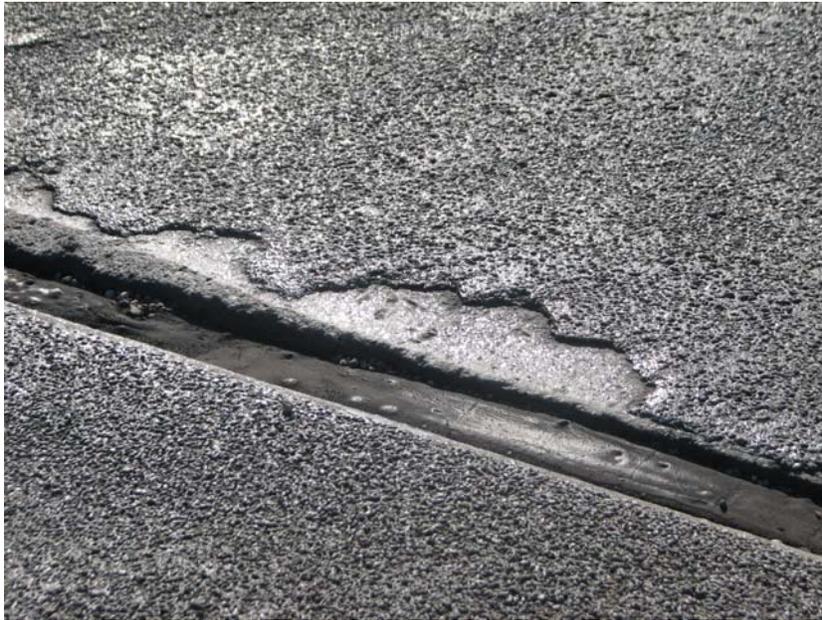
Figure 4.5. De-bonding at an expansion joint.

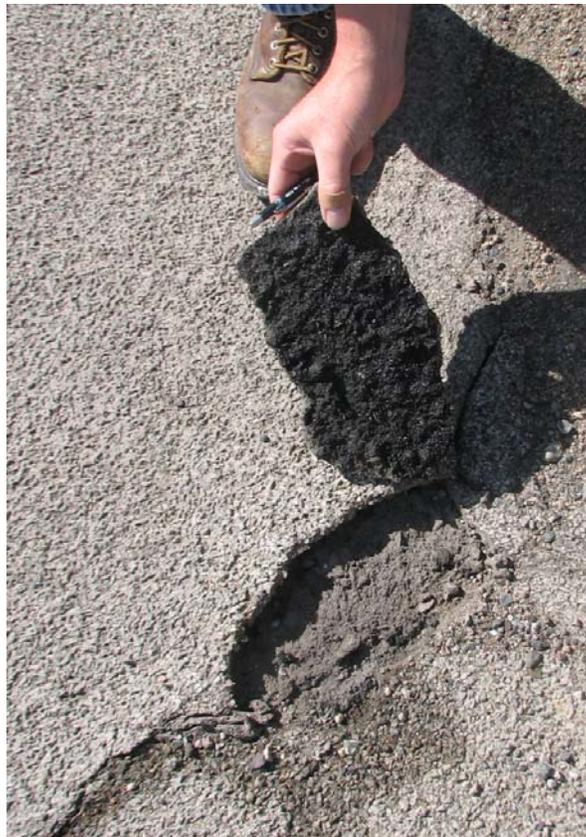
Figure 4.6. De-bonding over an asphalt repair patch.

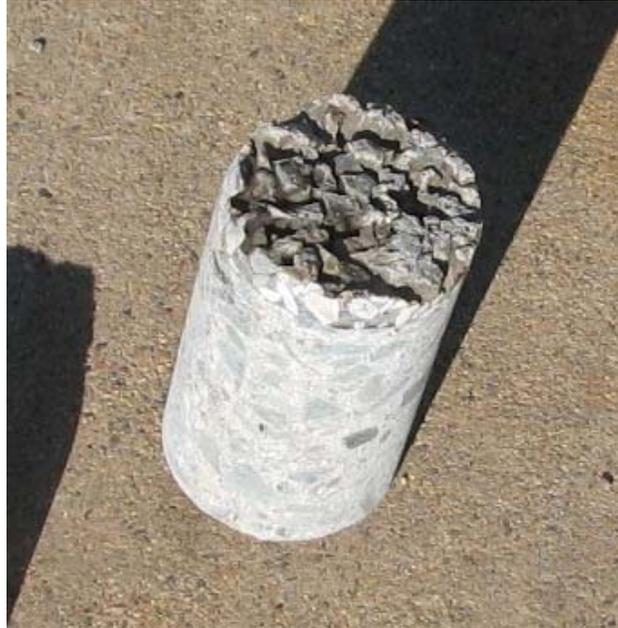
Core samples taken for chloride analyses all showed excellent bonding between the concrete and the overlay as typified by the photograph shown below (fig 4.7).

Figure 4.7. Photograph of core sample taken in September 2008. Location was at the edge of installation; outside of travel lane

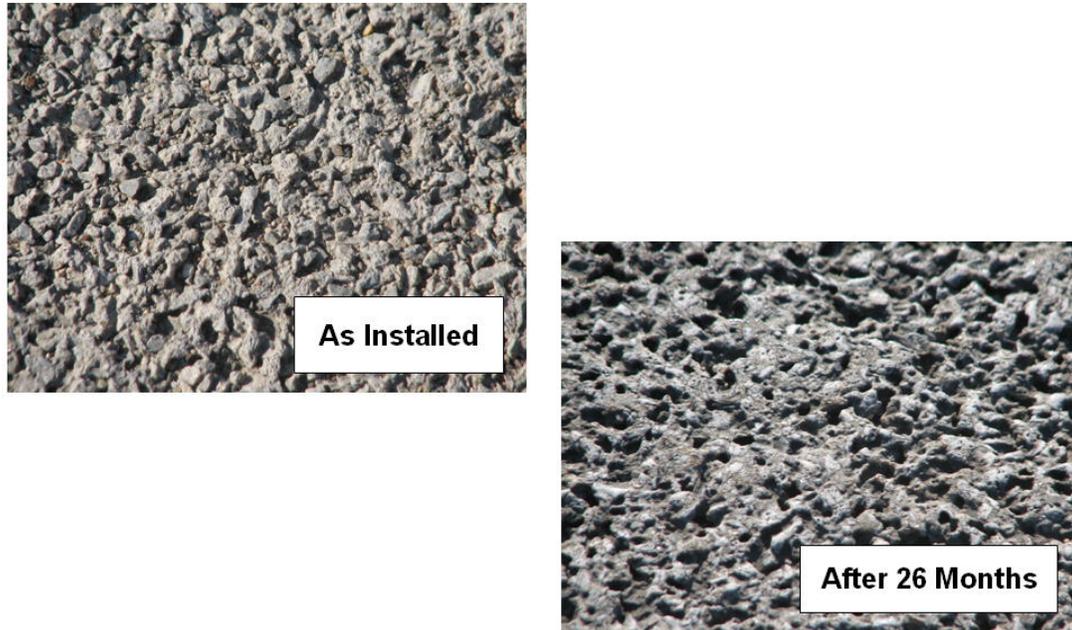
Although the integrity of the bonding of this overlay system to the concrete surface of the bridge deck on which it was installed was found to be excellent, as discussed in the previous chapter, other aspects of the mechanical performance of the system were less than satisfactory. These relate to wear observed in both the wheel lanes and the overall surface that were attributed to normal traffic and plowing. The plows used for winter maintenance all use significant down-force on the blades. Both contributed to significant shearing as shown in the photos below.

Figure 5.1. Photographs showing surface wear after two winters. Areas shown are approximately 4 x 6 inches.

The wear seemed in large part to be attributable to shearing of the aggregate and epoxy (above right). There was little, if any evidence of the aggregate being pulled out of the epoxy sealcoat, rather the surface appeared to have been milled after the first two winters, and more extensively so after the third. The consequences of this wear are twofold. Firstly there is a reduction of interstitial depressions between the aggregate pieces, which leaves less area to trap deicing chemicals between winter storms or icing “events”. Secondly, there is a significant reduction in traction as the surface wears. Both of these are expected to contribute adversely to performance from a traffic safety perspective.

The term of this study is too short. It is recommended that this overlay system be subjected to more long-term studies to determine if the short service life predicted above is correct. Other overlay systems that utilize aggregates that are less susceptible to ablation by plow blade shearing should also be evaluated for comparison.

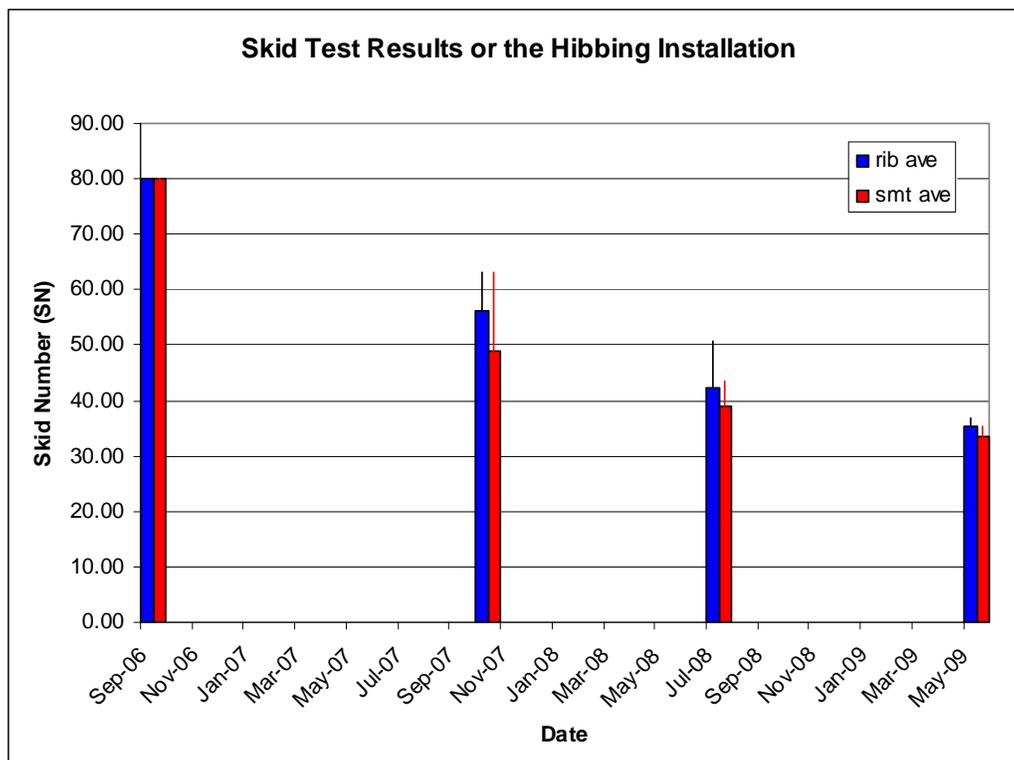
Figure 5.3. Skid test results for the Hibbing site. Error bars are at the 95% confidence level.

The data taken shortly after installation (9/06) is a minimum estimate provided by the operator. The traction was so good that the skid trailer would not skid for either tire type (ribbed vs smooth). This excellent initial performance degraded rather significantly after the first winter,

and continued to decline afterwards. These data are consistent with the qualitative observations discussed earlier.

Using the data from Figure 6.2, exponential decay functions were fit to the data. A least squares fit to the ribbed tire data yielded a correlation coefficient of 0.9908, while that for the smooth tire data gave a value of 0.9640. In each case the regression equation was used to predict the time a value of 15 would be expected for a smooth tire, and likewise a value of 25 for a ribbed tire, giving a value of 3.6 years for the ribbed tire data, and a value of 5.0 years for the smooth tire data. Unfortunately, either of these predictions suggests an unacceptably short service life for the overlay system.
