MnROAD Low Volume Road cells 55 - 58 Open Graded Friction Course

MnROAD Low Volume Road cells 55 - 58 OGFC Performance

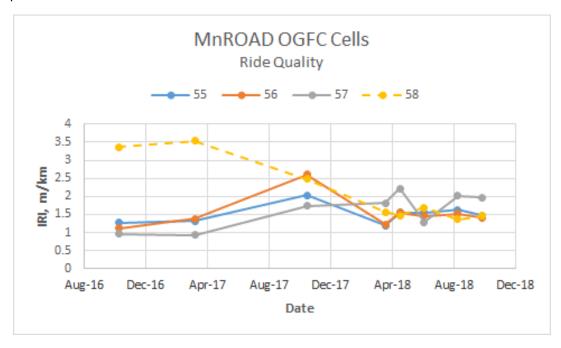
Note the decline in roughness of Cell 58 that occured in late 2017 (Figure 3). Continued monitoring is planned.

Figure 3 OGFC: Ride Quality of Trafficked (Inside) Lane.

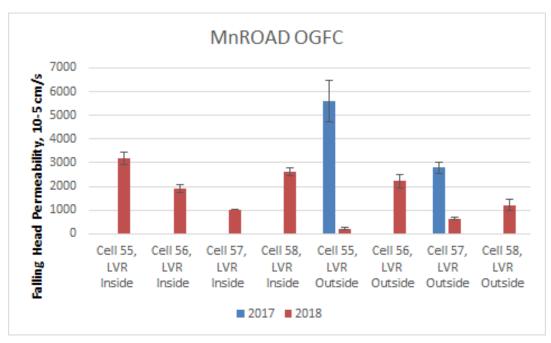
Several locations in the Environmental (Outside) Lane were tested for field permeability on June 1, 2017. Figure 4 shows that in 2018 permeability had declined at those points by 77 to 96 percent. Continued monitoring is planned.

Figure 4 OGFC: Falling Head Permeability at Inside (Left Wheel Path) and Outside Lane (Between Wheel Paths).

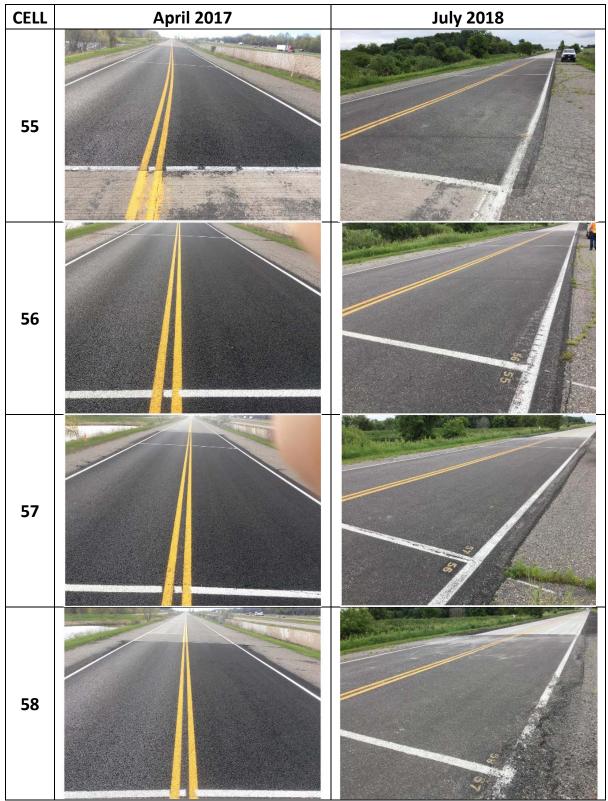
Figure 5 Photos of MnROAD OGFC Cells: Viewed Eastbound.
