**2016 MnROAD/NCAT Cracking Group Construction
Weekly Construction Update
For the week of July 25, 2016**

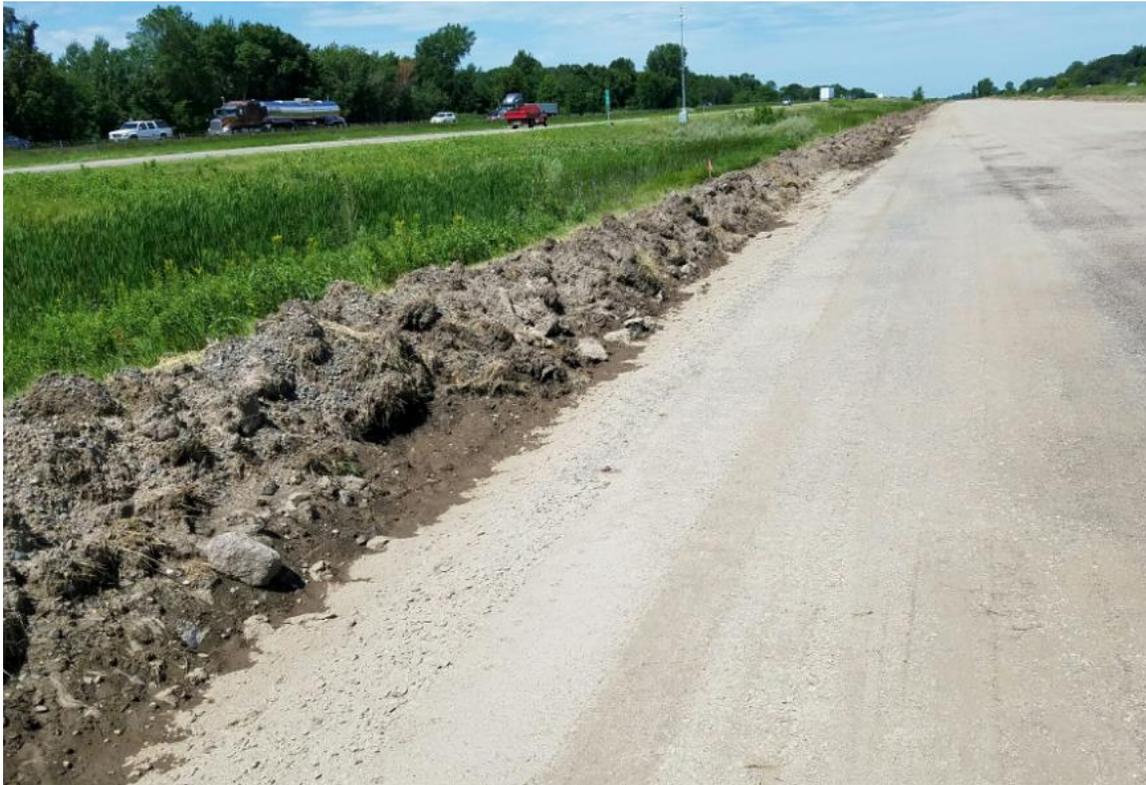
After an inspection of the site, it was found that moisture was present on the top of the subbase even though a rainfall event had not occurred in the previous 3 days. A meeting was scheduled for Wednesday, July 27 to discuss and seek a solution to mitigate the issue. New vaults were installed by MnROAD staff in cells 17 and 19 on Tuesday, July 26. After excavation of the vault location, aggregate was brought in to level the vault and provide a source for drainage.

Figure 1: Moisture on Subbase

A construction meeting was held Wednesday, July 27 to discuss subbase moisture issues. The issue of soft spot areas of concern was discussed in detail, and it was determined to pursue localized repairs of the subbase in especially bad areas. These areas were located and marked on Thursday, July 28. Proposed repairs will consist of excavating 12 inches of subbase material, followed by backfill with salvaged aggregate base from the stockpile area. The goal is to increase strength in the areas identified likely not to pass test rolling. A total of 12 areas were marked for excavation and fill. The work was completed that evening by New Look Contracting, Inc. Test rolling was scheduled for Friday, July 29.

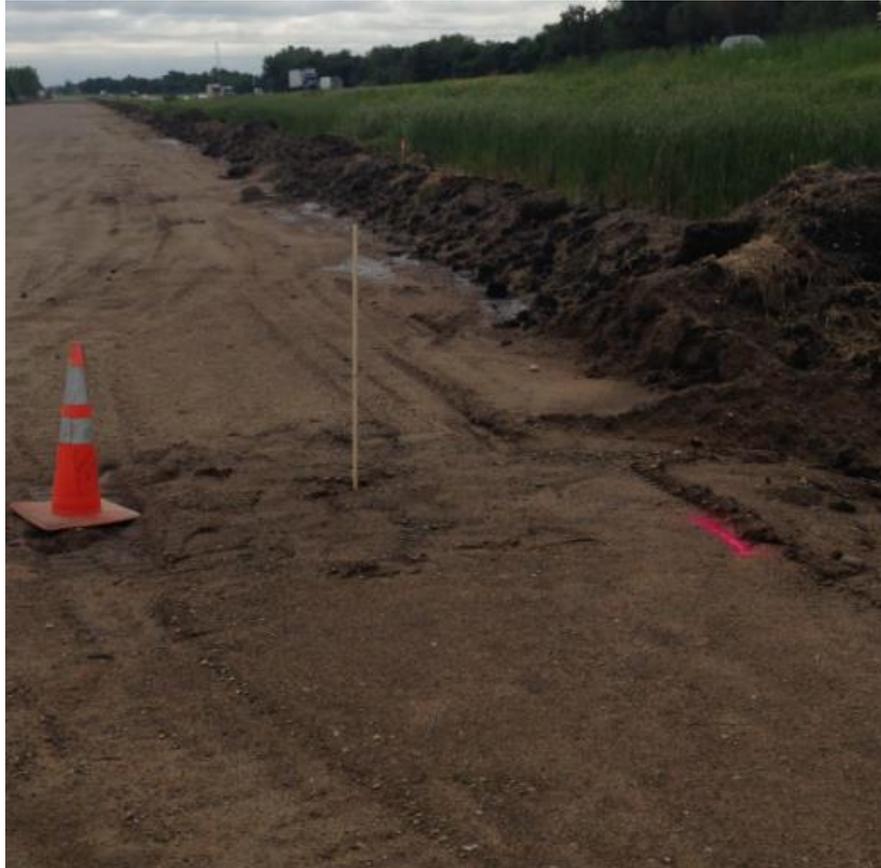
Figure 2: Location of Soft Areas for Excavation

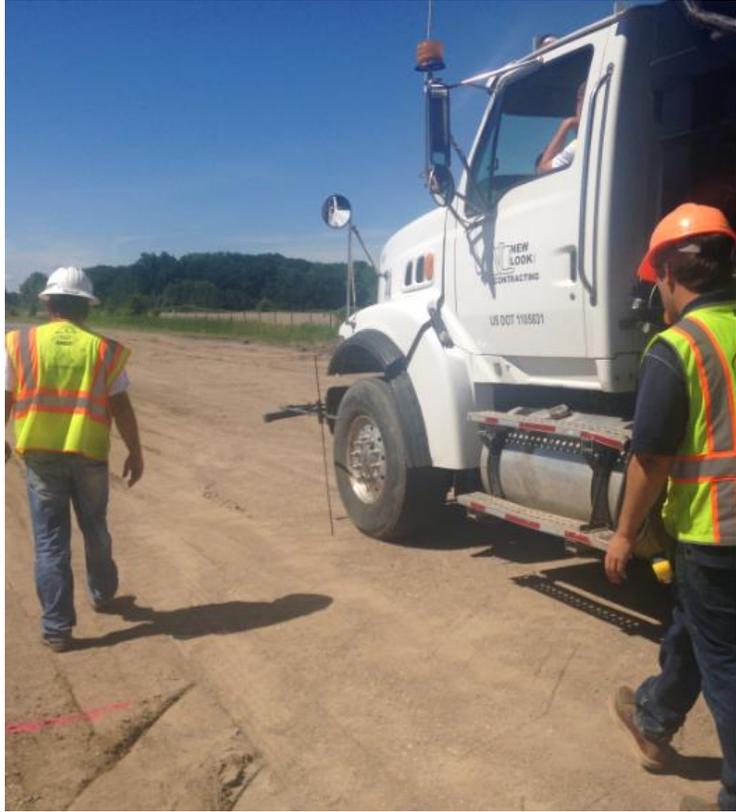
Test rolling was completed with the 10-ton test rolling (TR10) setup conducted on Friday, July 29. The test roller was weighed and documented with Kory Eichhorst present. Testing was done from shoulder point of intersection (PI) to opposite shoulder PI. Approximately 10% of the area between the PI and edge of pavement failed test rolling. These areas included the last 150 feet of the west side of the project and areas that were corrected on Thursday. It was found that all material within paving limits passed. It will be determined on Monday, August 1 how to proceed.

Figure 3: Test Rolling of Subbase
