Update – Spring review of Pavement Preservation Sections and Photos

E. Johnson 3/31/20

Low Volume CSAH8:

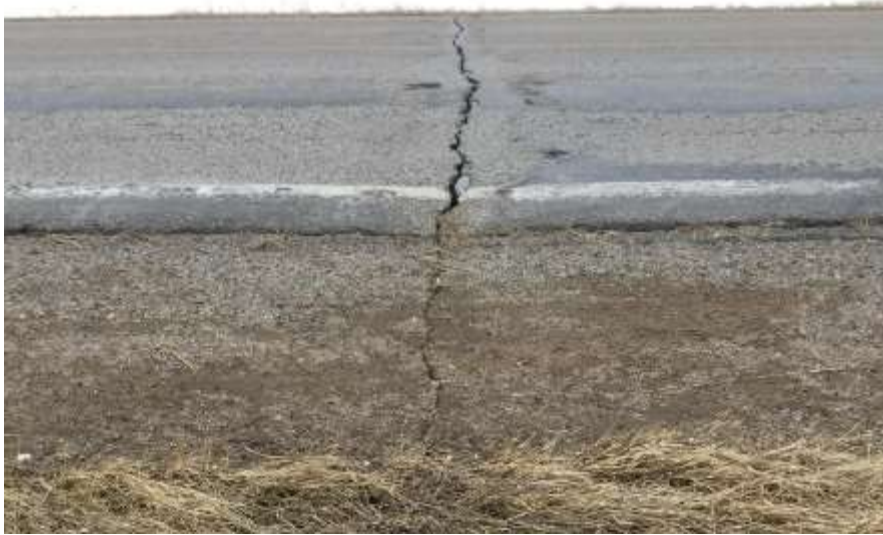
- Shallow potholes.
- Moisture moving through surface treatments.
- Transverse cracking extends through pavement and embankment.

Figure 1 CSAH 8 chip seal section with transverse crack through embankment 2/28/20.

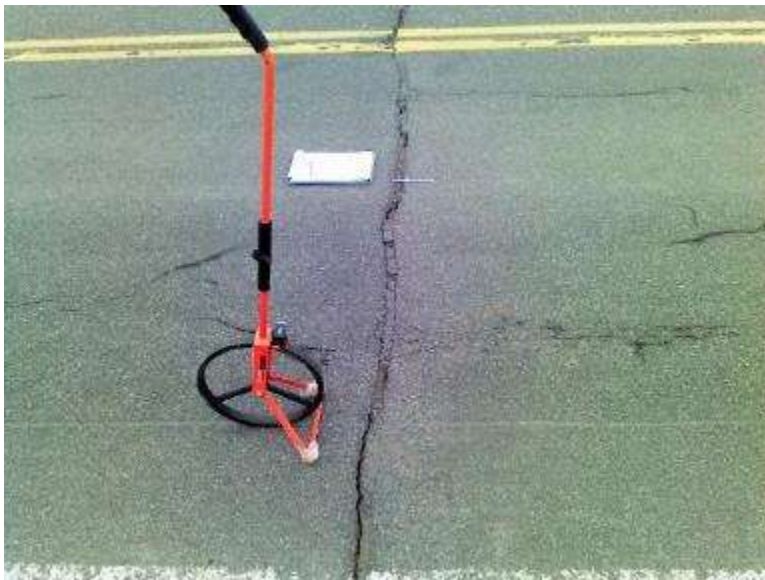
1. Crack sealant failures observed on Cell 8011. Photos are below.
2. Increased fatigue and standing water in wheel track (especially rejuvenator fog section).
3. Moisture moving through surface treatments.
4. Longitudinal cracking extended.
5. Longitudinal cracks also observed in the embankment at 1 – 3 ft outside the edge of pavement (settling of winter heave?).
6. Increased severity of edge cracking in eastbound Thinlays. This road receives traffic from several farms and equipment frequently travels with one wheel on the shoulder. Breakup has caused loss of material in an area, and may be a future maintenance concern.

Figure 2 Cell 8011. Crack seal adhesion failure 3/27/20.

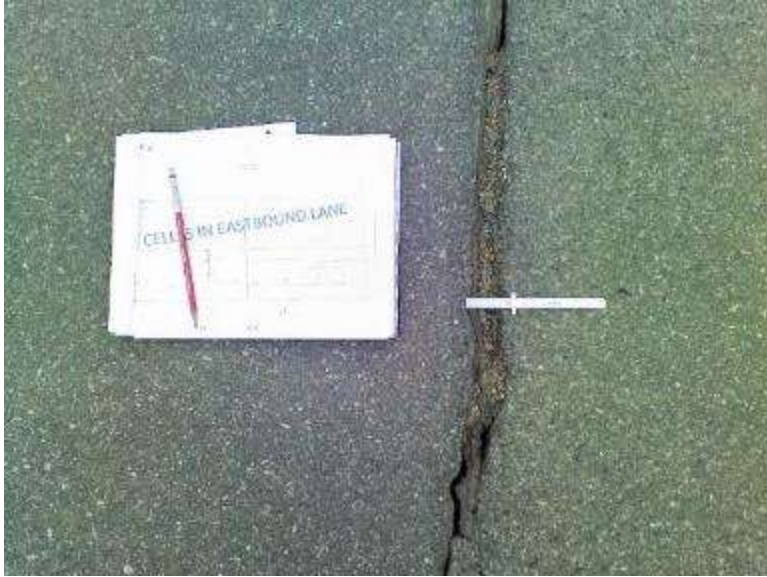
Figure 3 Cell 8011. Crack seal adhesion failure closeup 3/27/20.

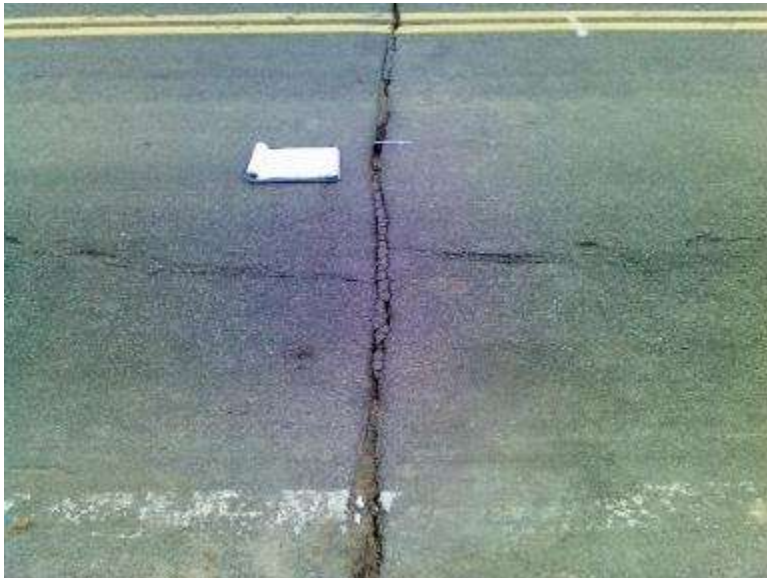
Figure 4 Cell 8011. Crack seal adhesion failure and loss 3/27/20.

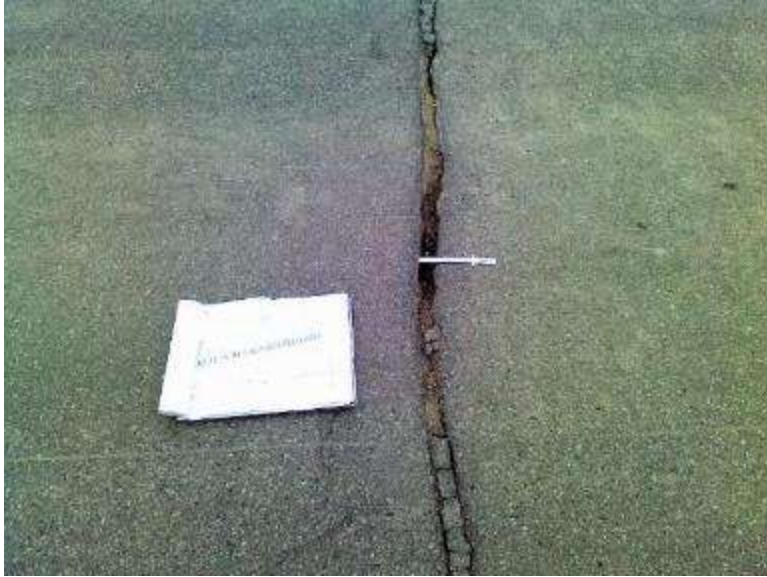
Figure 5 Cell 8011. Crack seal adhesion failure and loss 3/27/20.

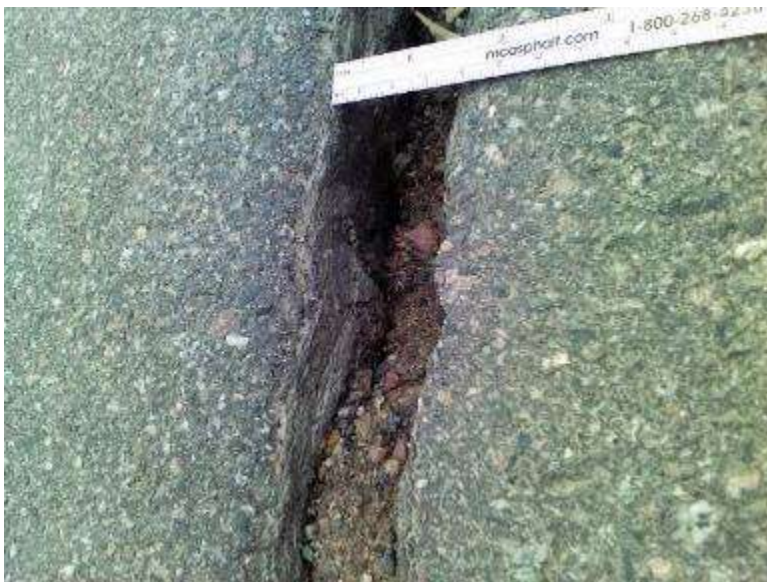
Figure 6 Cell 8011. Crack seal adhesion failure and loss closeup 3/27/20.

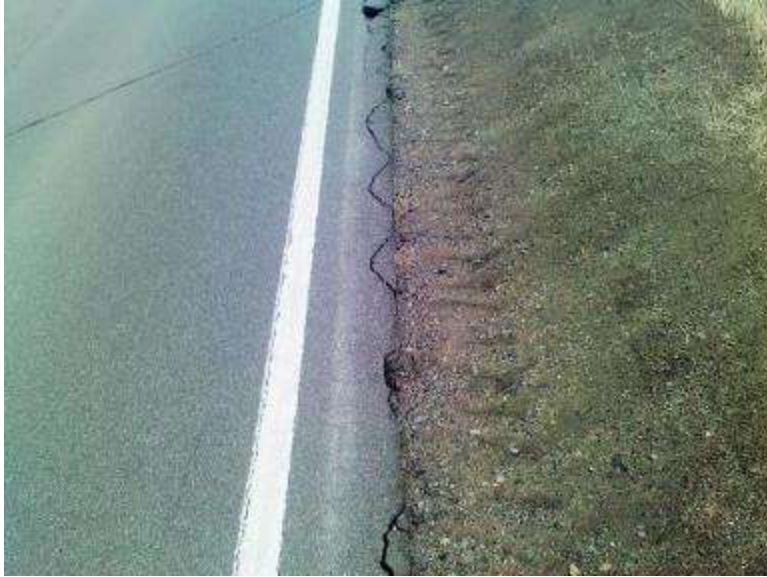
Figure 7 CSAH 8 Thinlay EB. Edge cracking 3/27/20.

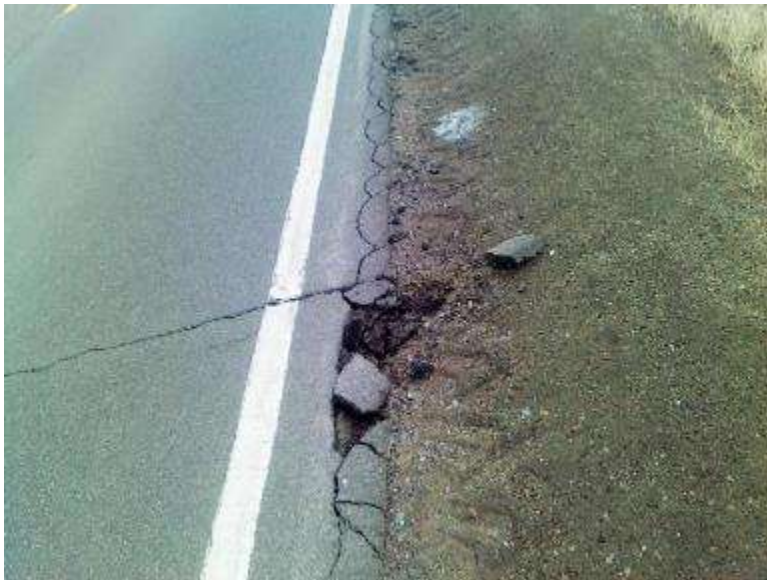
Figure 8 CSAH 8 Thinlay EB. Edge cracking and breakup 3/27/20.

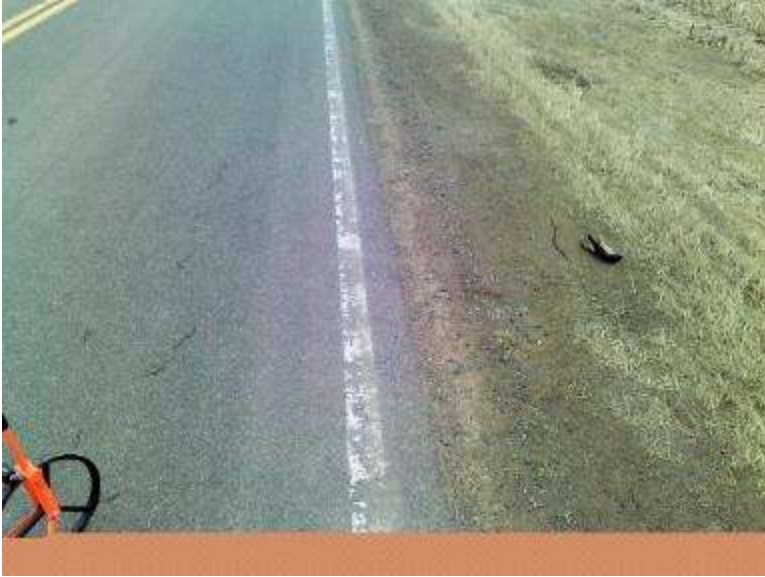
Figure 9 CSAH 8. Longitudinal cracking in wheel path and embankment at 3ft outside of edge 3/27/20.
