**PRESTON OVERLOOK**

**SHPO INV. # FL-PRC-041**

**Survey Date:** October 8, 2002

# **PRESERVATION AND TREATMENT REPORT COMMENTS**

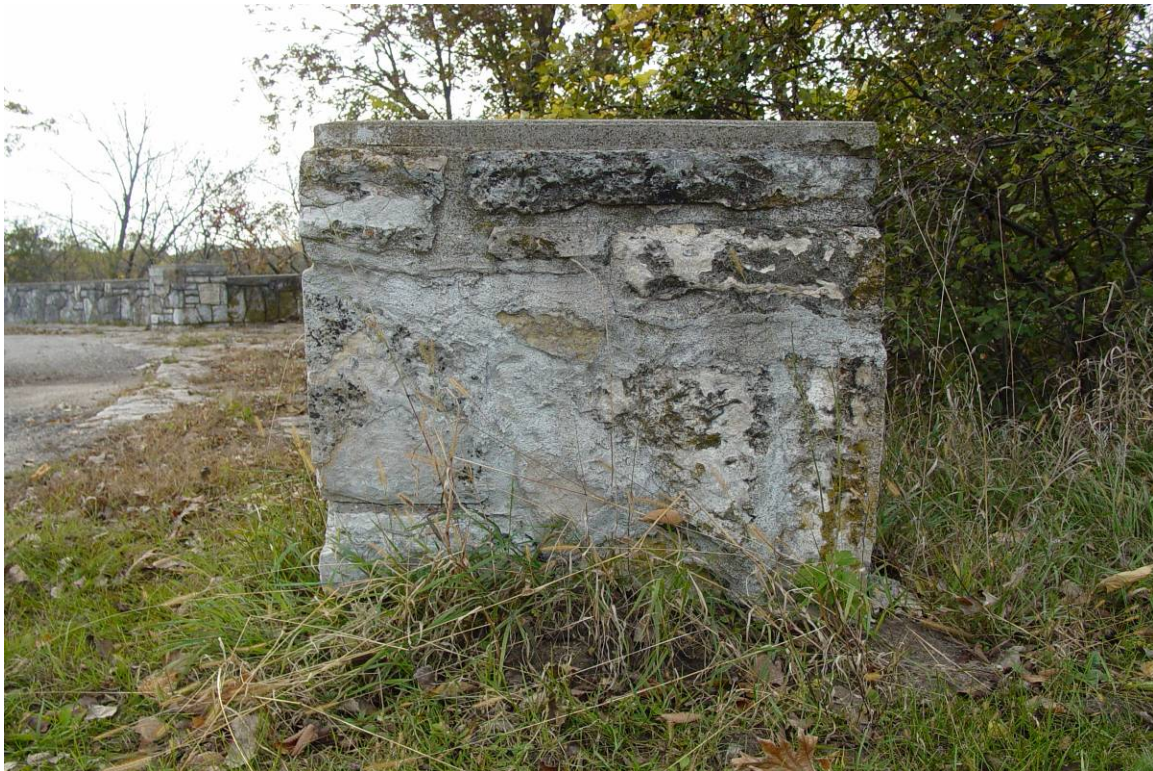
**Plate 5. Improper repointing on western pier of overlook wall, facing east**

**Preservation:** Remove all cement capping on the top surface of the overlook walls and piers. Replace all deteriorated masonry units, particularly those in the upper masonry course, with locally quarried stone to match color and appearance. All wall top surface joints should be hand-chiseled down to a depth of 2"-2.5" depth, a polyethylene backer-rod<sup>1</sup> installed in the joints, and a polysulfide sealant<sup>2</sup> applied on top of the backer-rod. After an appropriate curing interval, joints should be repointed with Type N mortar to match the marker's vertical joints.<sup>3</sup> While the use of synthetic sealant to repoint a historic structure is generally not recommended by the Department of the Interior,<sup>4</sup> the unusual joint configuration (common among Minnesota Highway Department wayside structures) and the potential damage caused by leaking wall joints warrants its application here. Repoint deteriorated vertical mortar

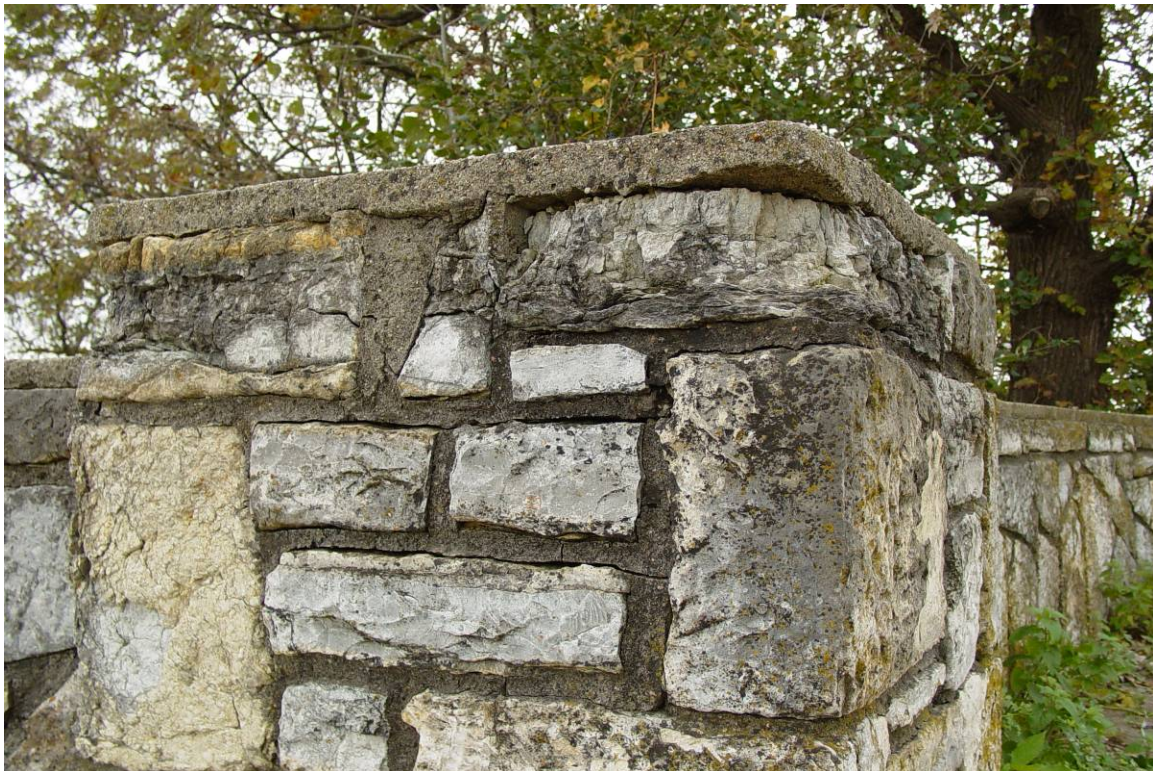
**Plate 7. Deteriorated stone in pier near central portion of overlook wall, facing southwest**

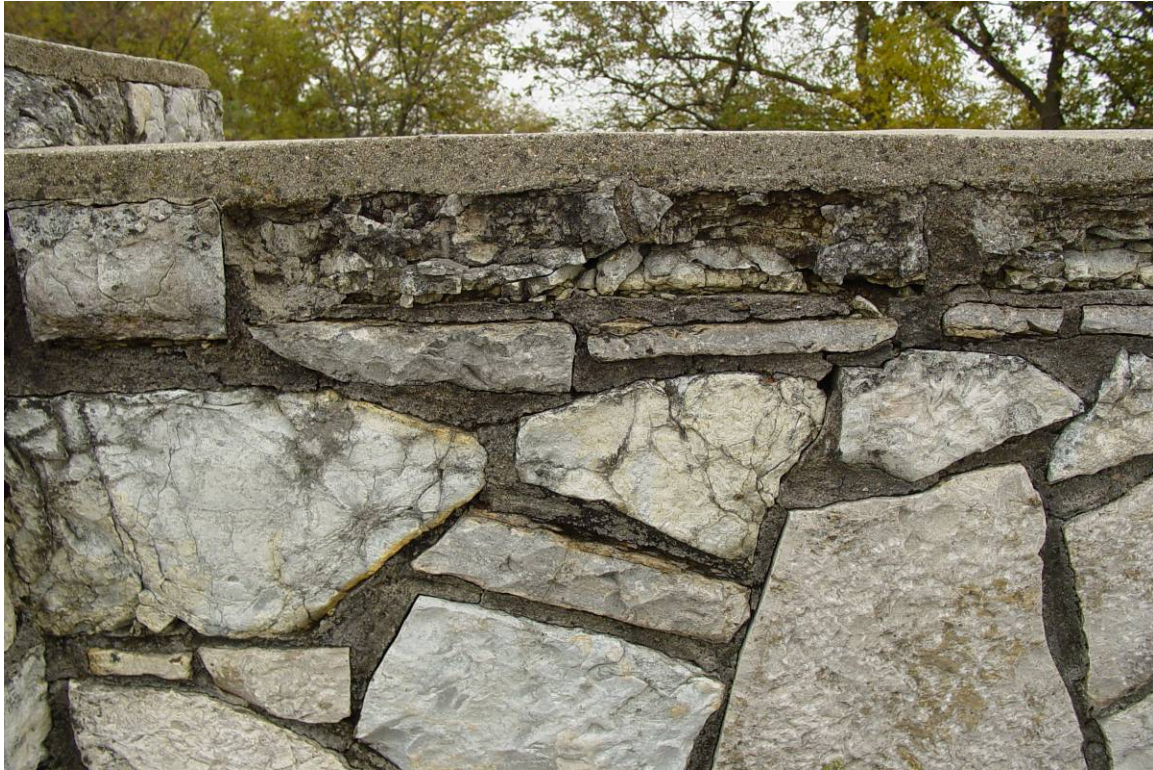
**Plate 8. Deteriorated stone in overlook wall, facing east**

Replace some stones generally at top where badly deteriorated

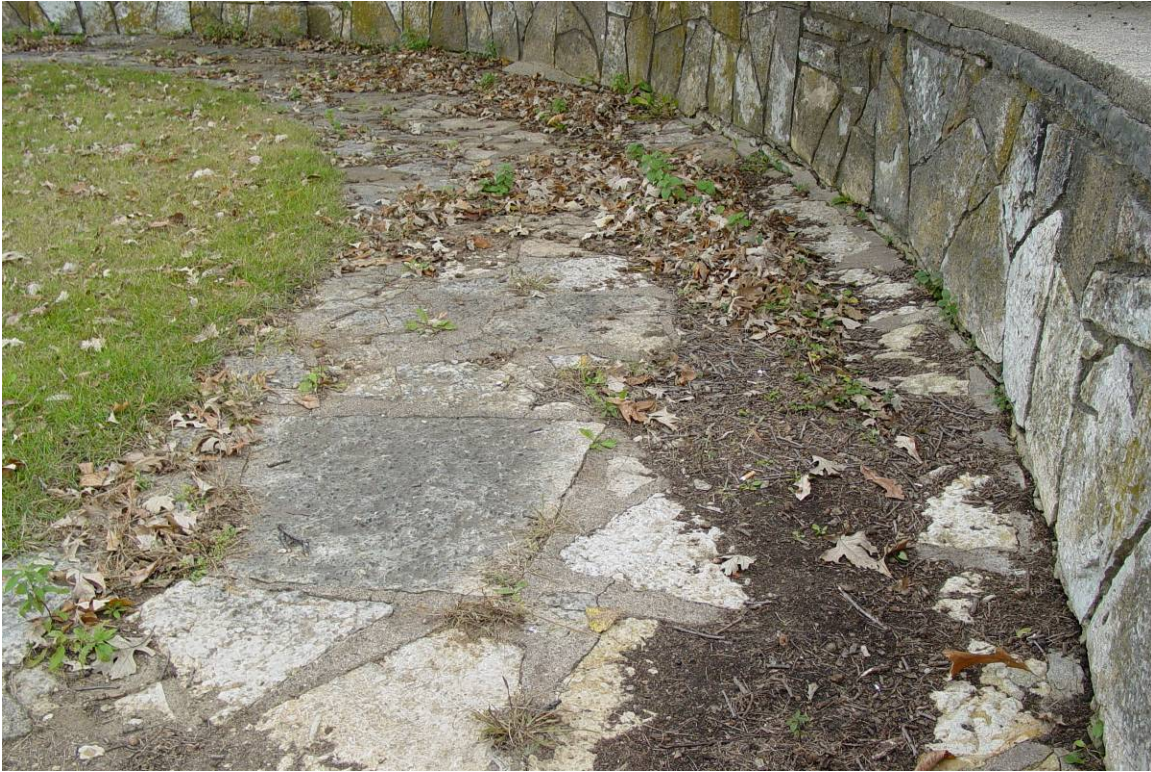
**Plate 12. Subsidence of flagstone terrace adjacent to overlook wall and gravel island, facing east**

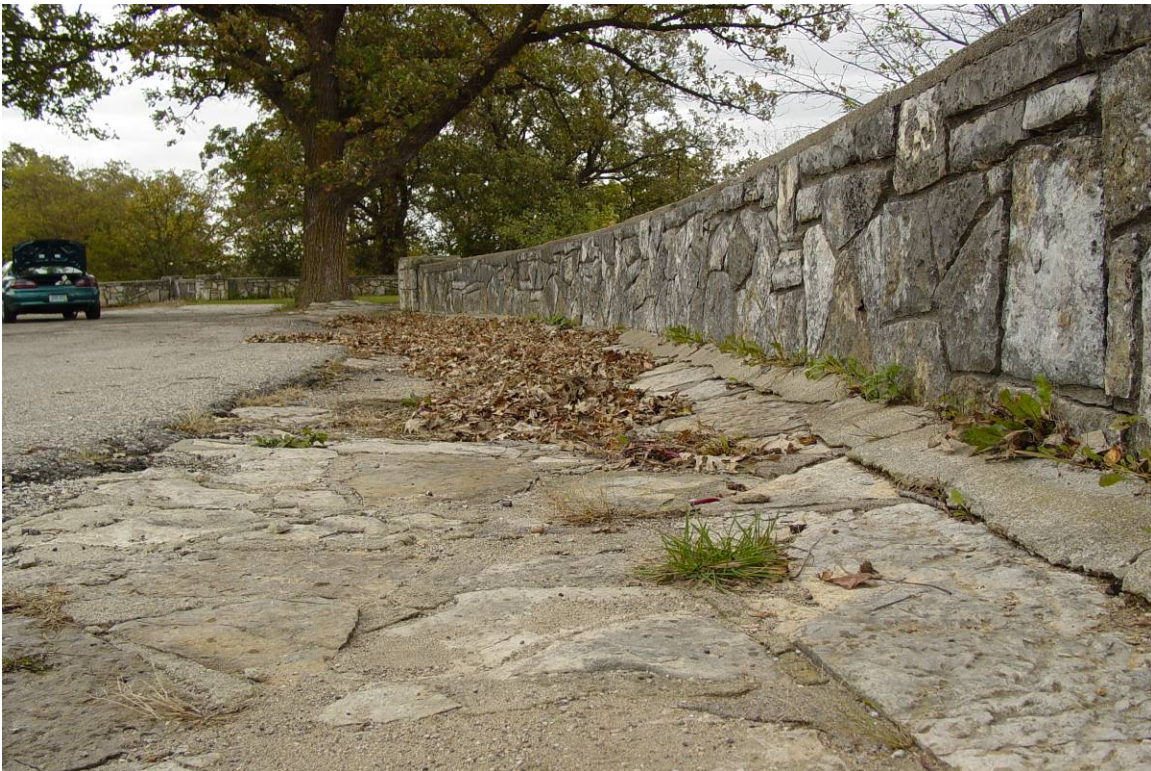
**Plate 13. Subsidence of flagstone terrace adjacent to central portion of overlook wall, facing east**

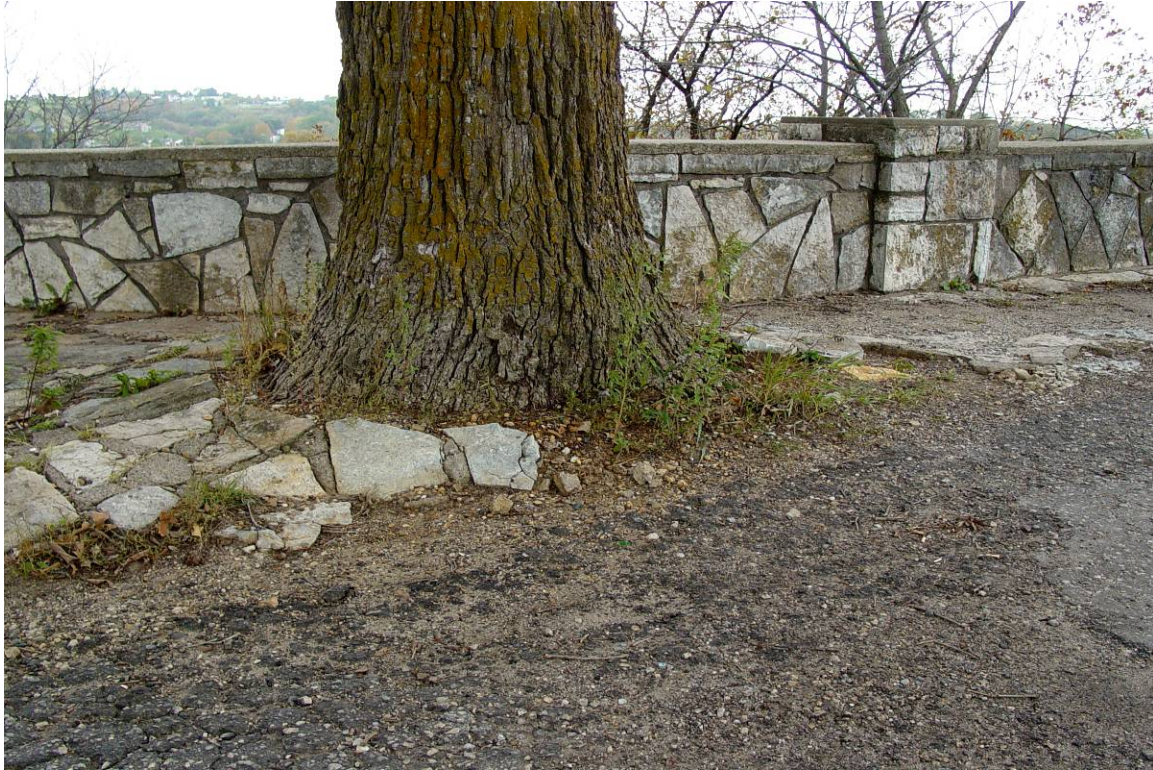
**Plate 14. Disruption of flagstone terrace by tree growth, facing south**

- Restoration:** Prune and trim the elm and oak at the overlook wall. Remove the dislodged flagstones from the base of the oak and reposition them, or use them to replace other broken flagstones. Following the scheduled TH 52 alterations, (as noted previously in *Topography*) install new plants in the central island and on the hillside across from the overlook (duplicating original species where possible and approximating the patterns shown on Sheets 3, 6, and 7 of the 1937-38 plans [Appendix B]). The current cost sheet for the overlook and central island estimates 26 juniper shrubs and 2

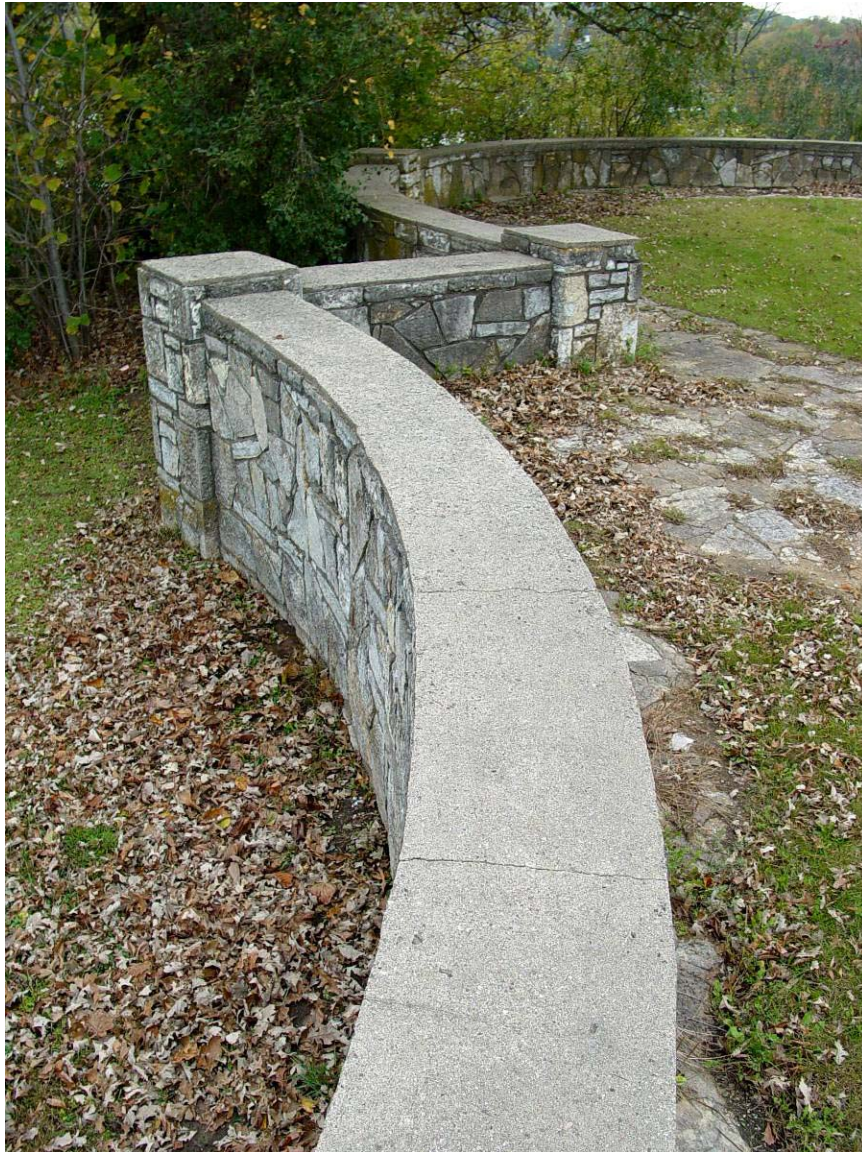
**Plate 16. Cracks in concrete cap at east end of overlook wall, facing south**

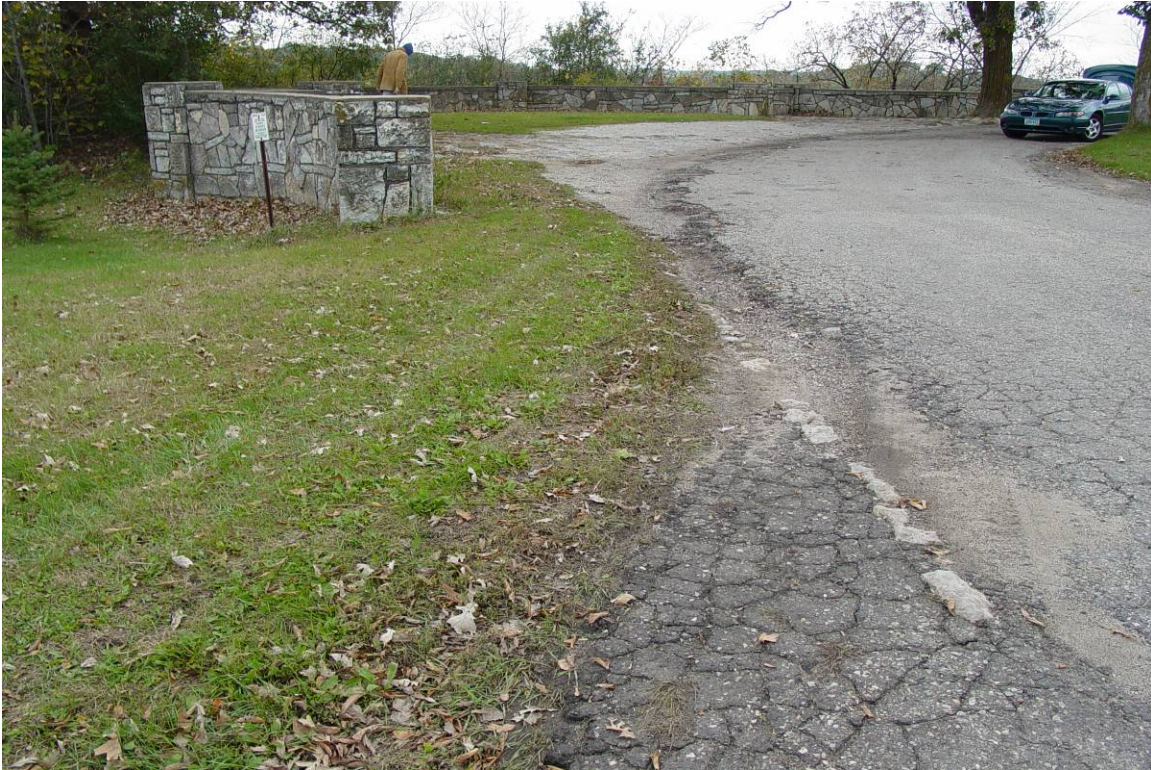
- **Assessment:** As previously noted (*Circulation: Parking Areas*), the asphalt access drive at the site has partially buried the limestone curbing around the edge of the central island. The stone curbing on the north side of the central island will be removed during the scheduled widening of TH 52 and then replaced. Stone curbing also originally extended east and west from the ends of the overlook wall. Several of these stones are missing and it is possible that this curbing will also be disturbed during TH 52 construction.

**Plate 17. Buried stone curbing at east end of overlook site, facing south**

- **Recommendations:**  
**Stabilization:** None. Work Period: Not applicable.  
**Preservation:** Avoid the removal of the curb stones or the installation of asphalt that buries the curb. Work Period: 1 - 3 years.

**Restoration:** Remove the asphalt road to expose the historical profile of the stone curb, and regrade the road to drain water away from the site. Replace any missing curb stones where necessary with a matching stone from a local quarry. During TH 52 construction, all affected curbing stones should be photographed and marked before removal, stored during construction, and replaced after the highway is widened. Work Period: 1 - 5 years.

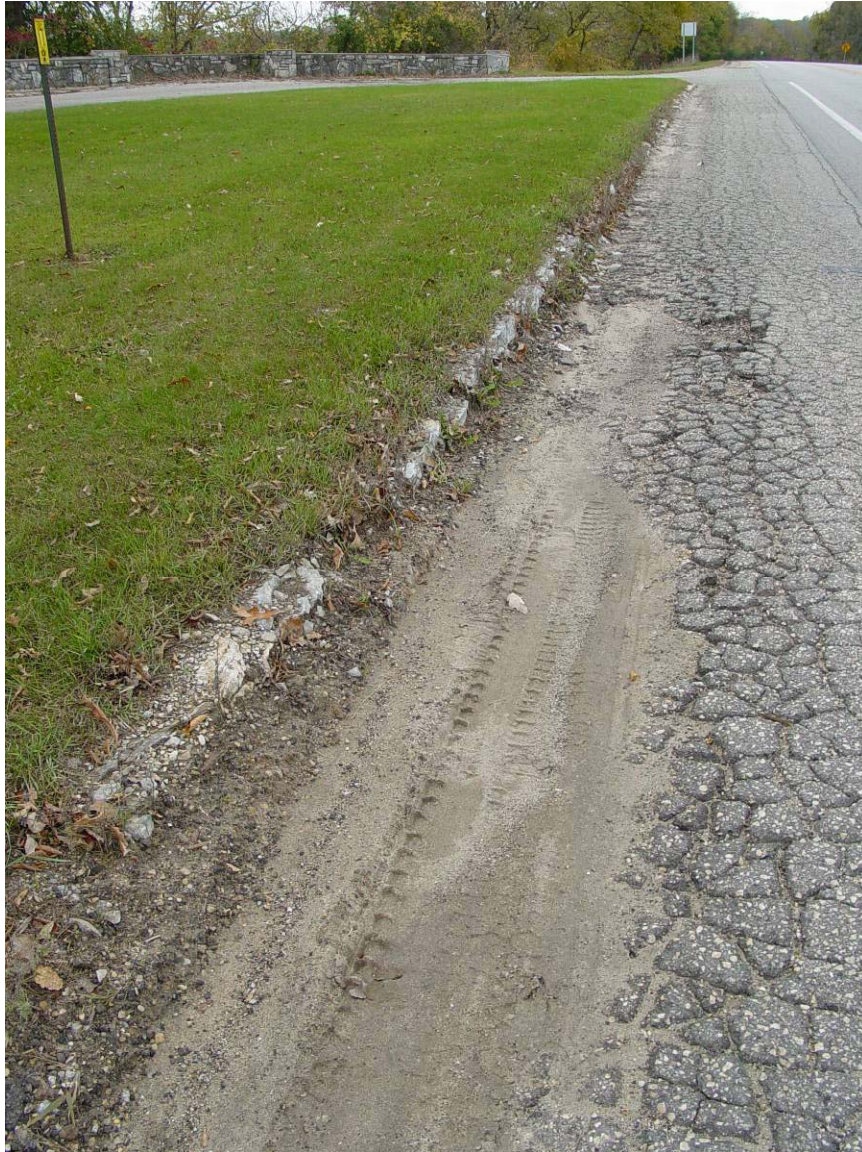
Stone Curbing Assessment: The stone curbing on the northern side of the island will be removed during the highway widening and then replaced. Stone curbing also originally extended east and west from the ends of the overlook wall. Several of these stones are missing. It is possible that this curbing will also be disturbed during construction.

**Plate 18. Stone curbing adjacent to TH 52, facing west**

Add to Recommendations: All curb stones should be photographed and marked before removal, stored during construction, and replaced after the highway is widened. The recommendations should probably reference both the curbing around the island and the curbing at the ends of the wall.

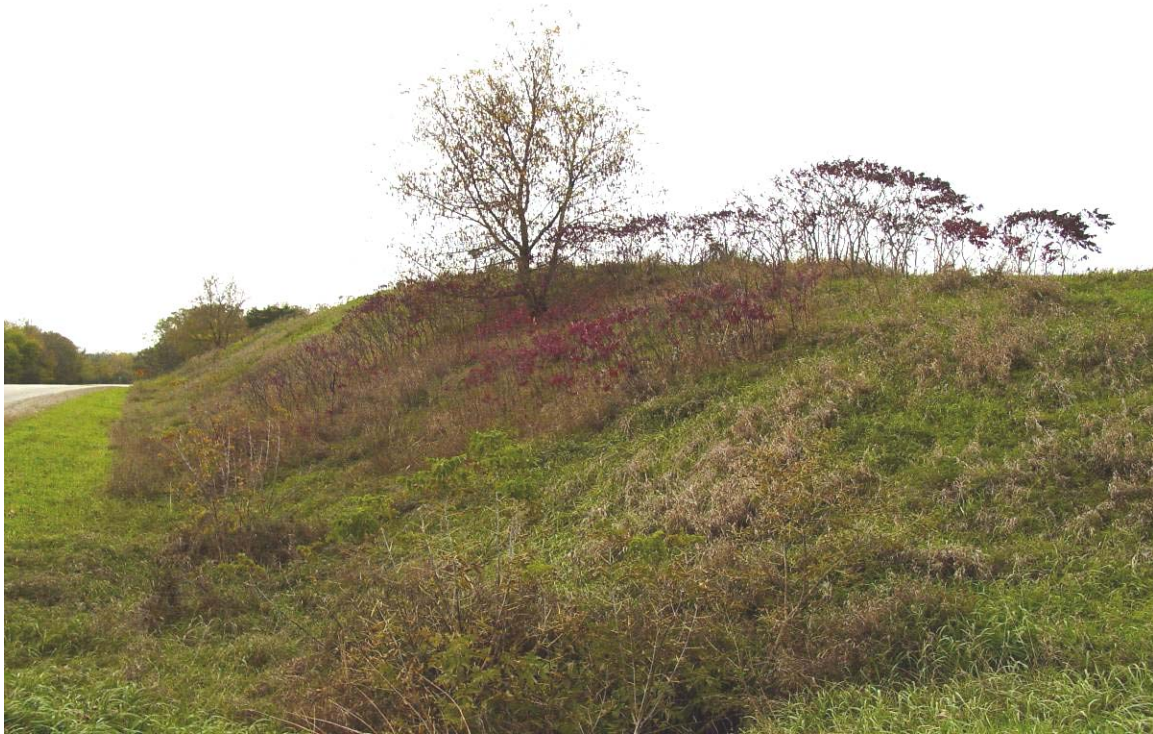
Assessment: Information that should probably be added: The impending highway widening described above will likely remove all vegetation across the highway from the overlook wall, and much of the vegetation in the corridor that was landscaped following the 1937-1938 plans.

Plate 19. Remains of original plantings across from overlook wall site, facing west

Add to Recommendations: After construction it is recommended that Mn/DOT reforest the T.H. 52 corridor, installing plants specified in the 1937-1938 plans and adding additional trees and shrubs in the vicinity of the wayside rest to mitigate the fact that the steep backslopes will be altered.

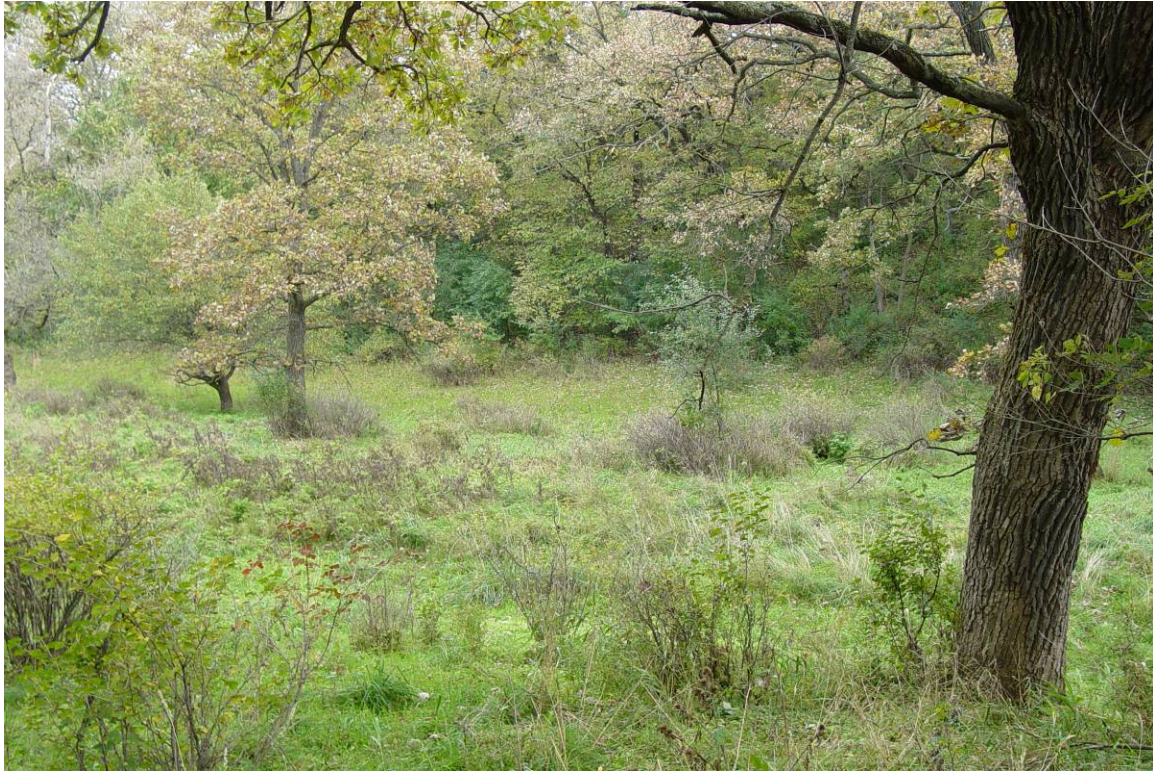
**Plate 23. Undeveloped picnic area at east end of Preston wayside complex, facing northeast**
