## WILLOW LAKE ROADSIDE PARKING AREA

SHPO INV. #CA-TOR-002

**Architect's Survey Date:** September 16, 1999

FIELD SURVEY OBSERVATIONS / RECOMMENDATIONS

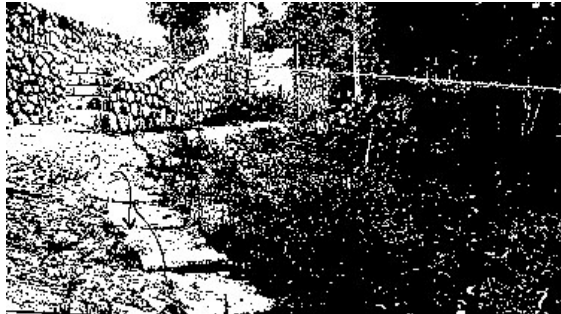
- **Assessment:** No remnants exist at the base of the hillside descending from the overlook wall steps to the lakeside trail ("Old Tote Road"). Photos #7 (Nichols) and #8 (Olson), taken in September 1941 show trail steps with log risers defining the walking trail. (See comments in Trails above.)

7. Trail Steps

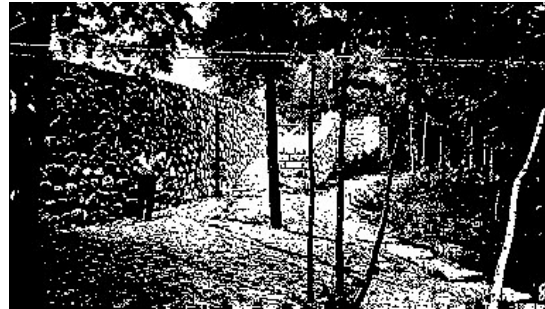
8. Trail Steps

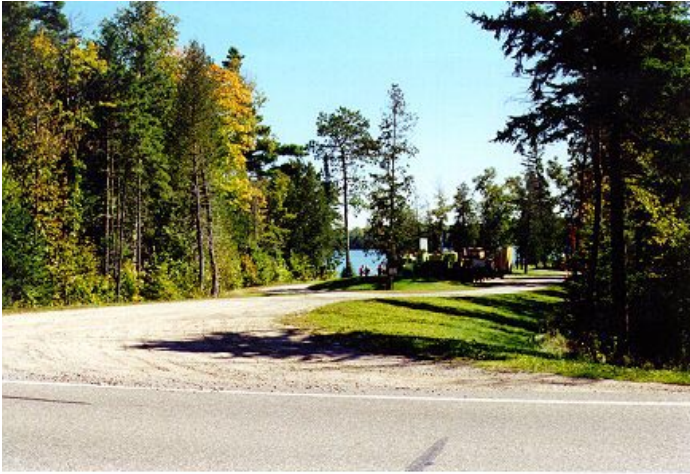
1. South site access.

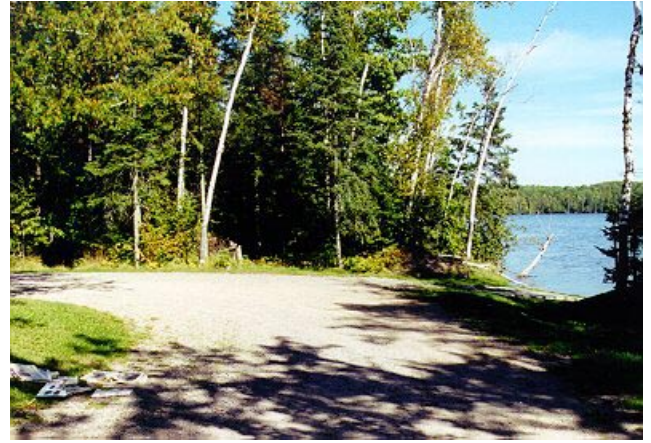
2. Boat launch at south access.

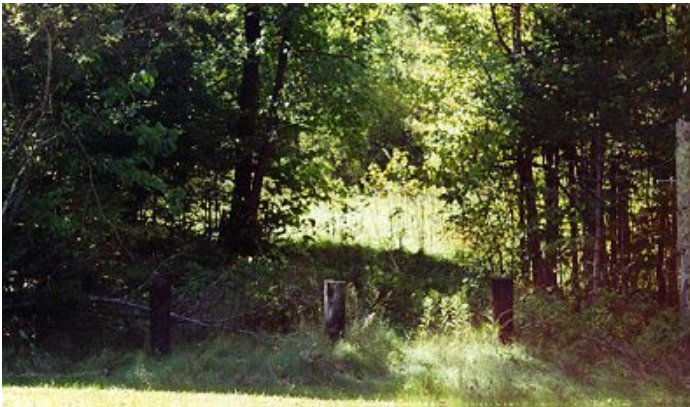
3. Walking trail to bath house. North from south parking area.

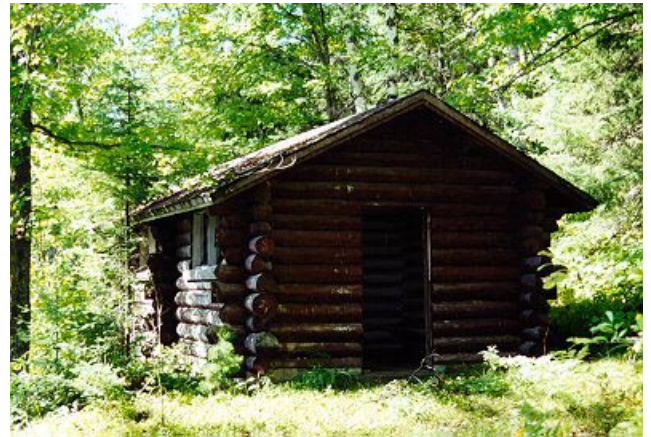
- **Assessment:** The condition of the log structure is fair. Many of the log ends are split, severely deteriorated or missing. The fascia boards are in poor condition. The asphalt shingles are in very poor condition. The surrounding vegetation is beginning to overtake the building and the structural stability of the historic edifice is in jeopardy. The concrete floors, which appear to be newer than the log structure, are in good condition and each side contains a poured-in-place steel floor drain.

4. North east views of log bath house.

- **Recommendations:**  
**Stabilization:** Remove all deteriorated shingles and replace with new. Repair sections of deteriorated fascia and logs to stabilize using acceptable preservation/restoration techniques. Paint sections to match existing materials. Remove all encroaching overgrown vegetation about 6'-0" from the building and re-grade as required for proper drainage. **Work Period:** 1 - 3 years.

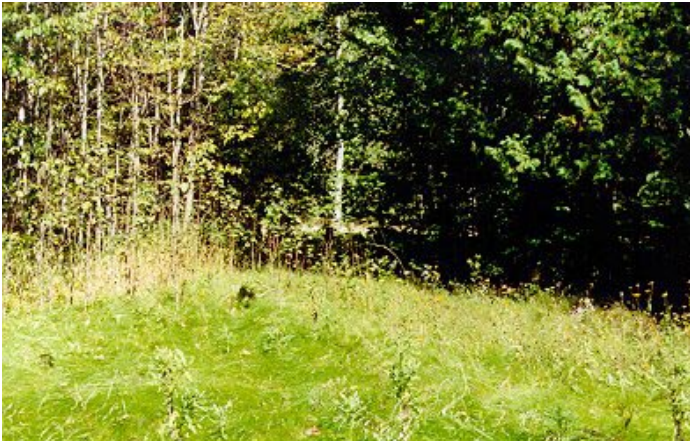
The original southern parking area has been abandoned, probably when the adjacent picnic area was abandoned. Three short, wood posts block its entrance. It is a grassy clearing that is filling with encroaching vegetation. Currently a gravel parking area and boat launch located about 100' north of the original parking location exists. It is assumed from 1986 aerial photos that the entrance from T.H. 6 is near Station 524 as shown on the original plans. The current parking area has an oval shape, a gravel surface in good condition, and two small bermed islands. The boat launch has a simple concrete ramp and a small wooden dock.

5. Original parking lot at south site.

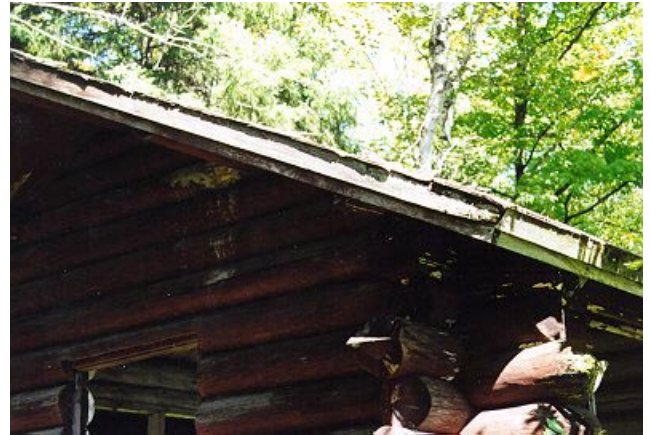
6. Fascia/shingle and log end deterioration.

**Preservation:** Clear all the vegetation around the building to a distance of about 6'-0". Replace the asphalt shingles and significantly deteriorated fascia boards. Fill and stabilize the ends of the rotting logs with epoxy or similar preservation measures. Paint logs ends to match existing color. **Work Period:** 1 - 3 years.

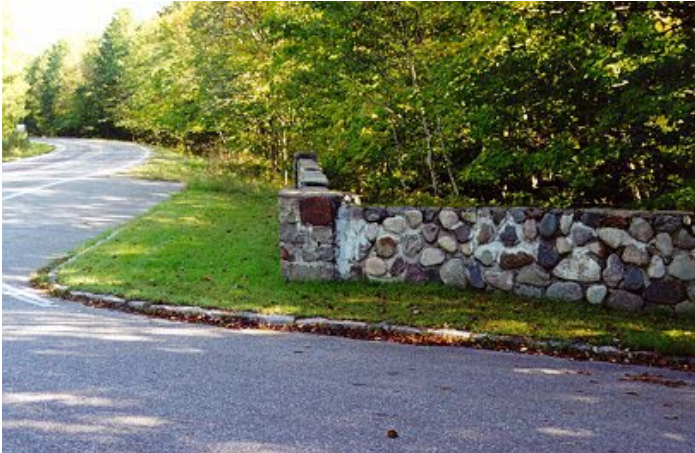
Today, the northern entrance drive/parking area is paved with asphalt, which is in good condition. The drive/parking area retains an unusual amount of intact granite curbing, with only several missing. Willow Lake is one of the sites with the largest amount of stone curbing in the entire Roadside Development inventory of 102 sites.

7. North site access – granite curb and stone wall (looking north).

1. North site: remove asphalt surfaces, compacting and re-grading as required to reestablish the original 6" face exposure of the granite curb. Carefully preserve the stone curbing. Replace missing and broken units with matching pieces of similar color and texture. This work extends out onto T.H. 6 at both the south and north ends of the overlook wall. At the catch basin remove asphalt and felt covering and clean it out and restore drainage to both drainpipe and catch basin.

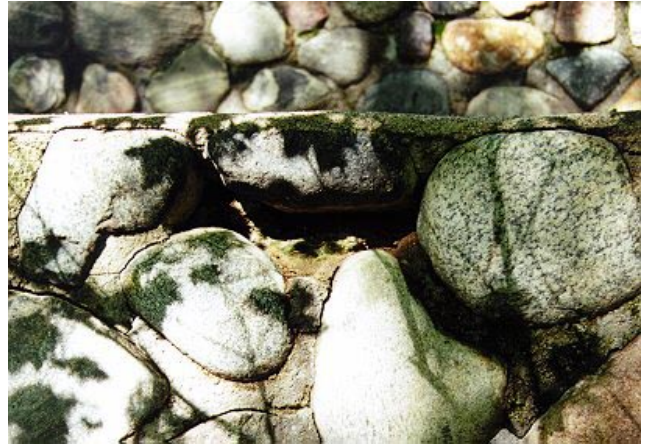
8. Existing condition.

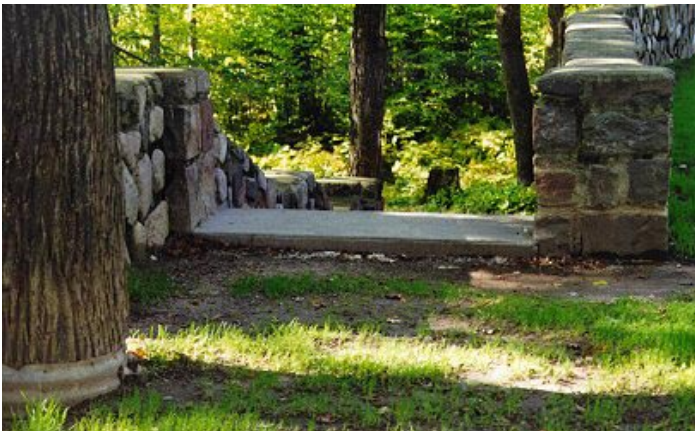
9. Steps to lower level. Remove tree.

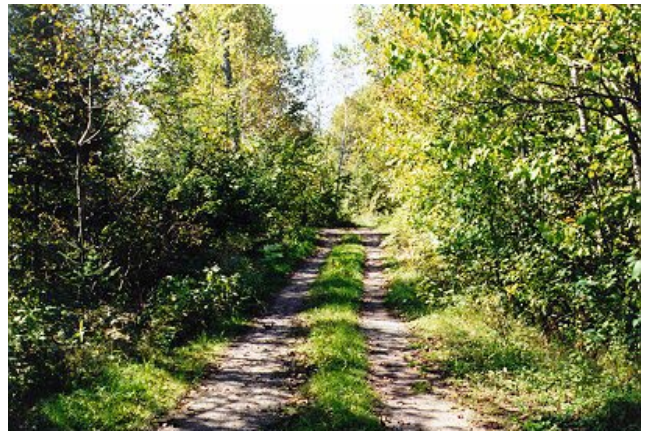
10. Vehicle access to loop at north end of north site.

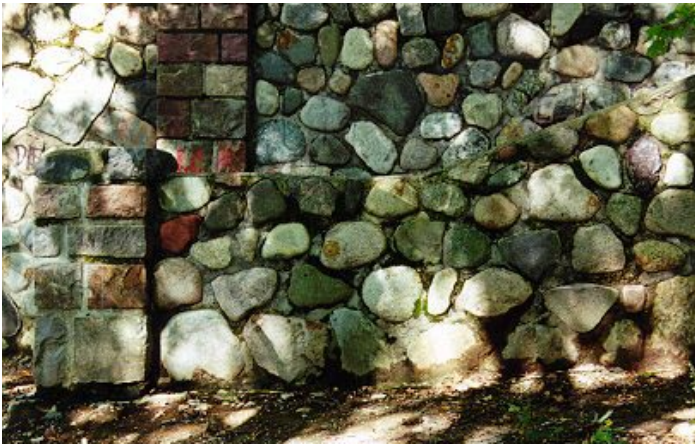
The steps were recently poured over the top of the existing with new concrete, thus changing the rise and tread dimensions of the original and also adding a 4" step above the walkway. At the bottom of the steps the grade is very uneven and hazardous due to settling and incomplete construction.

11. Bottom of stone steps.

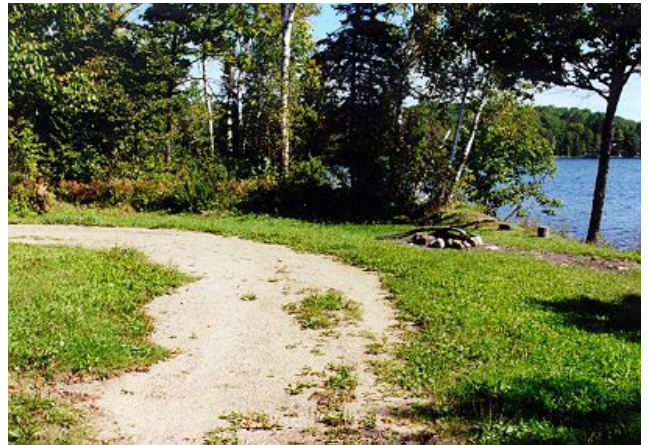
- Assessment: A newer metal fire ring exists near the water north of the overlook wall.
- Recommendations:  
Stabilization/Preservation/Restoration: Remove to prevent "camping". Work Period: ASAP.

12. North site vehicle trail and fire ring.

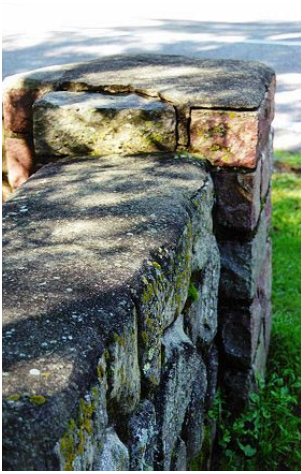
- **Assessment:** The wall is in generally good condition. Mortar topping is old, cracked and spalled in numerous places. The use of this feature does not comply with the Nichol's wall design and construction elsewhere. Mortar joints require replacement due to their condition—cracked, broken bonds with stone, mismatched coloration, etc. Graffiti occurs along the lakeside (east) elevation near the bottom of the steps and several other locations.

13. Existing mortar cap condition

**Restoration:** Remove graffiti. Carefully remove mortar topping and clean stone surfaces. Remove stone joints and repoint to match original joint types and design. Add compacted fill along the eastern perimeter of the wall. Remove the recently poured concrete steps; remove the original step remnants; provide compacted base fill to match the original elevations of the steps and pour new concrete steps and landings extending 9" into each side of the granite walls. Replace missing stones in wall as required. Remove debris at the bottom of the steps and provide finished grade to match the original landing height. Adding a steel handrail, anchoring it to the "tall" wall will increase user safety—this material shall be carefully chosen and anchored to limit its intrusion on the wall's historic fabric. **Work Period:** 1 - 3 years.

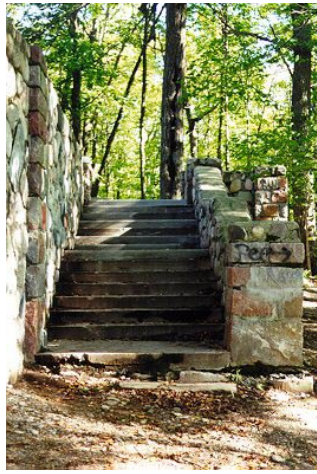
14. View new concrete step repairs.

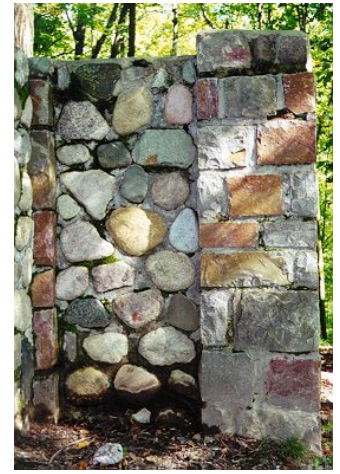
15. View of lower wall condition.

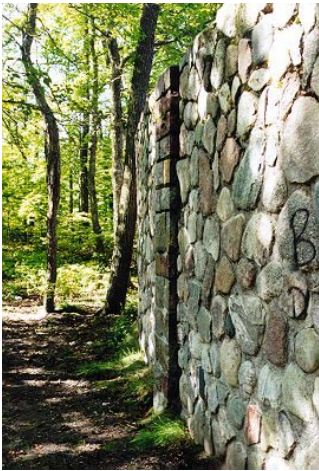
The site's vegetation is in good condition but overgrown. Numerous trees have grown adjacent to the east face of the wall potentially threatening the struc-

16. Base of overlook wall showing existing vegetation.

**Stabilization:** Verify the wall's structural stability prior to any tree removal as the larger tree roots may have grown underneath the footings. To avoid wall damage, clear trees and brush from the eastern face of the overlook wall to a distance of about 4'-0" to 6'-0". Remove grass and weeds from the wall base and curbing. **Work Period:** 1 - 2 years.

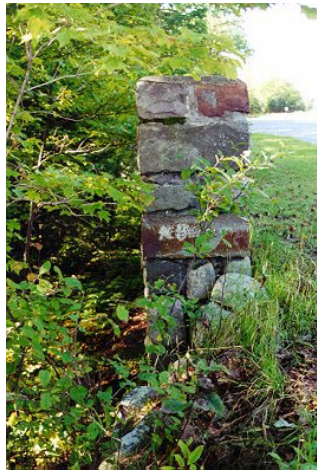
17. North end of overlook wall.

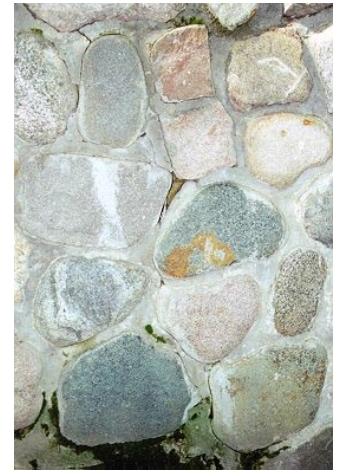
18. Wall repairs.

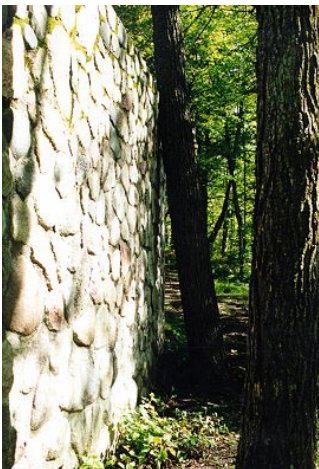
19. Lower wall view showing vegetation proximity.

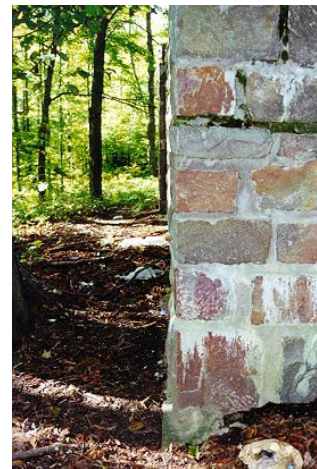
20. Recent mortar repairs.

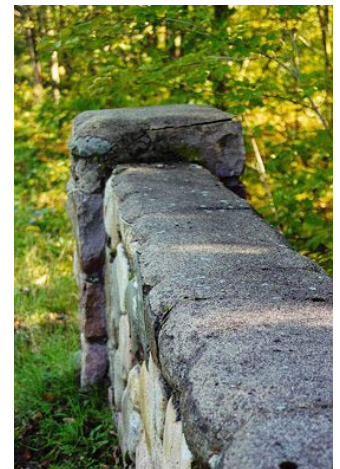
21. Mortar Cap.

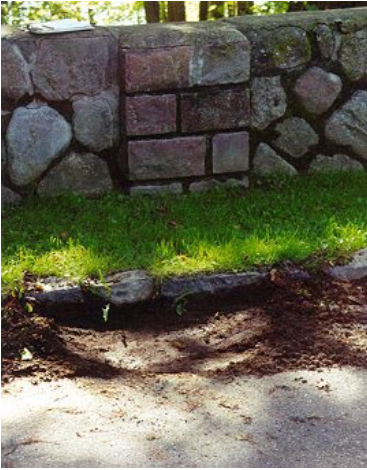
22. Original catch basin covered with asphalt overlay.
