Pavement Condition Report

Owatonna - Degner Regional Airport (OWA)

December 2016

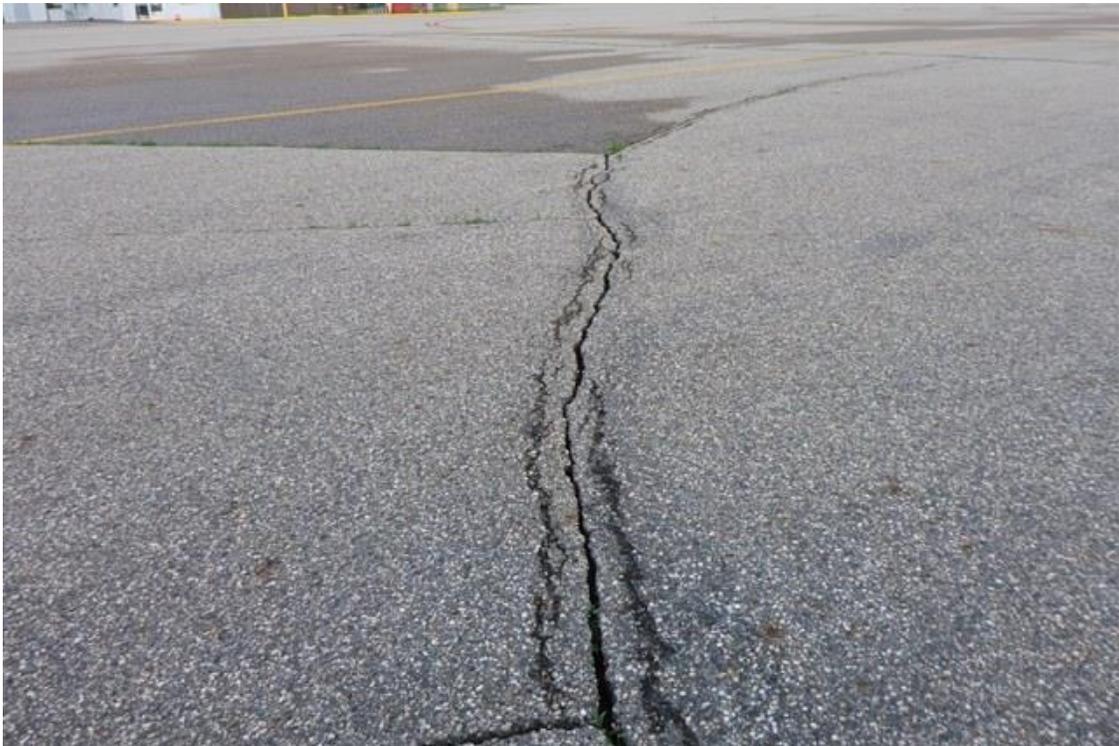
OWA APA 002 (PCI = 52)

Inspection Comments: crack seal not satisfactory

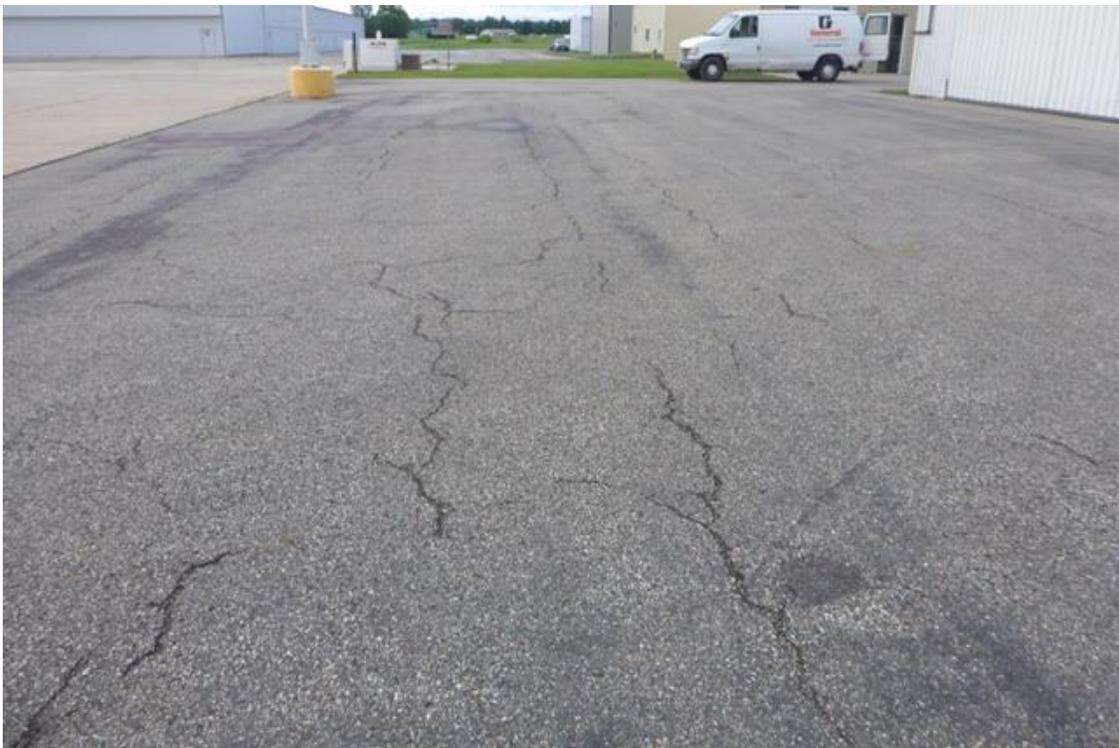
CFE APA 005 (PCI = 70)

Network:	OWA		Name:	OWATONNA					
Branch:	APA	Name:	Apron A	Use:	APRON	Area:	243,879 SqFt		
Section:	005	of 4	From:	100	To:	100	Last Const.:	9/26/1998	
Surface:	AC	Family:	MN2013 Asphalt Aprons	Zone:	S	Category:	3	Rank:	S
Area:	5,076 SqFt	Length:	108 Ft	Width:	47 Ft				
Slabs:	Slab Length:	Ft	Slab Width:	Ft	Joint Length:	Ft			
Shoulder:	Street Type:		Grade:	0	Lanes:	0			
Section Comments:									
Last Insp. Date:	5/28/2016	TotalSamples:	1	Surveyed:	1				
Conditions:	PCI: 70								
Inspection Comments:									
Sample Number:	100	Type:	R	Area:	5076.00 SqFt	PCI:	70		
Sample Comments:									
48	L & T CR	M	29.00	Ft					
48	L & T CR	L	584.00	Ft

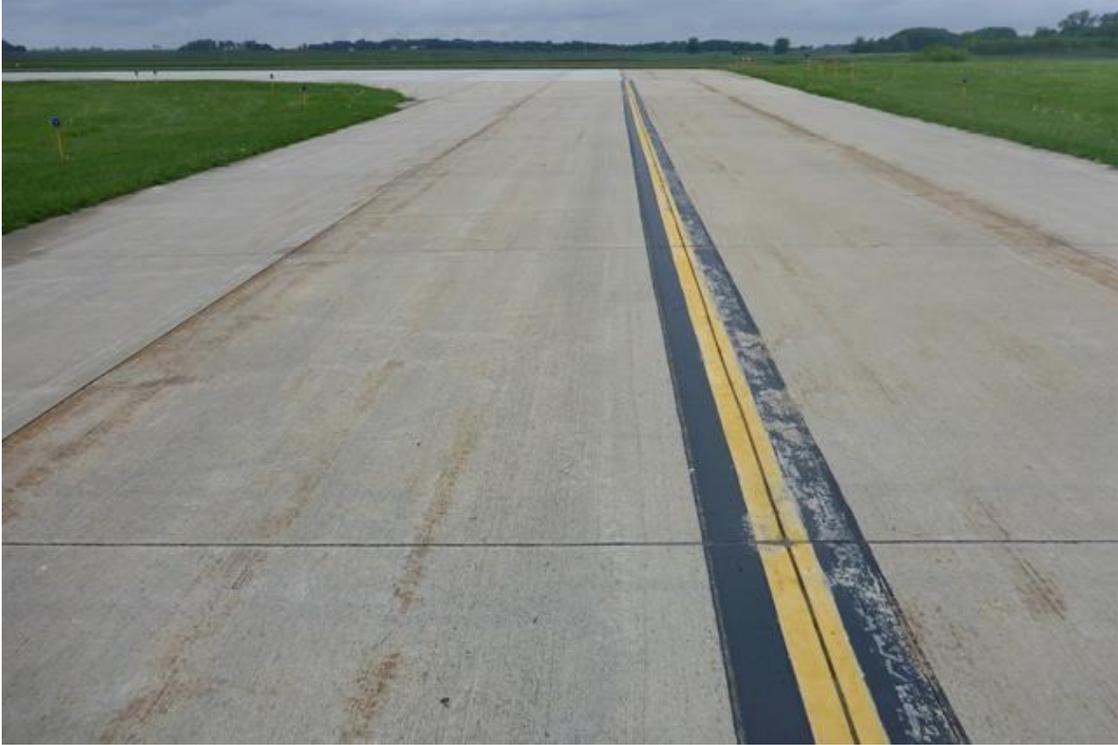
OWA CTA1 001 (PCI = 99)

Network:	OWA		Name:	OWATONNA					
Branch:	CTA1	Name:	Connecting Taxiway A1	Use:	TAXIWAY	Area:	17,500 SqFt		
Section:	001	of 2	From:	100+40	To:	105	Last Const.:	9/27/1996	
Surface:	PCC	Family:	MN2013 PCC	Zone:	S	Category:	3	Rank:	P
Area:	15,650 SqFt	Length:	385 Ft	Width:	40 Ft				
Slabs:	104	Slab Length:	15 Ft	Slab Width:	10 Ft	Joint Length:	2,142 Ft		
Shoulder:		Street Type:		Grade:	0	Lanes:	0		
Section Comments:	Maint. (R&E) JSR								
Last Insp. Date:	5/28/2016	TotalSamples:	5	Surveyed:	2				
Conditions:	PCI: 99								
Inspection Comments:									
Sample Number:	102	Type:	R	Area:	20.00 Slabs	PCI:	100		
Sample Comments:									
<No Distress>									
Sample Number:	104	Type:	R	Area:	20.00 Slabs	PCI:	99		
Sample Comments:									
73	SHRINKAGE CR	N	1.00	Slabs
