# Pavement Condition Report

## Falls International Airport (INL)

**December 2019**

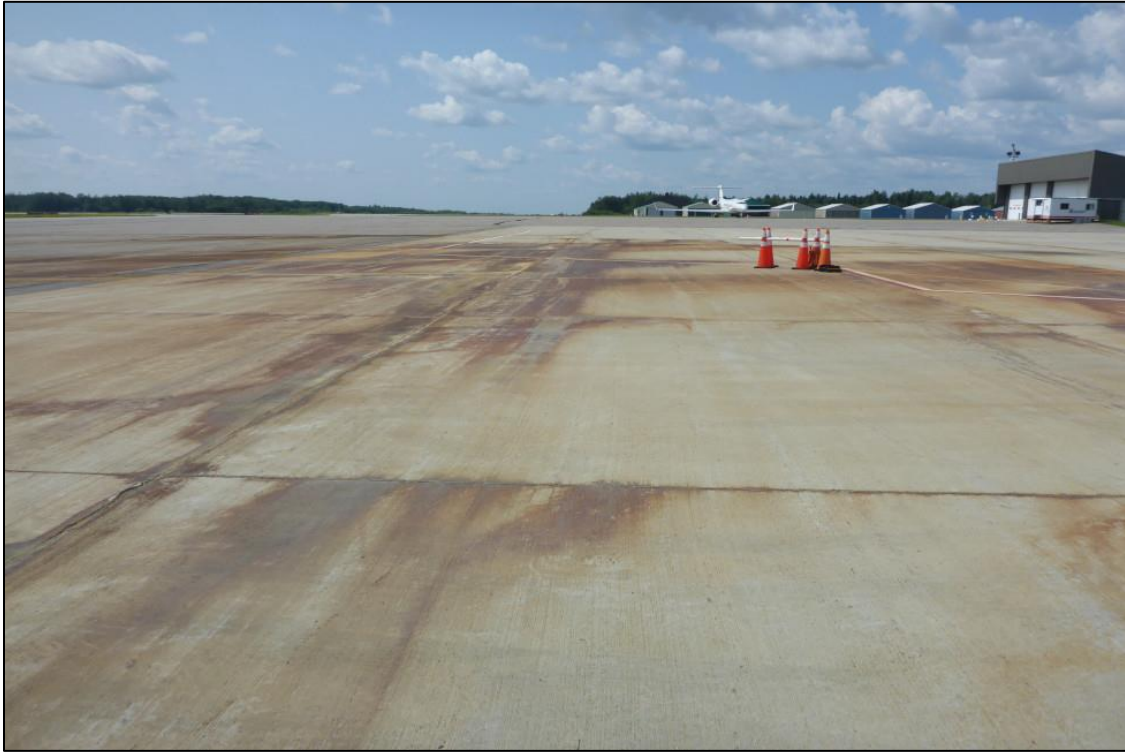
INL APA 001 (PCI = 62)

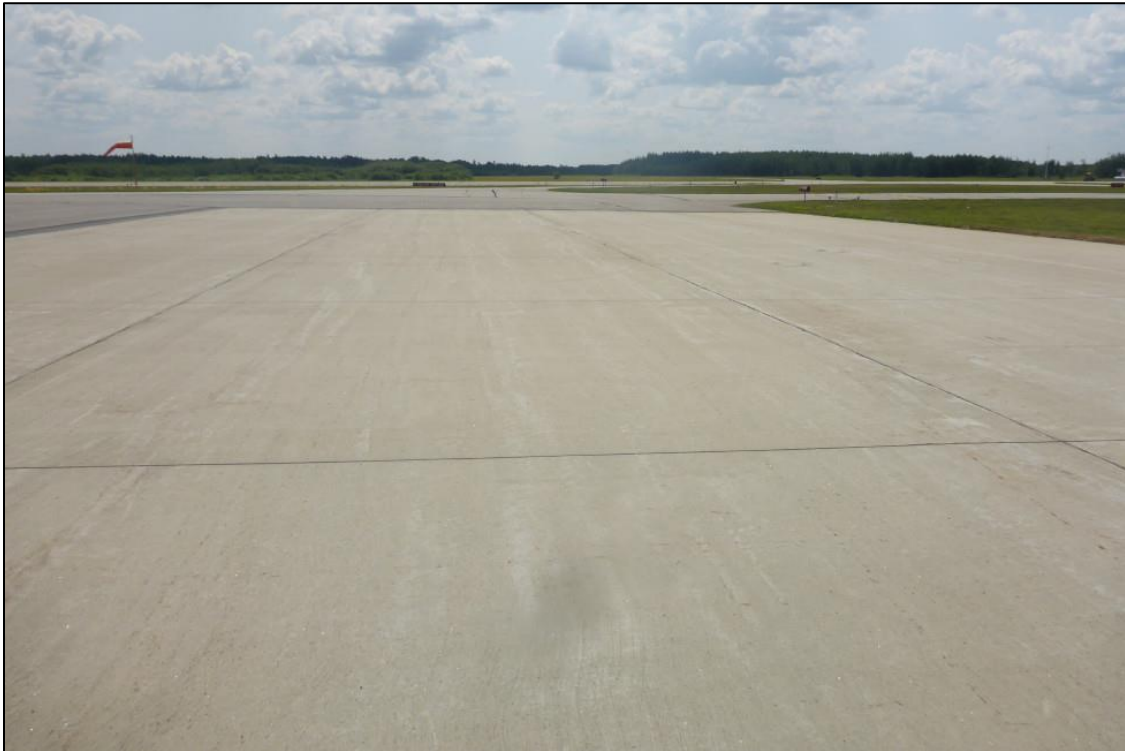
INL APA 002 (PCI = 94)

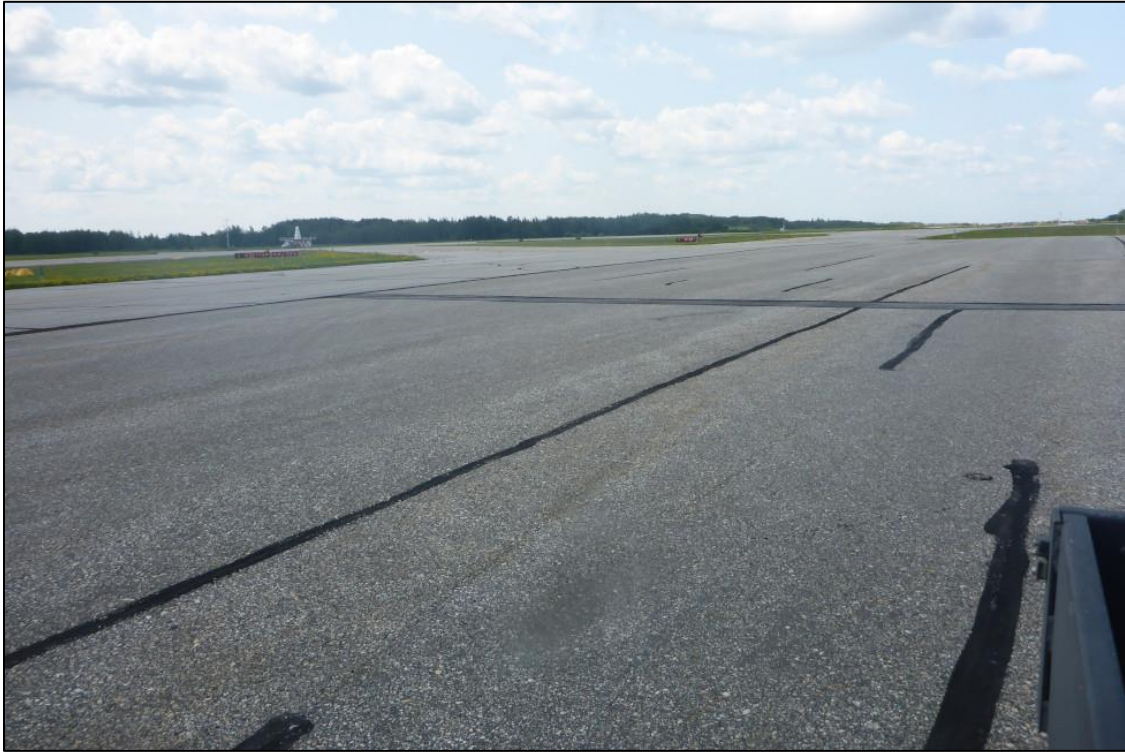
INL APA 003 (PCI = 85)

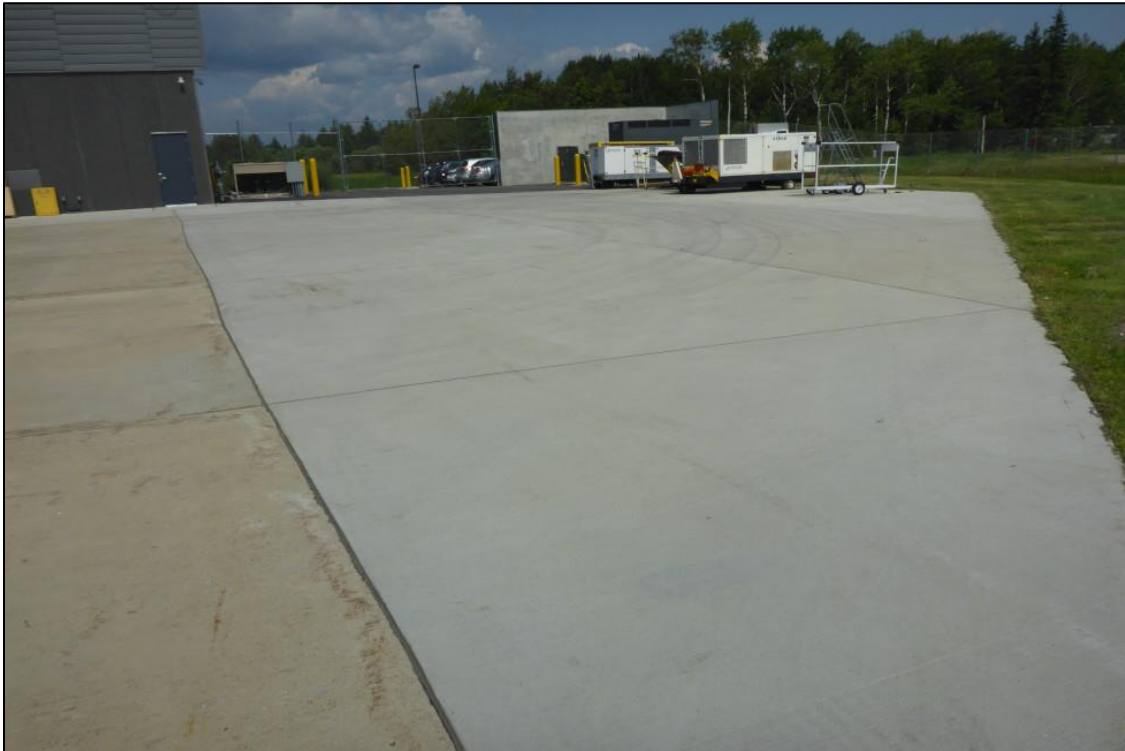
INL APA 004 (PCI = 100)

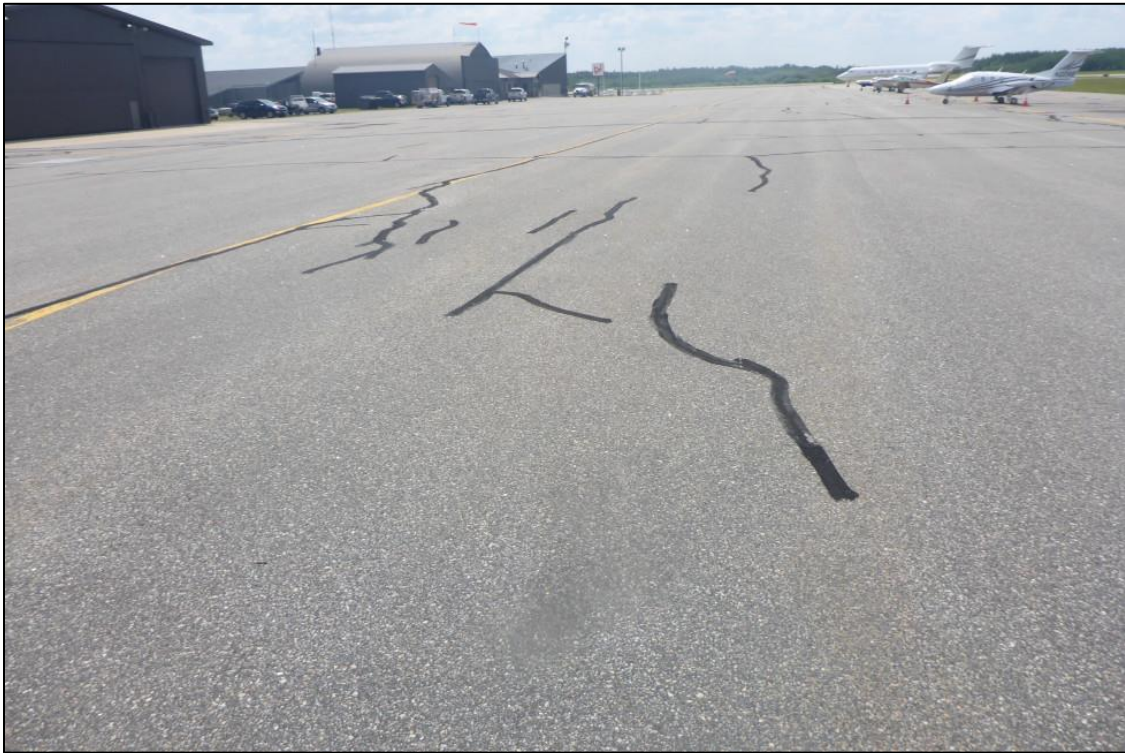
INL APB 001 (PCI = 77)

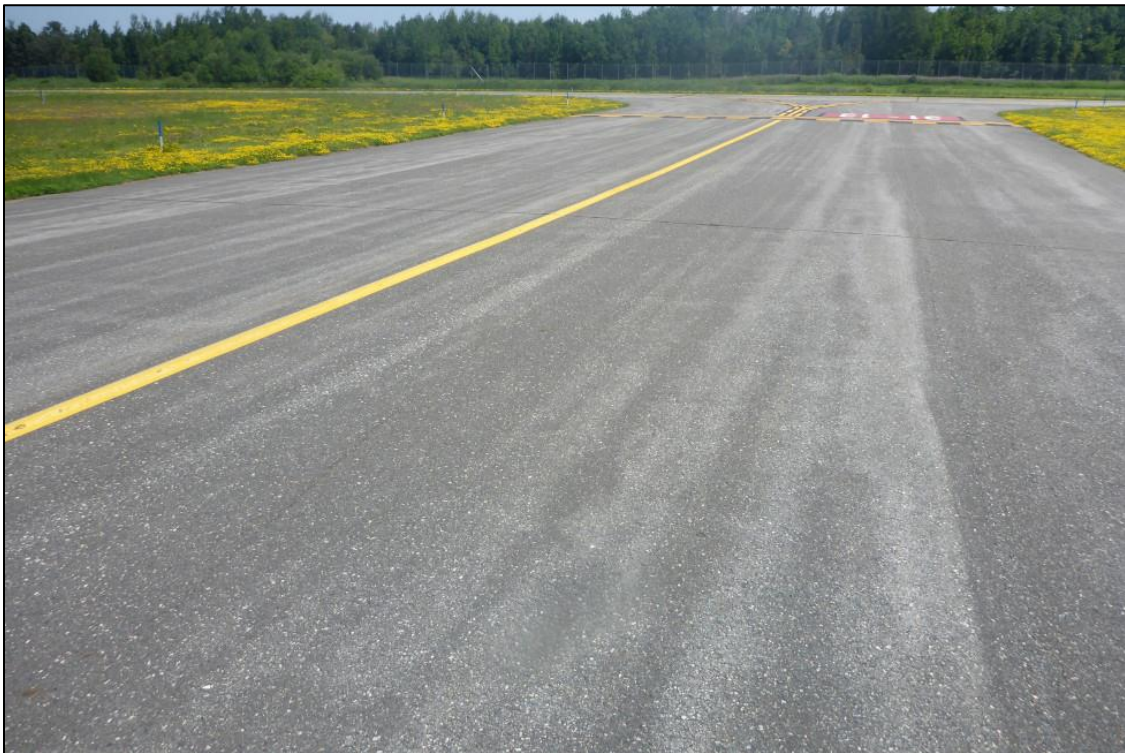
INL CTA1 001 (PCI = 86)

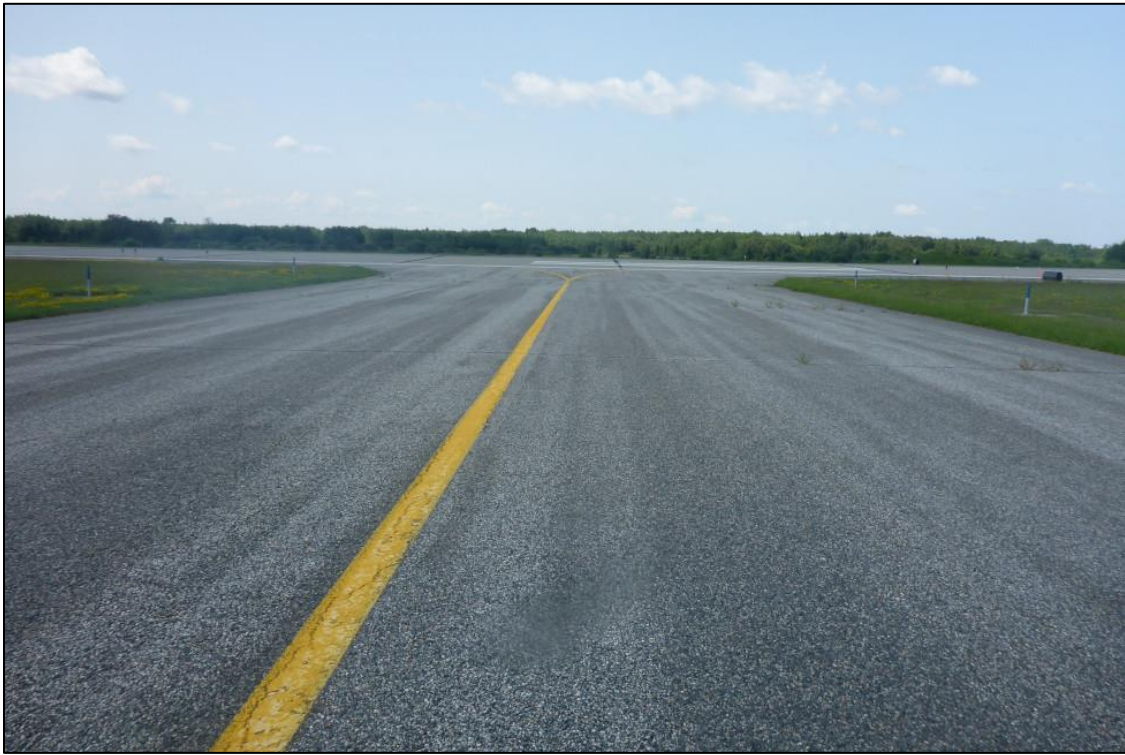
INL CTA2 001 (PCI = 76)

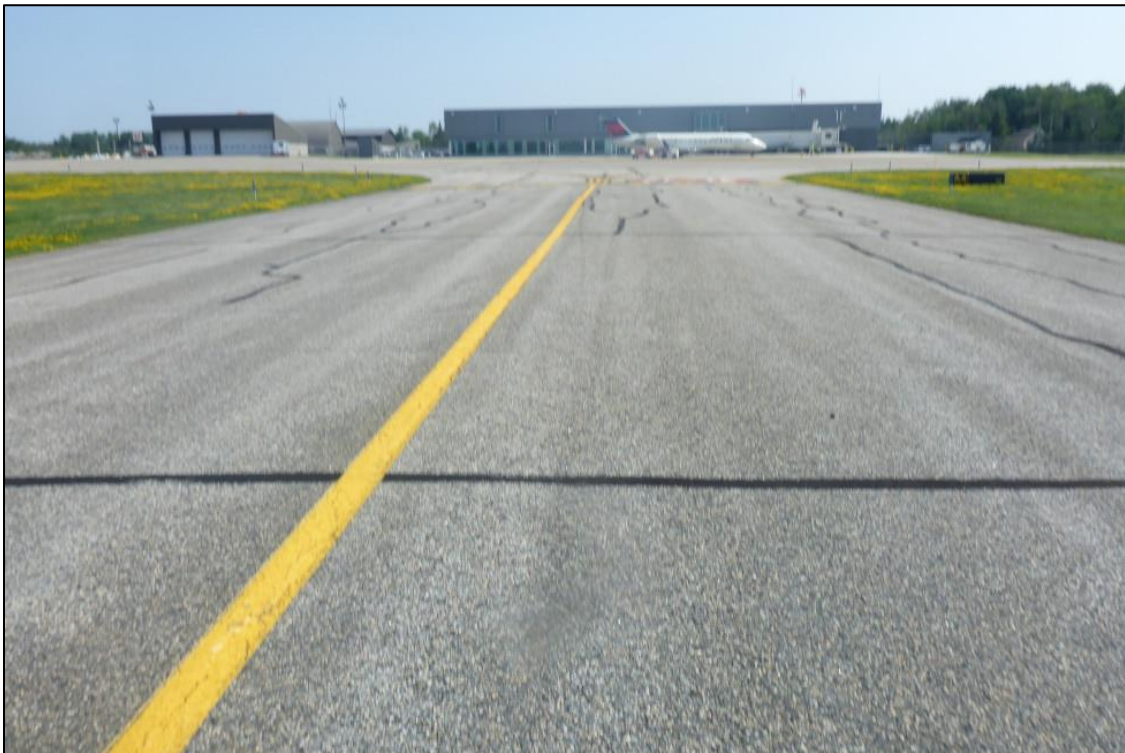
INL CTA3 001 (PCI = 74)

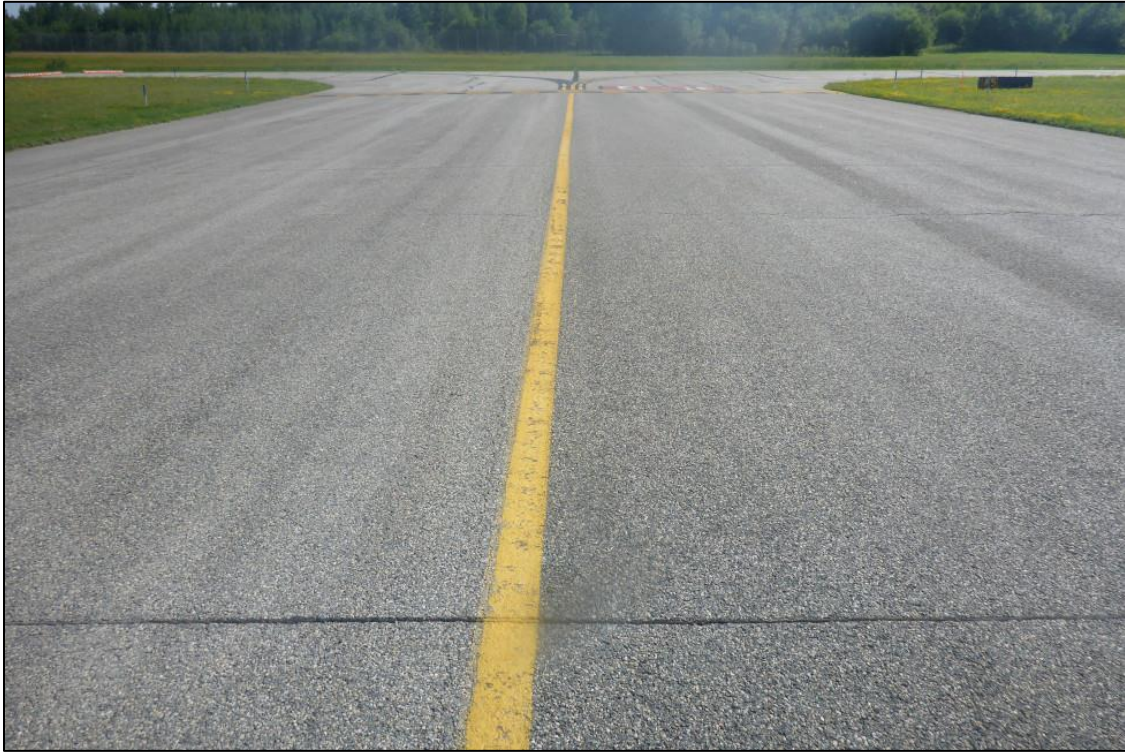
INL CTA4 001 (PCI = 74)

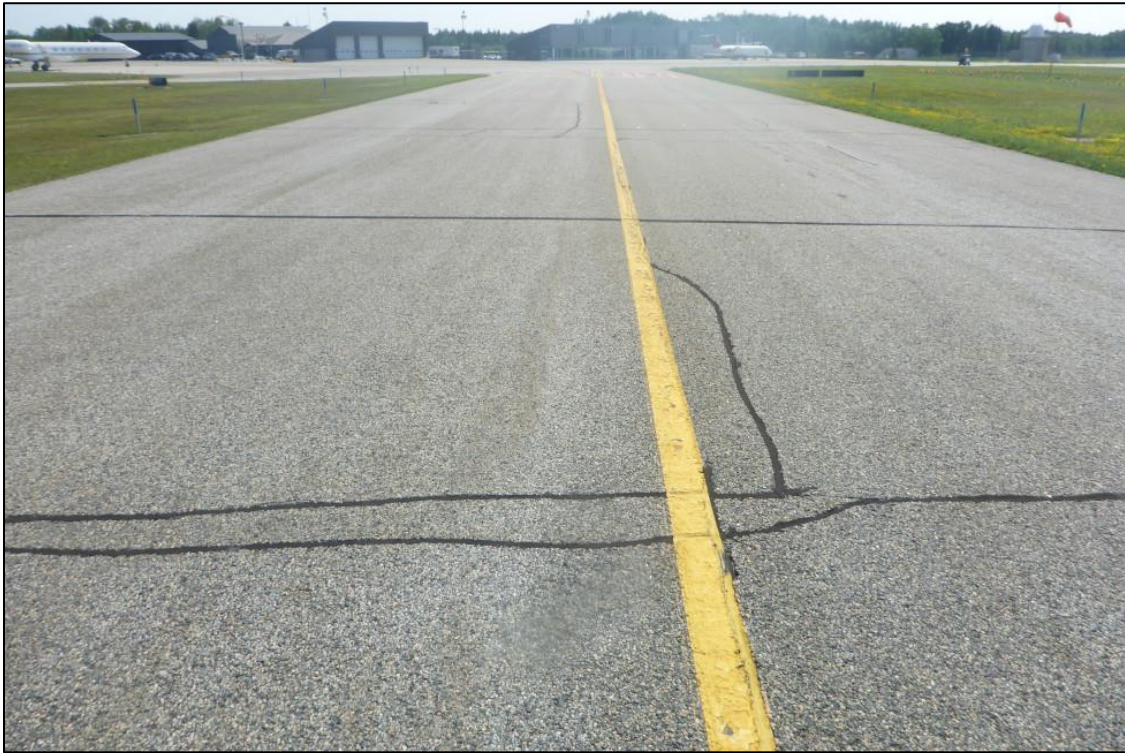
INL CTB 001 (PCI = 74)

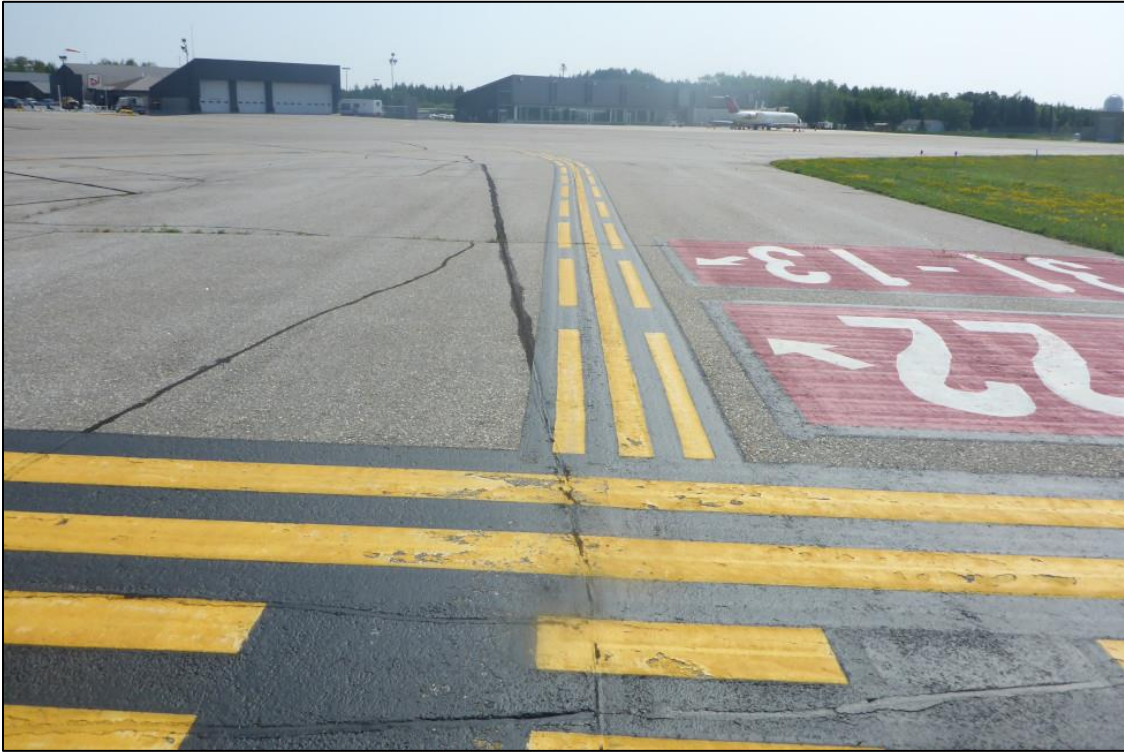
INL CTB 002 (PCI = 63)

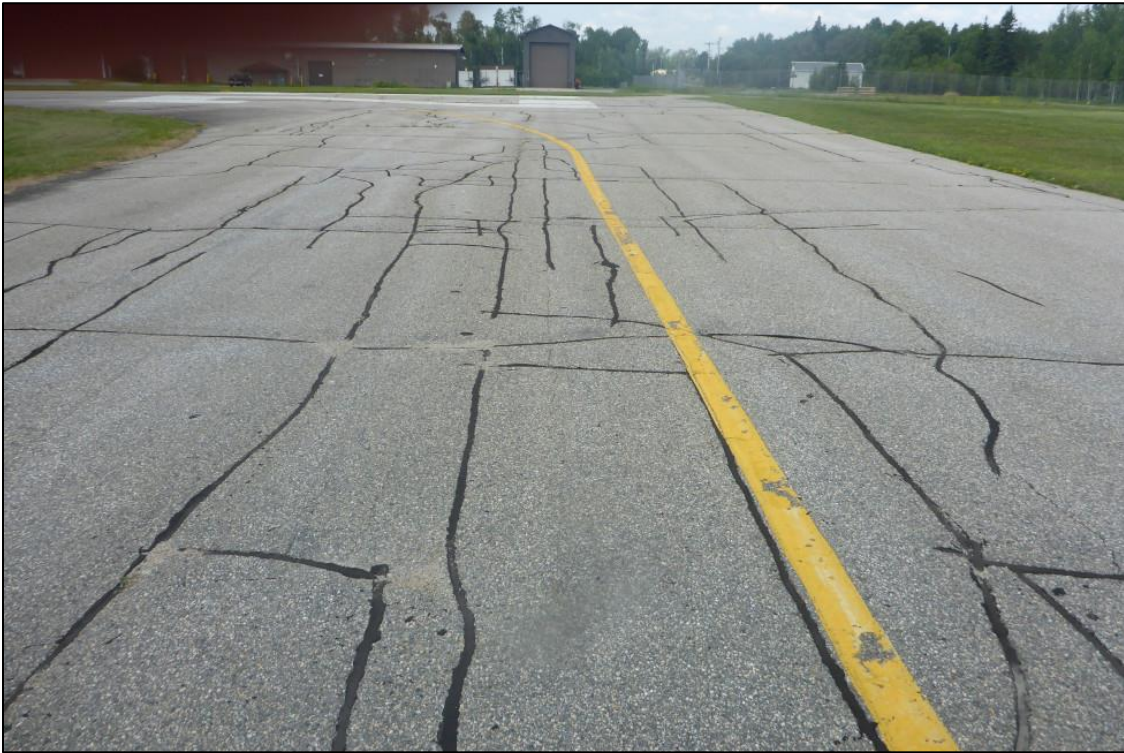
INL CTC 001 (PCI = 36)

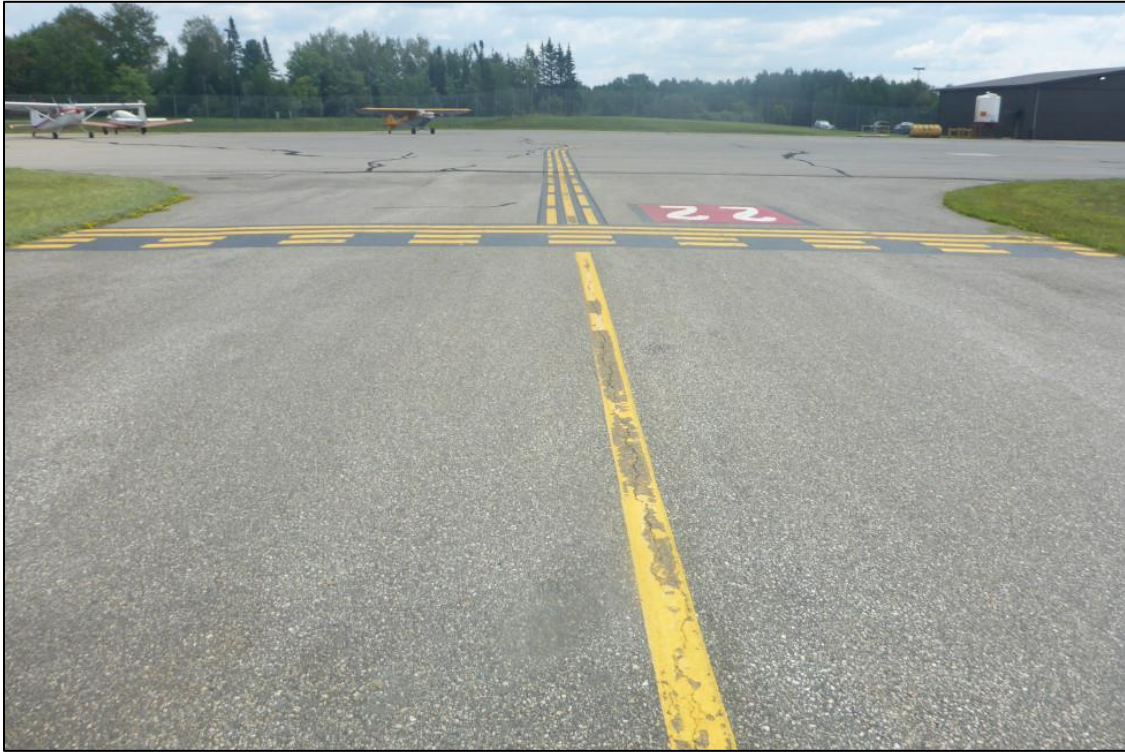
INL CTC 002 (PCI = 78)

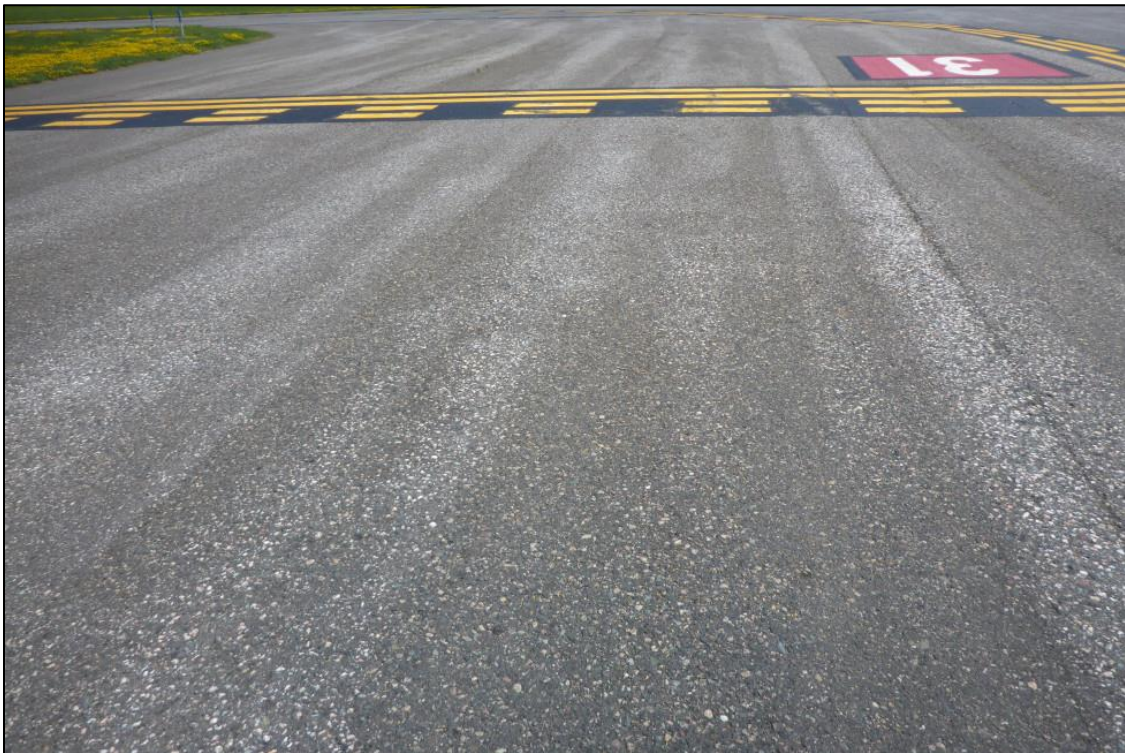
INL PTA 001 (PCI = 57)

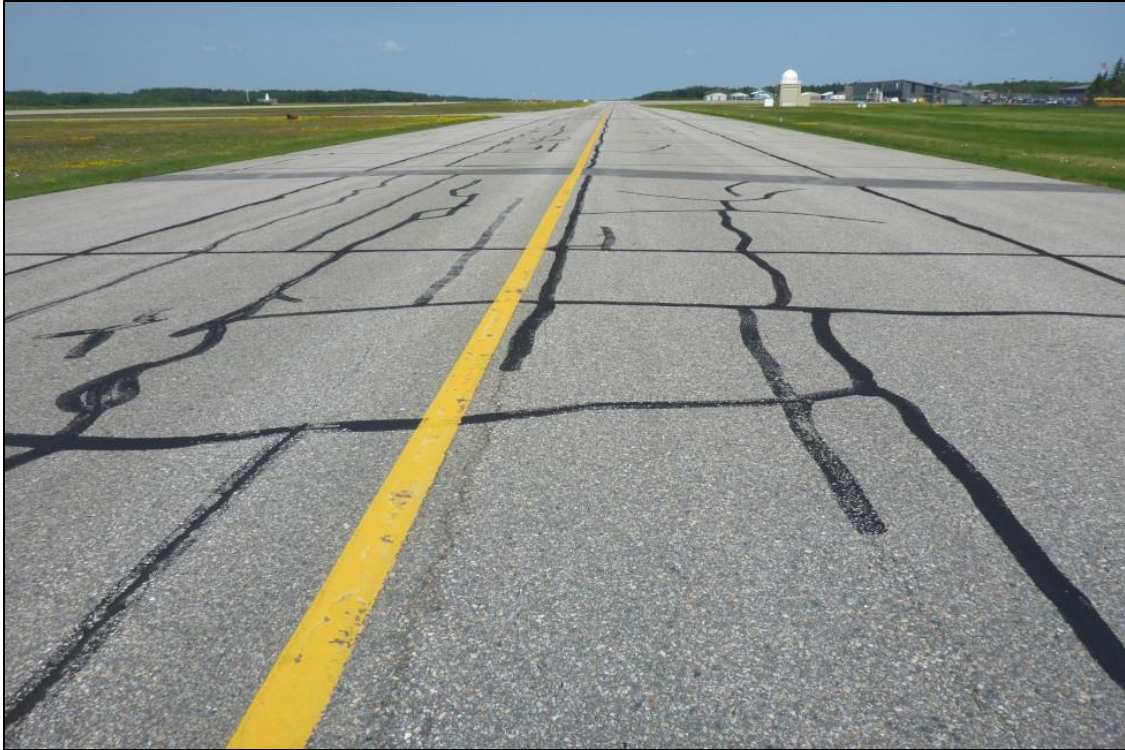
INL PTA 002 (PCI = 55)

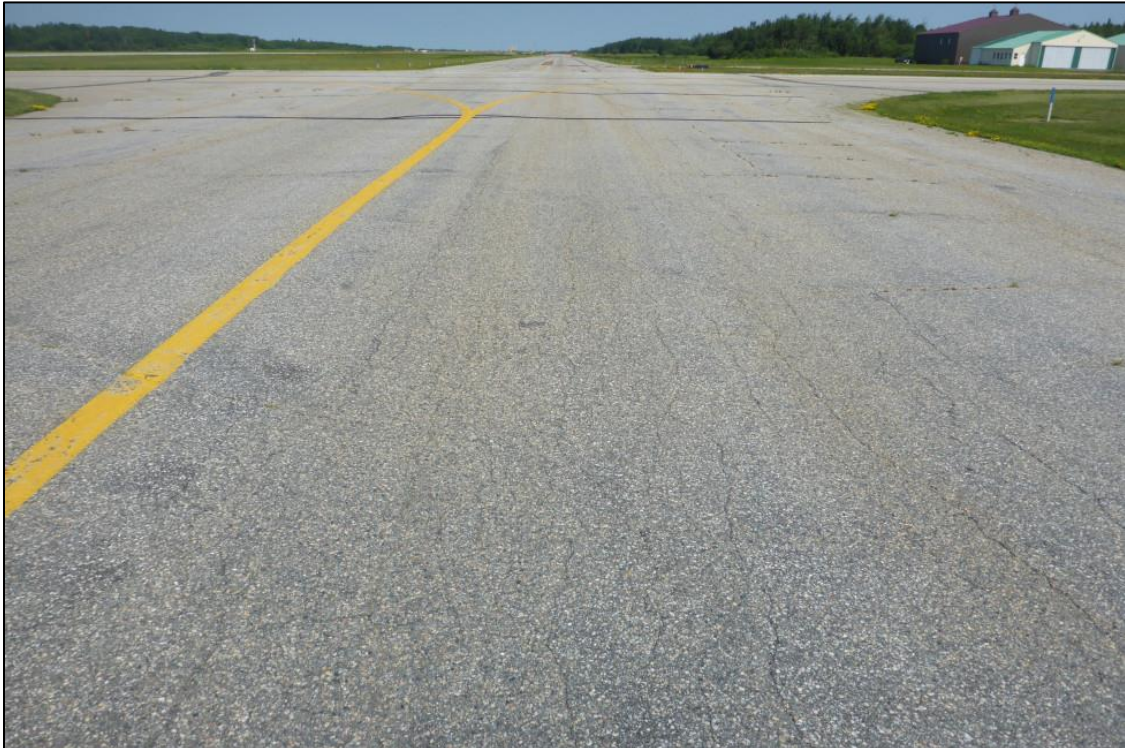
INL PTA 003 (PCI = 19)

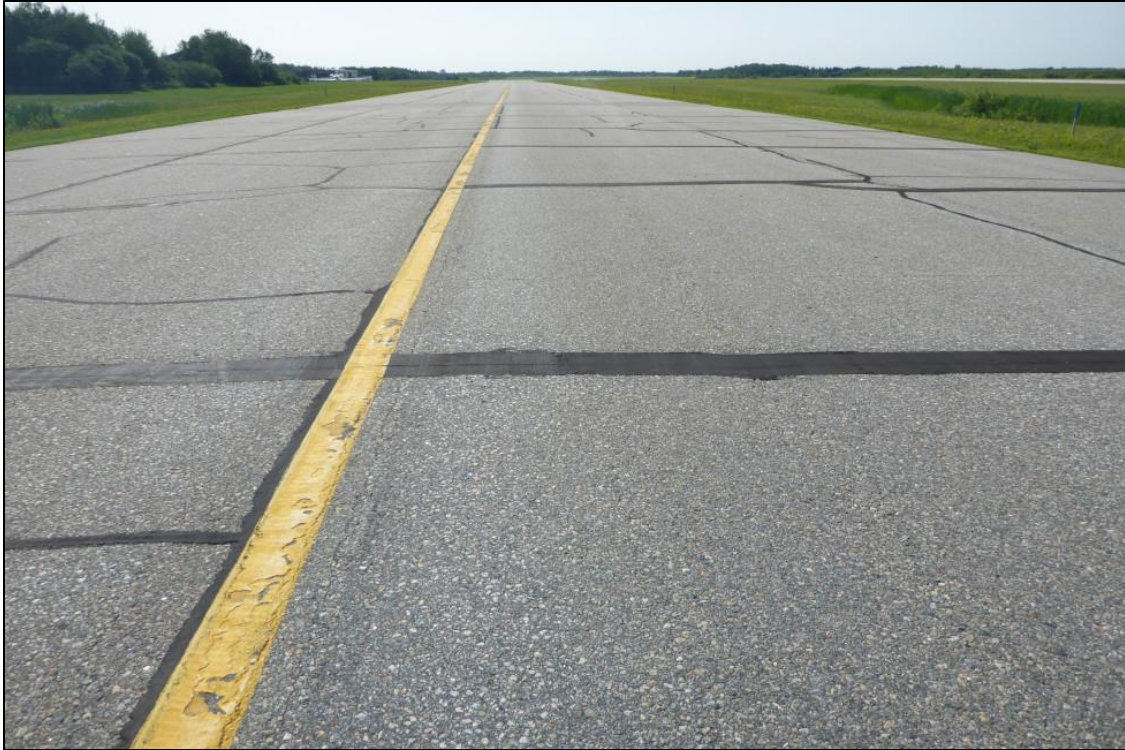
INL PTA 004 (PCI = 49)

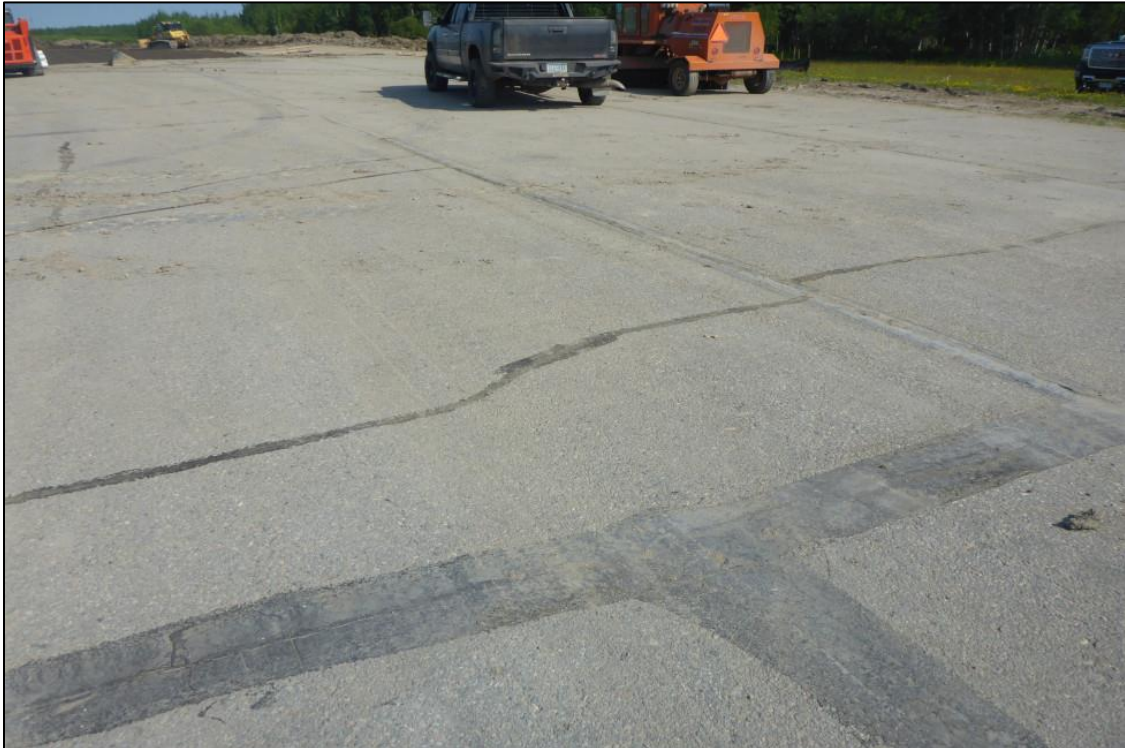
INL PTA 005 (PCI = 100) (under construction)

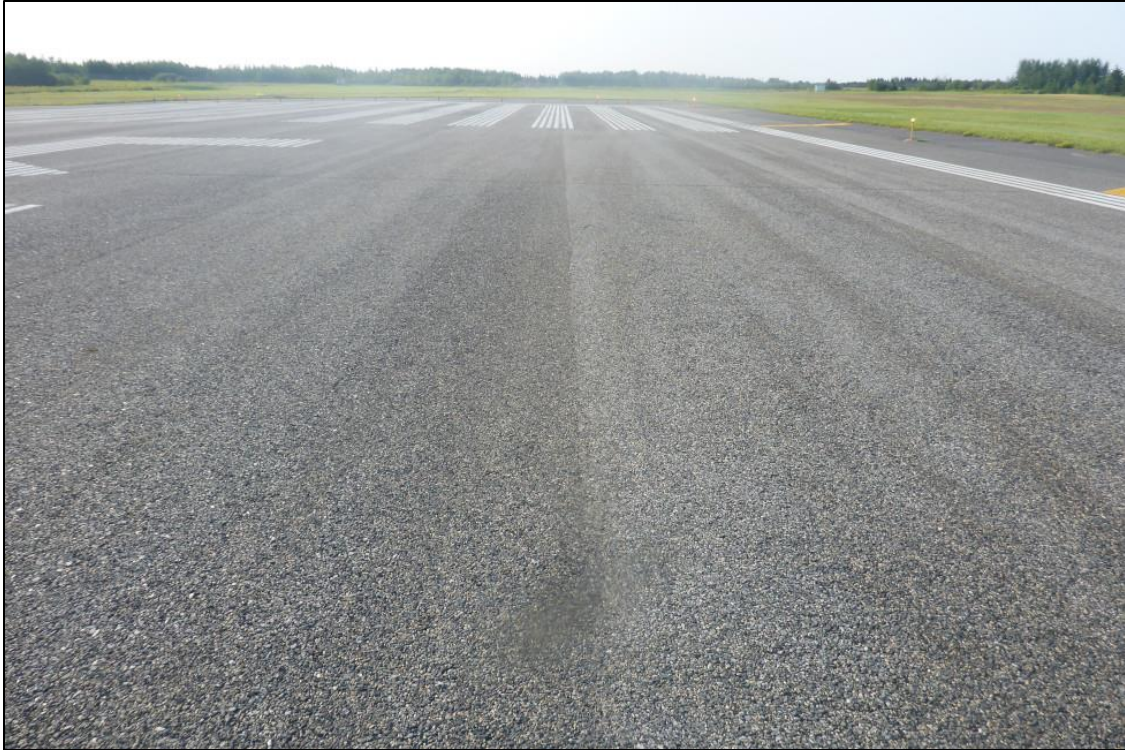
INL RY1331 001 (PCI = 92)

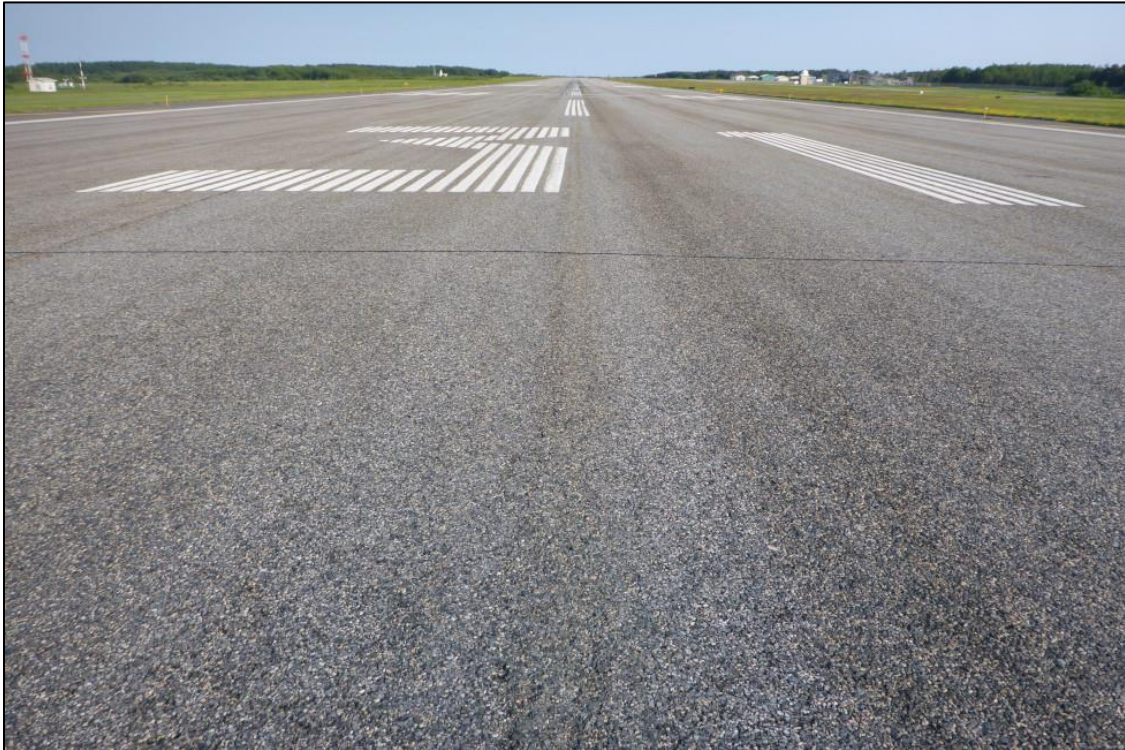
INL RY1331 002 (PCI = 79)

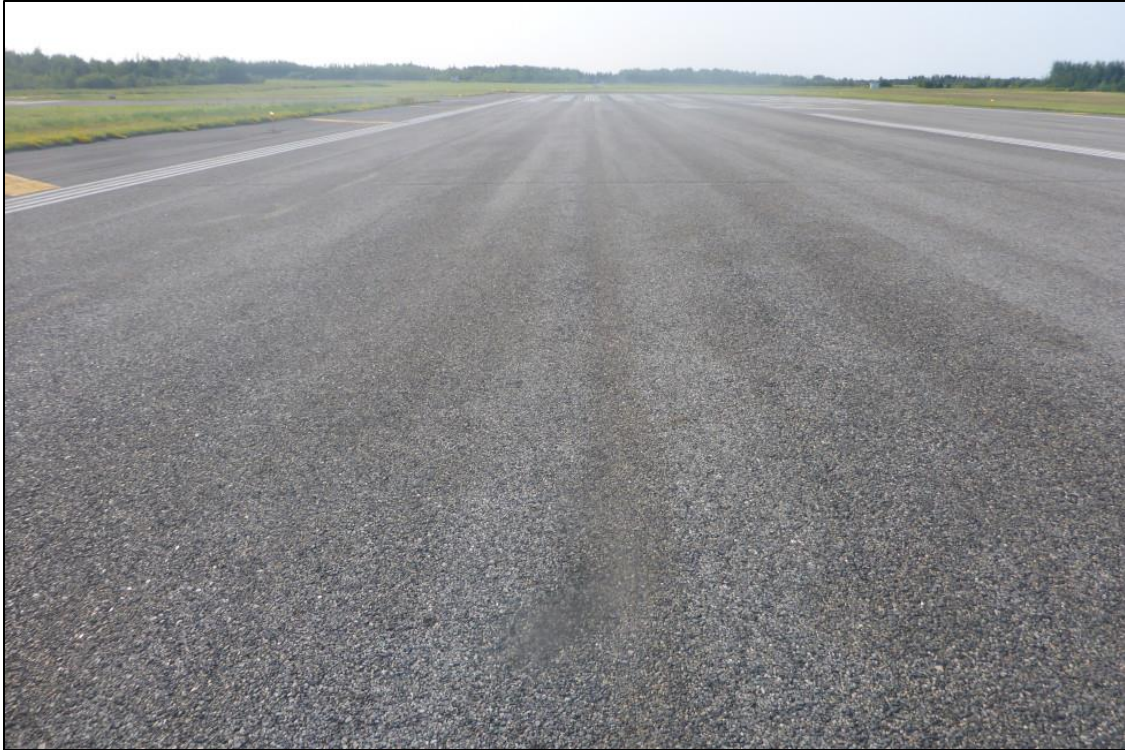
INL RY1331 003 (PCI = 81)

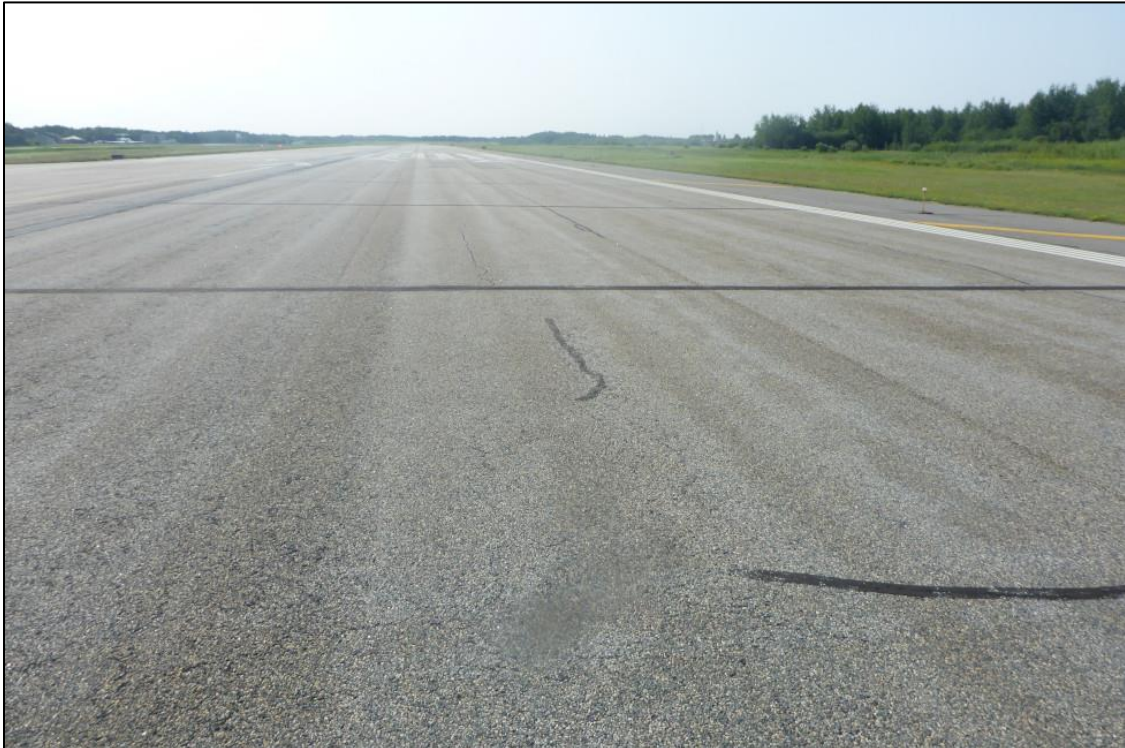
INL RY1331 004 (PCI = 75)

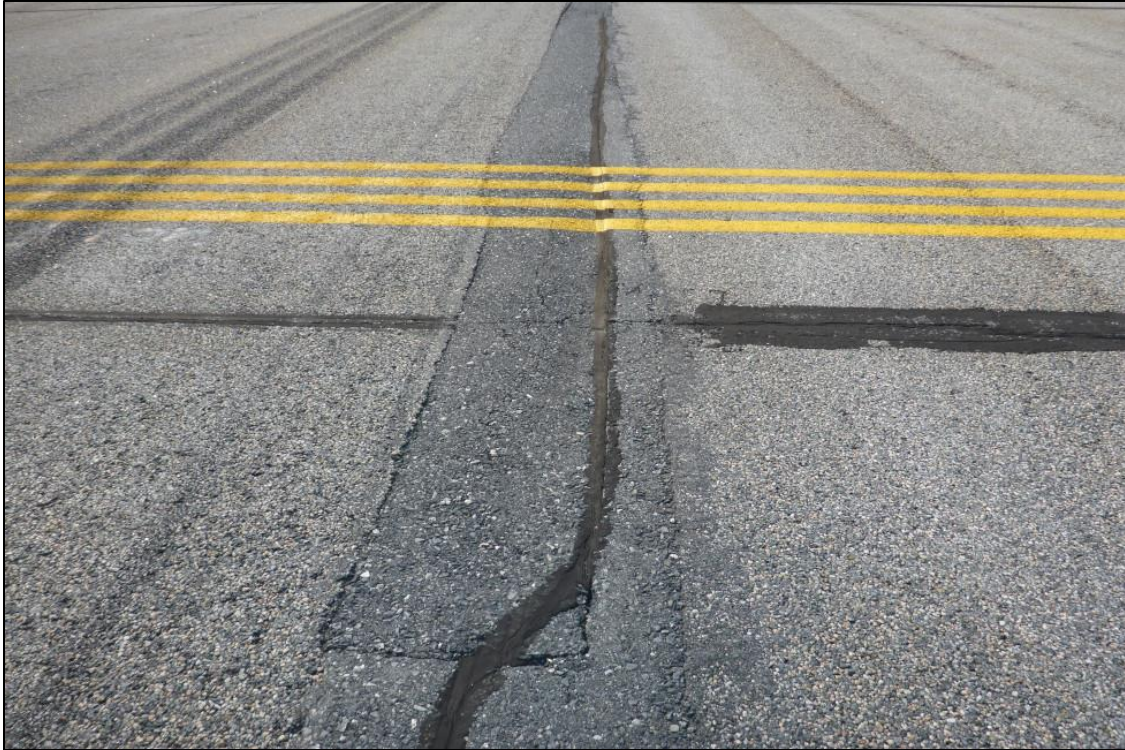
INL RY1331 005 (PCI = 69)

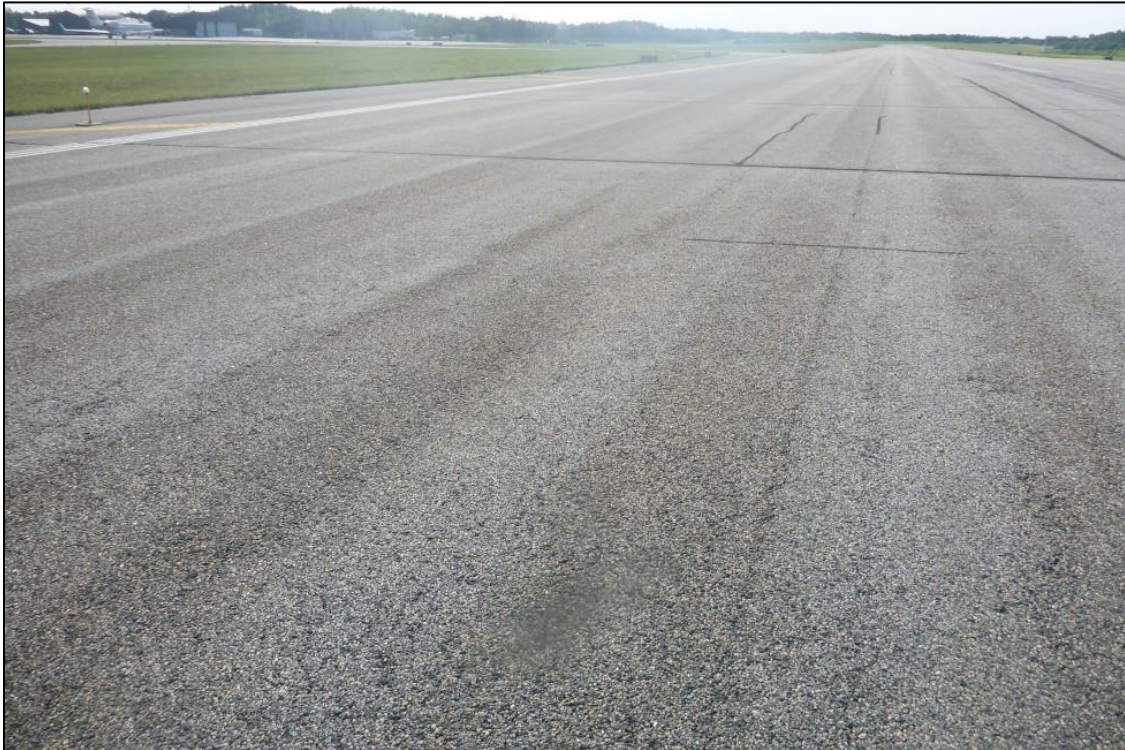
INL RY1331 006 (PCI = 78)

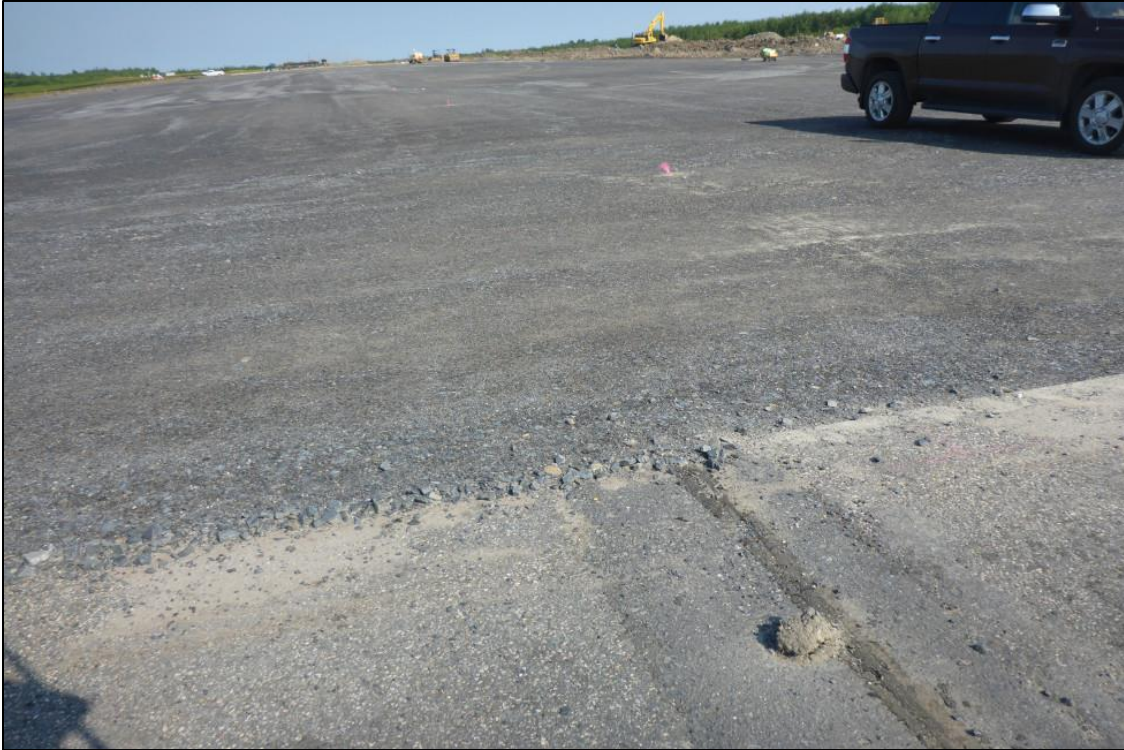
INL RY1331 007 (PCI = 100) (under construction)

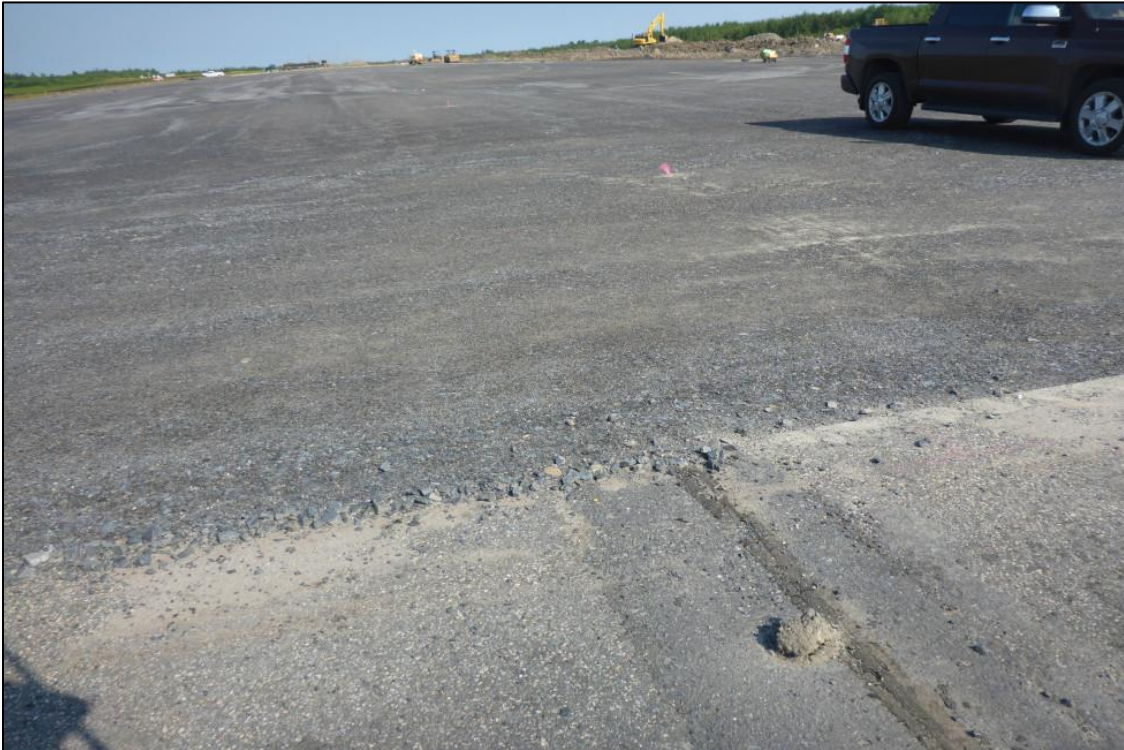
INL RY1331 008 (PCI = 100) (under construction)

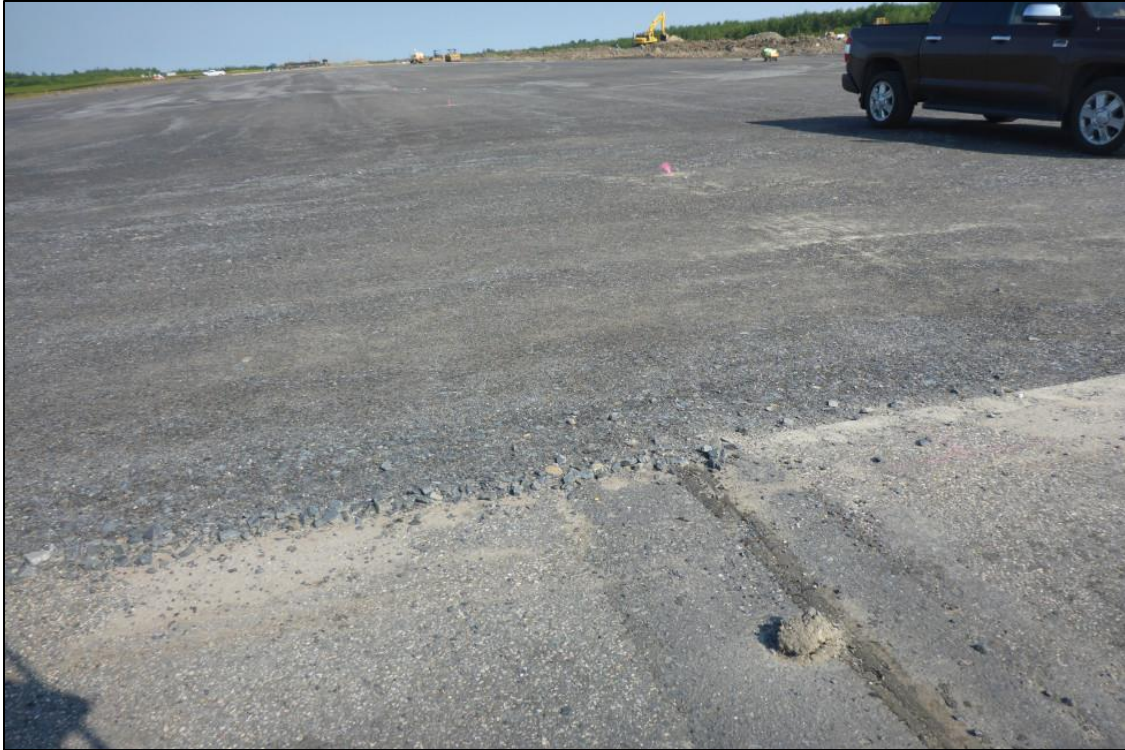
INL RY1331 009 (PCI = 100) (under construction)
