# Pavement Condition Report

## Falls International Airport (INL)

**December 2019**

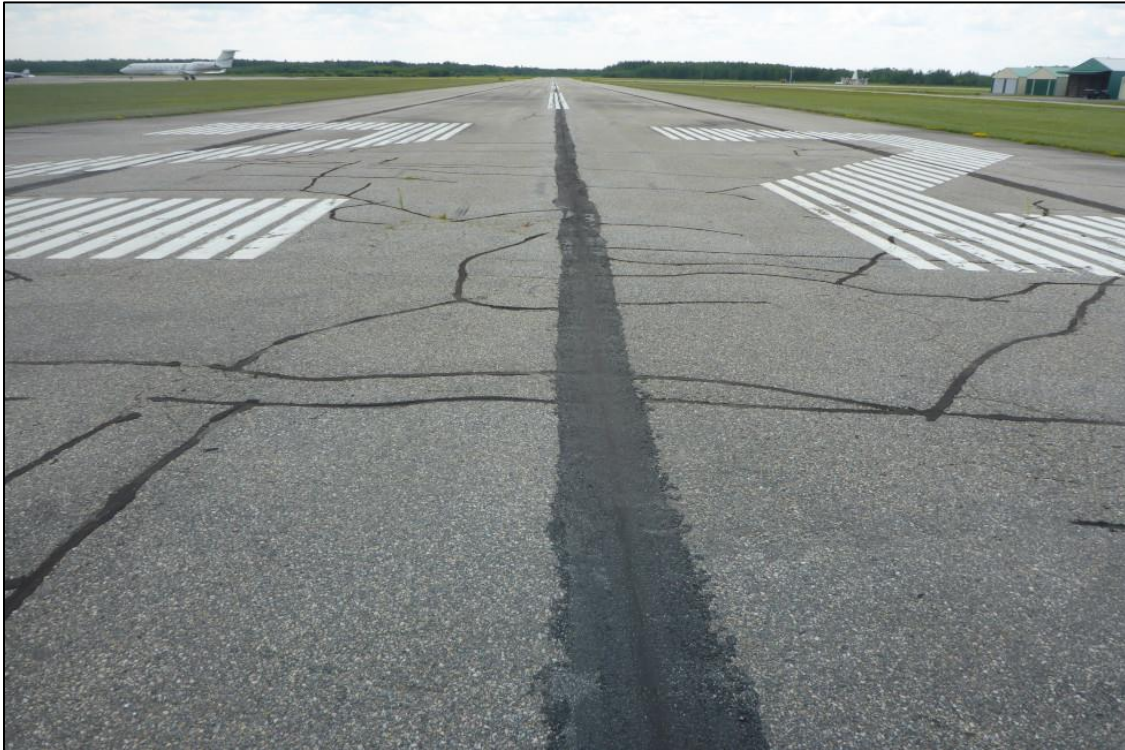
INL RY422 001 (PCI = 66)

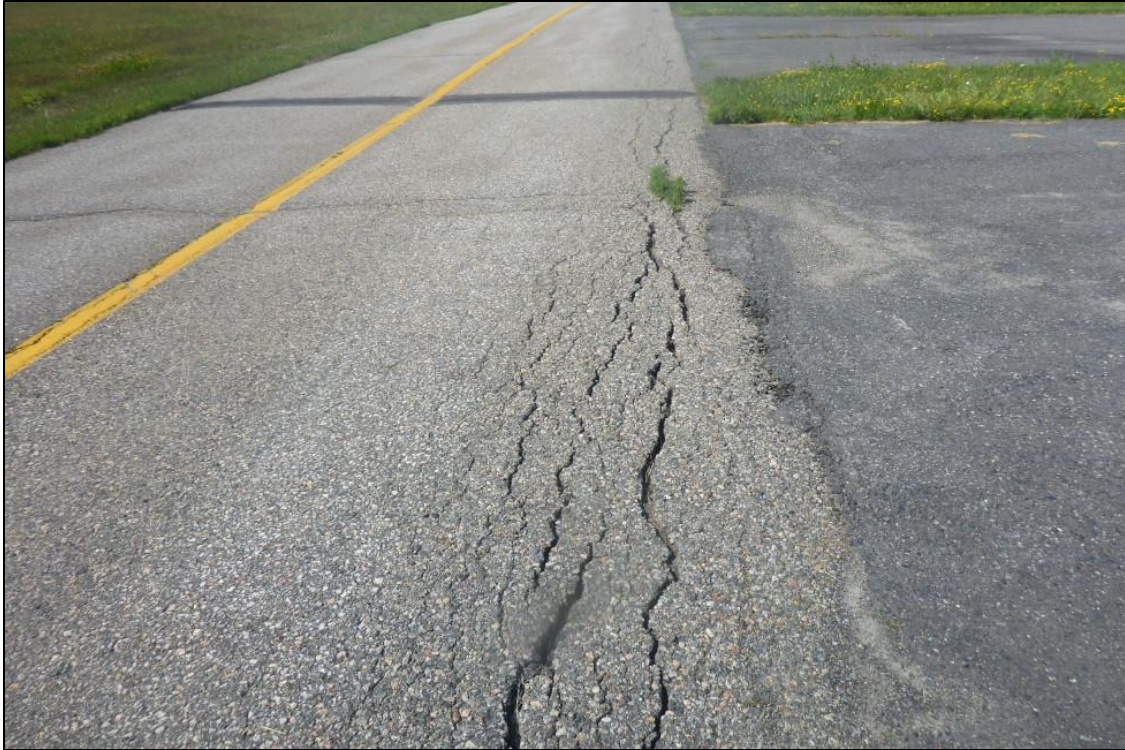
INL TLA 001 (PCI = 16)

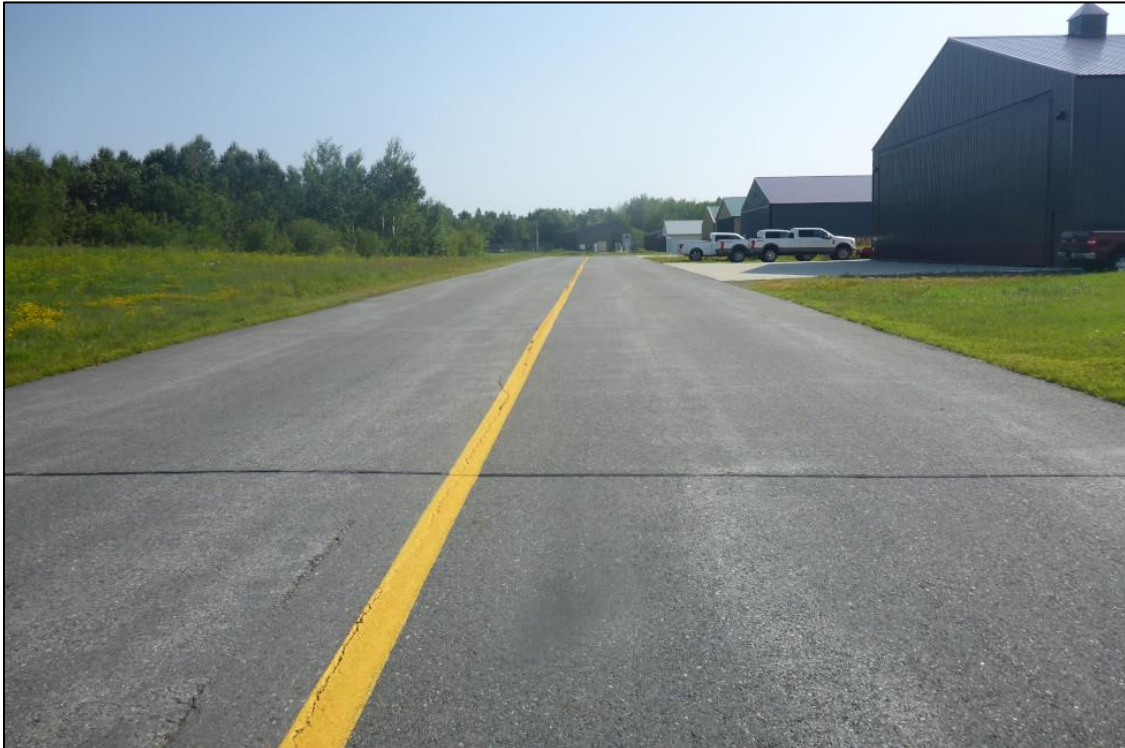
INL TLB 001 (PCI = 82)
