Pavement Condition Report

Orr Regional Airport (ORB)

Applied Research Associates, Inc.
6314 Odana Rd
Madison, WI 53719
(608) 274-6409

December 2019

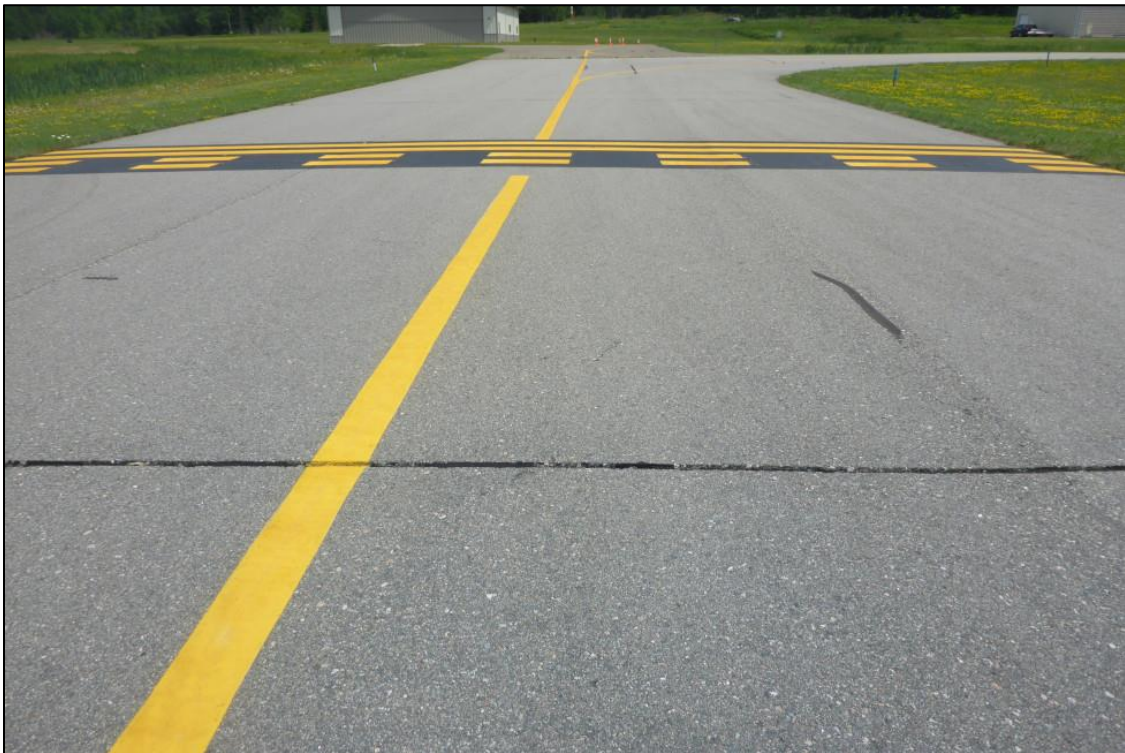
ORB CTA1 001 (PCI = 80)

Network:	ORB	Name:	ORR				
Branch:	CTA1	Name:	CONNECTING TAXIWAY A1	Use:	TAXIWAY	Area:	8,235 SqFt
Section:	001	of 1	From: 100	To:	101	Last Const.:	6/1/2011
Surface:	AC	Family:	MN2018 Asphalt Runway- Taxiways	Zone:	N	Category:	3
Area:	8,235 SqFt	Length:	193 Ft	Width:	40 Ft		
Slabs:		Slab Length:	Ft	Slab Width:	Ft	Joint Length:	Ft
Shoulder:		Street Type:		Grade:	0	Lanes:	0
Section Comments:							
Last Insp. Date:	7/16/2019	TotalSamples:	2	Surveyed:	1		
Conditions:	PCI: 80						
Inspection Comments:							
Sample Number:	101	Type:	R	Area:	3800.00 SqFt	PCI:	80
Sample Comments:	pic 626						
48	L & T CR	L	196.00 Ft				
48	L & T CR	M	21.00 Ft

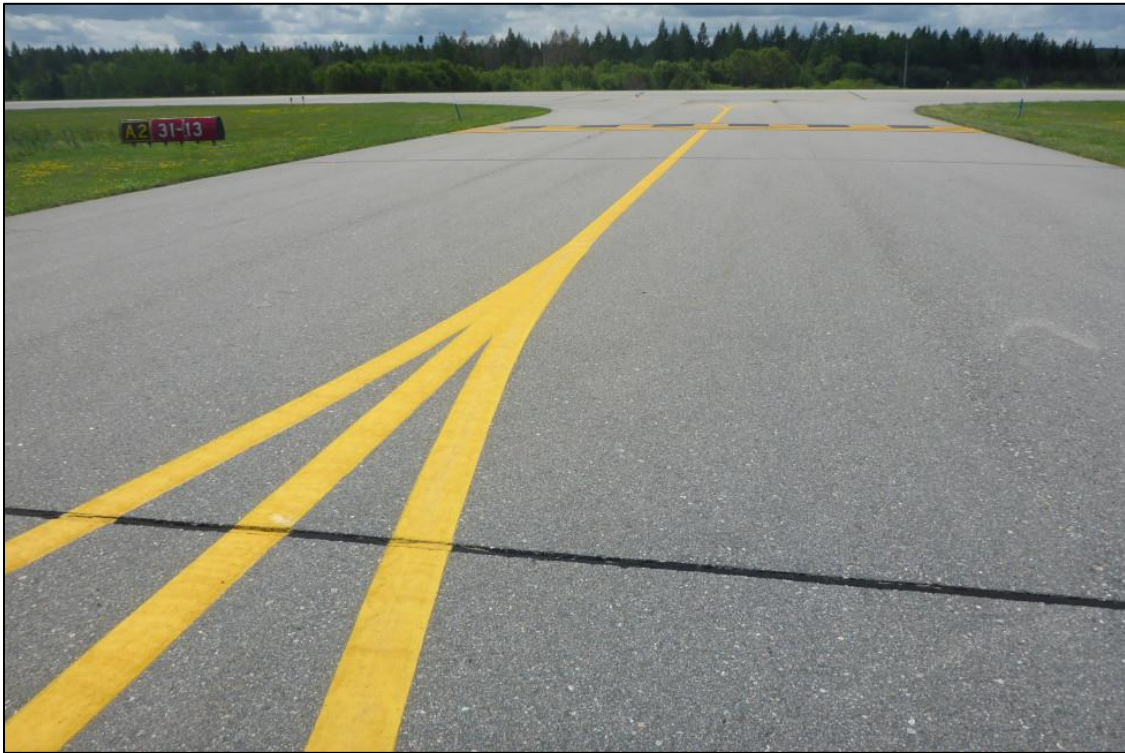
ORB CTA2 001 (PCI = 83)

Network:	ORB	Name:	ORR				
Branch:	CTA2	Name:	CONNECTING TAXIWAY A2	Use:	TAXIWAY	Area:	8,750 SqFt
Section:	001	of 1	From: 100	To:	101	Last Const.:	6/1/2011
Surface:	AC	Family:	MN2018 Asphalt Runway- Taxiways	Zone:	N	Category:	3
Area:	8,750 SqFt	Length:	193 Ft	Width:	40 Ft		
Slabs:		Slab Length:	Ft	Slab Width:	Ft	Joint Length:	Ft
Shoulder:		Street Type:		Grade:	0	Lanes:	0
Section Comments:							
Last Insp. Date:	7/16/2019	TotalSamples:	2	Surveyed:	1		
Conditions:	PCI: 83						
Inspection Comments:							
Sample Number:	100	Type:	R	Area:	4515.00 SqFt	PCI:	83
Sample Comments: pic 627							
48	L & T CR	L	136.00 Ft				
48	L & T CR	M	50.00 Ft

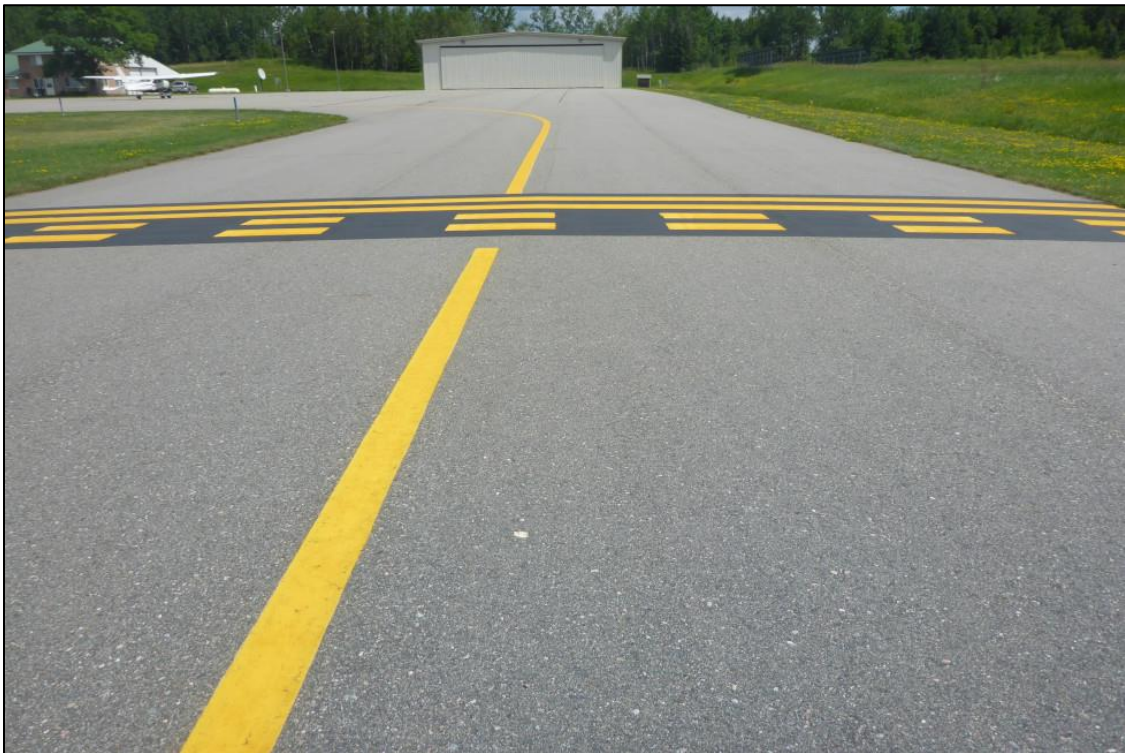
ORB CTA3 001 (PCI = 82)

Network:	ORB	Name:	ORR				
Branch:	CTA3	Name:	CONNECTING TAXIWAY A3	Use:	TAXIWAY	Area:	8,490 SqFt
Section:	001	of 1	From: 100	To:	101	Last Const.:	6/1/2011
Surface:	AC	Family:	MN2018 Asphalt Runway- Taxiways	Zone:	N	Category:	3
Area:	8,490 SqFt	Length:	193 Ft	Width:	40 Ft		
Slabs:		Slab Length:	Ft	Slab Width:	Ft	Joint Length:	Ft
Shoulder:		Street Type:		Grade:	0	Lanes:	0
Section Comments:							
Last Insp. Date:	7/16/2019	TotalSamples:	2	Surveyed:	1		
Conditions:	PCI: 82						
Inspection Comments:							
Sample Number:	101	Type:	R	Area:	3800.00 SqFt	PCI:	82
Sample Comments:	pic 628						
48	L & T CR	L	69.00 Ft				
48	L & T CR	M	50.00 Ft

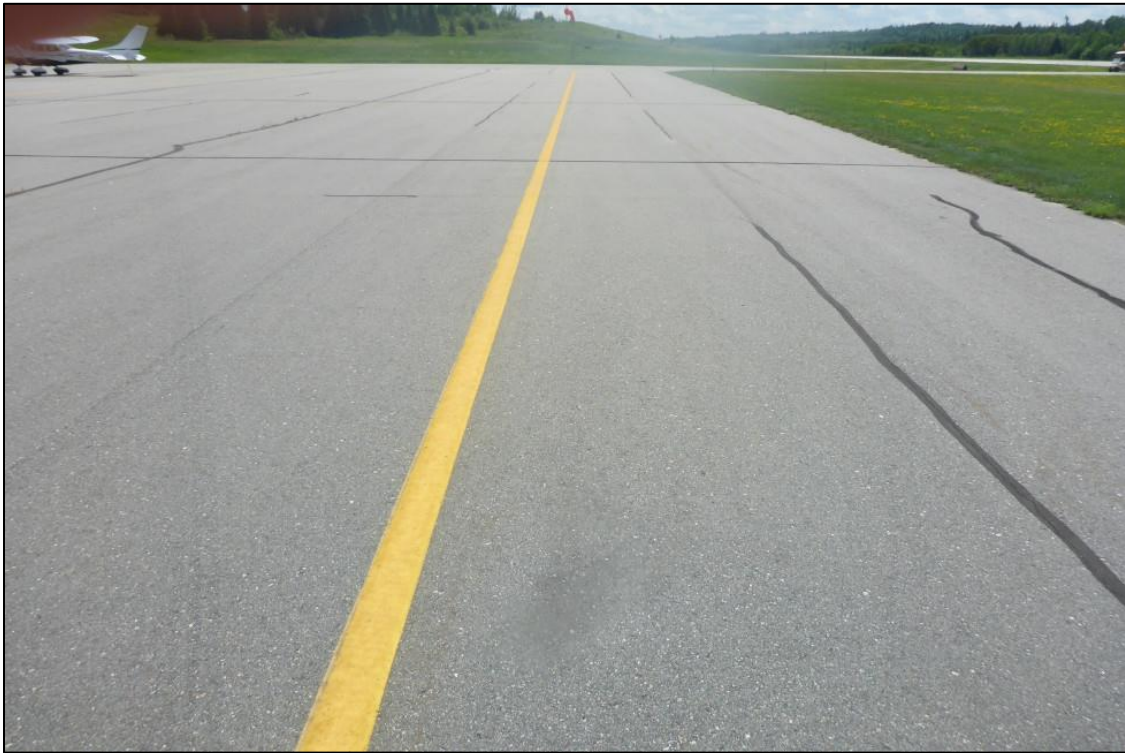
ORB PPTA 001 (PCI = 84)

Network:	ORB	Name:	ORR						
Branch:	PPTA	Name:	PART PARALLEL TAXIWAY A	Use:	TAXIWAY	Area:	39,950 SqFt		
Section:	001	of 1	From:	100	To:	108	Last Const.: 6/1/2011		
Surface:	AC	Family:	MN2018 Asphalt Runway- Taxiways	Zone:	N	Category:	3	Rank:	P
Area:	39,950 SqFt	Length:	340 Ft	Width:	50 Ft				
Slabs:		Slab Length:	Ft	Slab Width:	Ft	Joint Length:	Ft		
Shoulder:		Street Type:		Grade:	0	Lanes:	0		
Section Comments:	added sample units from APA because of traffic configuration (2013)								
Last Insp. Date:	7/16/2019	TotalSamples:	9	Surveyed:	2				
Conditions:	PCI: 84								
Inspection Comments:									
Sample Number:	102	Type:	R	Area:	5000.00 SqFt	PCI:	85		
Sample Comments:	p158								
48	L & T CR	L	258.00	Ft					
Sample Number:	106	Type:	R	Area:	4000.00 SqFt	PCI:	84		
Sample Comments:	p159								
48	L & T CR	L	231.00	Ft

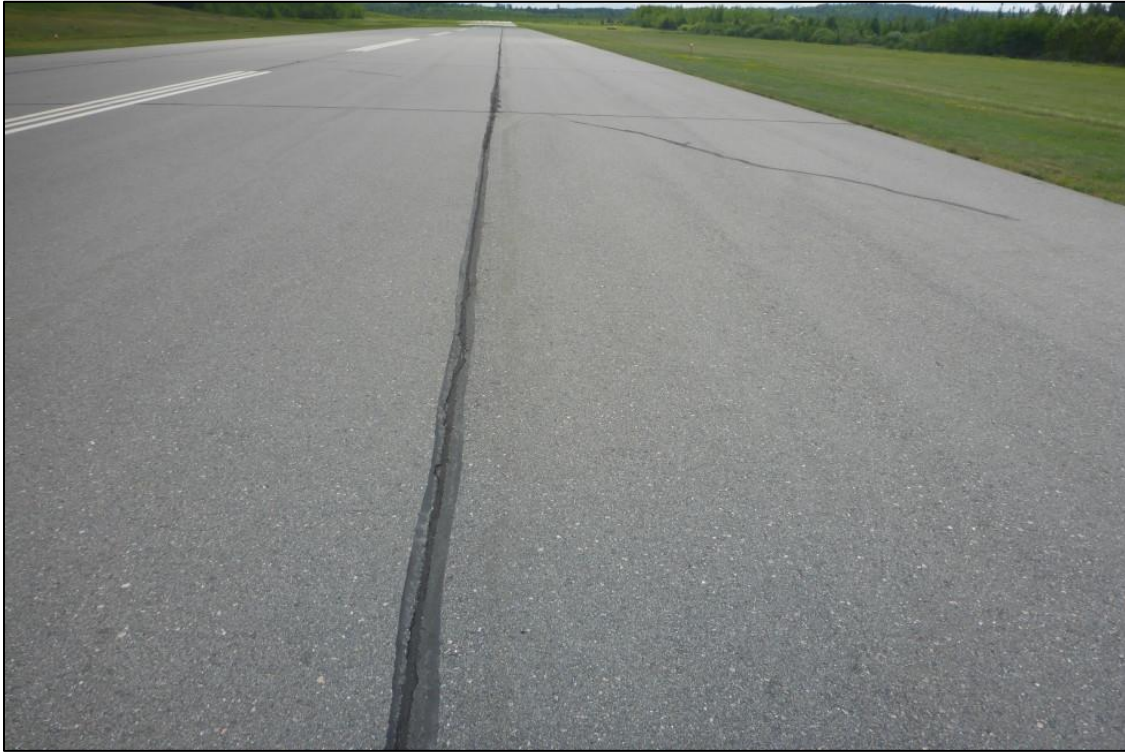
ORB RY1331 001 (PCI = 82)

Network:	ORB	Name:	ORR				
Branch:	RY1331	Name:	RUNWAY 13-31	Use:	RUNWAY	Area:	300,000 SqFt
Section:	001	of 1	From: 100	To:	179	Last Const.:	6/1/2011
Surface:	AC	Family:	MN2018 Asphalt Runway- Taxiways	Zone:	N	Category:	3
Area:	300,000 SqFt	Length:	4,000 Ft	Width:	75 Ft		
Slabs:		Slab Length:	Ft	Slab Width:	Ft	Joint Length:	Ft
Shoulder:		Street Type:		Grade:	0	Lanes:	0
Section Comments:							
Last Insp. Date:	7/16/2019	TotalSamples:	80	Surveyed:	8		
Conditions:	PCI: 82						
Inspection Comments:							
Sample Number:	104	Type:	R	Area:	3750.00 SqFt	PCI:	81
Sample Comments:	pic 623						
48	L & T CR	L	225.00 Ft				
57	WEATHERING	L	500.00 SqFt				
Sample Number:	114	Type:	R	Area:	3750.00 SqFt	PCI:	83
Sample Comments:							
48	L & T CR	L	225.00 Ft				
Sample Number:	124	Type:	R	Area:	3750.00 SqFt	PCI:	83
Sample Comments:							
48	L & T CR	L	225.00 Ft				
Sample Number:	134	Type:	R	Area:	3750.00 SqFt	PCI:	79
Sample Comments:

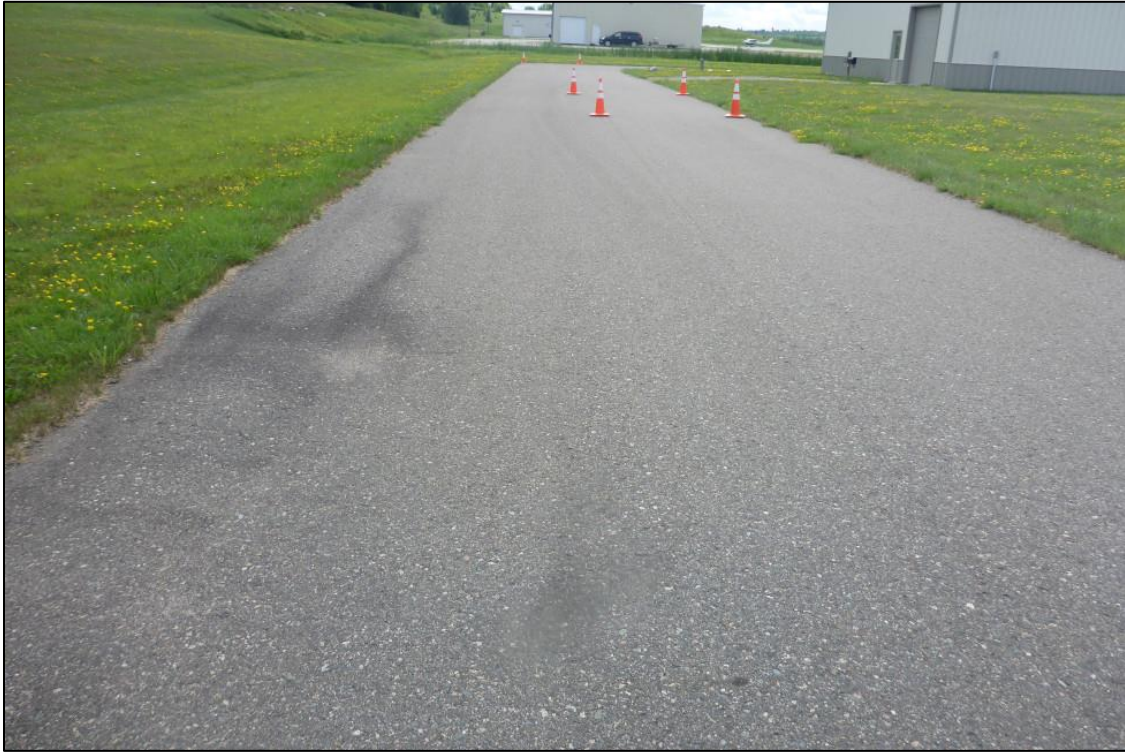
ORB TLB 001 (PCI = 90)

Network:	ORB	Name:	ORR						
Branch:	TLB	Name:	Taxilane B	Use:	TAXILANE	Area:	31,780 SqFt		
Section:	001	of 1	From:	100	To:	106	Last Const.:	6/1/2008	
Surface:	AC	Family:	MN2018 Asphalt Taxilanes	Zone:	N	Category:	3	Rank:	T
Area:	31,780 SqFt	Length:	1,500 Ft	Width:	20 Ft				
Slabs:	Slab Length:	Ft	Slab Width:	Ft	Joint Length:	Ft			
Shoulder:	Street Type:	Grade:	0	Lanes:	0				
Section Comments:	maint. (R&E) patching								
Last Insp. Date:	7/16/2019	TotalSamples:	7	Surveyed:	2				
Conditions:	PCI: 90								
Inspection Comments:									
Sample Number:	102	Type:	R	Area:	4000.00 SqFt	PCI:	92		
Sample Comments:	p152								
52	RAVELING	L	240.00	SqFt					
Sample Number:	105	Type:	R	Area:	4000.00 SqFt	PCI:	88		
Sample Comments:									
50	PATCHING	L	100.00	SqFt					
52	RAVELING	L	200.00	SqFt
