Installation and Performance Monitoring of a Pothole Patched Using Asphalt Pavement Millings and a 915 MHz Microwave

20 March 2009 to 21 July 2009

Ed Johnson, Mn/DOT Office of Materials and Road Research

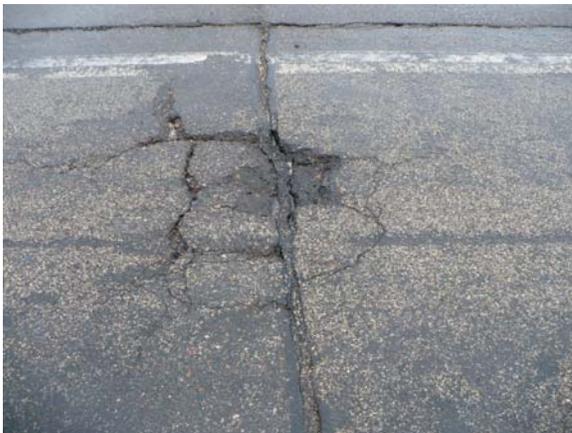
The pothole work occurred on March 20, 2009. Air temperature was approximately 33 °F, and pre-treatment pothole temperatures ranged from 27.6 to 37.3 °F. The area had received a light dusting of snow overnight, and pavements were lightly damp at 9 AM. Loss of pavement material was less on the traffic approach side than on the departure side of the pothole. A small amount of water was visible in the hole. Figure 1 shows the existing conditions immediately prior to patch treatment. Traffic approaches from the right side of the image.

Figure 1 - Pre-patch condition 3-20-2009.

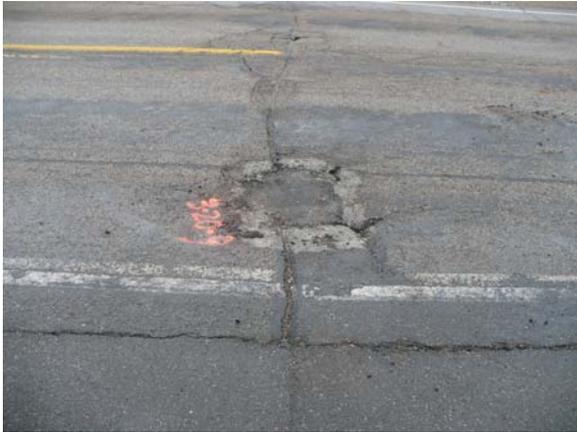
Figure 2 shows the condition of the patch treatment immediately following installation. The patch was smooth with no material loss. Traffic approaches from the left side of the image.

Figure 2 - Pothole filled using microwave and RAP 3-20-2009.

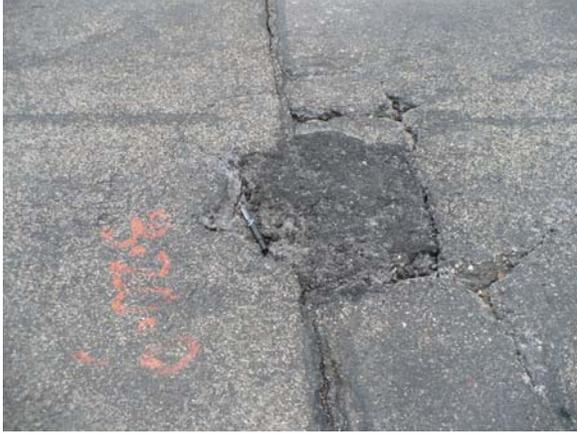
Figure 3 shows the condition at 15 days of service. At that time the pothole patch was developing material loss along five in. of the approach side and at one corner. The total amount of missing material was estimated to be less than 10 percent of the total patch material. Traffic approaches from the left side of the image.

Figure 3 - Condition after 15 days in service 4-4-2009.

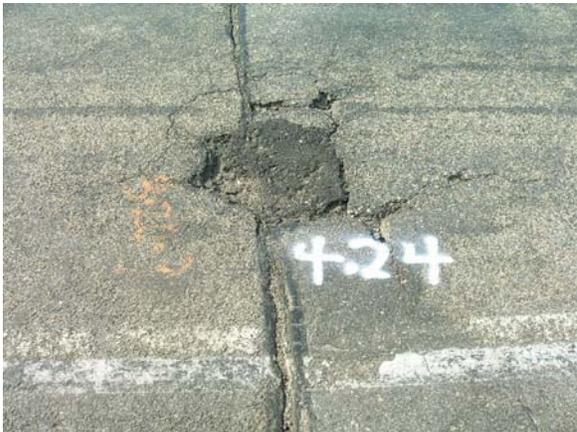
Figure 4 shows the condition of the patch after 35 days in service. Increasing regions of material loss were visible. At that point an estimated 10 percent of patch material was missing. Traffic approaches from the left of the image.

Figure 4 - Condition after 35 days in service 4-24-2009.

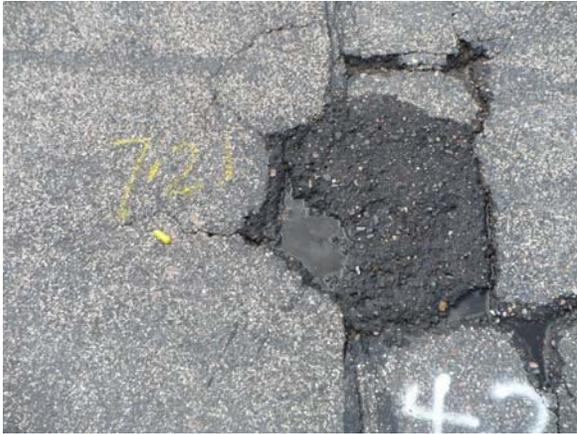
Figures 5 and 6 show the patch condition after 123 days in service. At that time material loss had increased along the sides of the patch to a depth of two inches. It was estimated that more than 10 percent of the patch material was missing at this time. Traffic approaches from left of image.

Figure 5 - Condition after 3 months in service 7-21-2009.

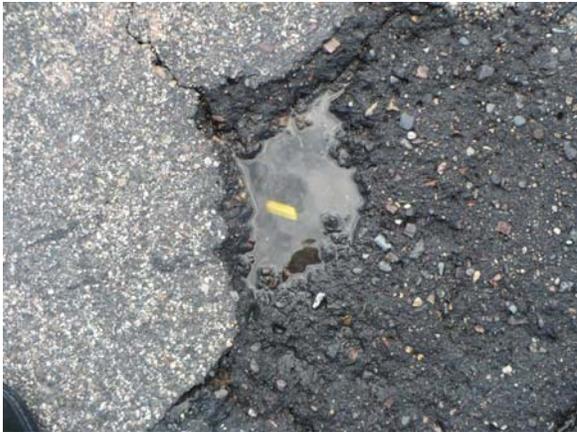
Figure 6 - Condition after 3 months in service 7-21-2009.
