Advanced Timber Bridge Inspection

Field Manual for Inspection of
Minnesota Timber Bridges

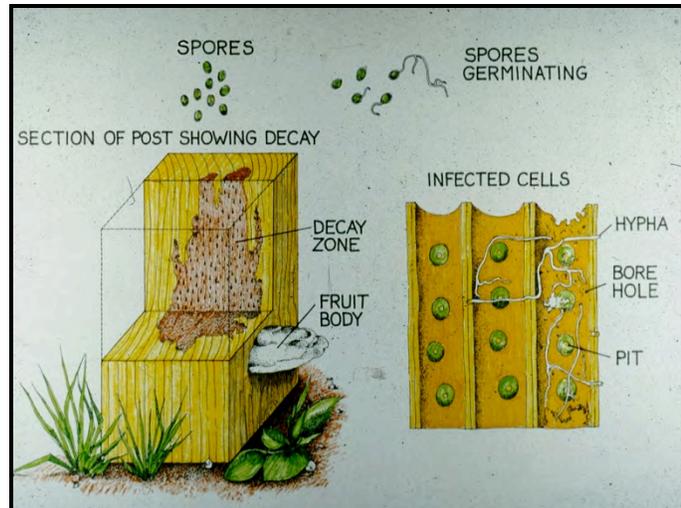
Figure 3.1. Image of decay affecting a timber member. Courtesy of USDA Forest Service, Forest Products Laboratory.

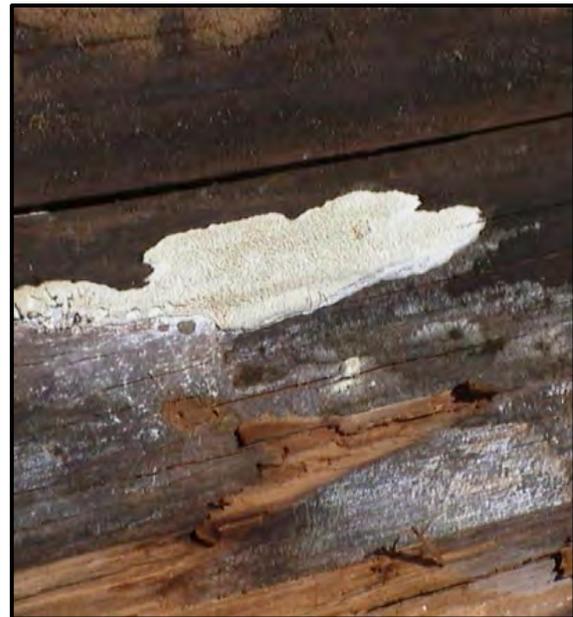
Figure 3.2. Douglas fir bridge member showing visual evidence of a fruiting body on the surface in addition to visual evidence of decayed timber.

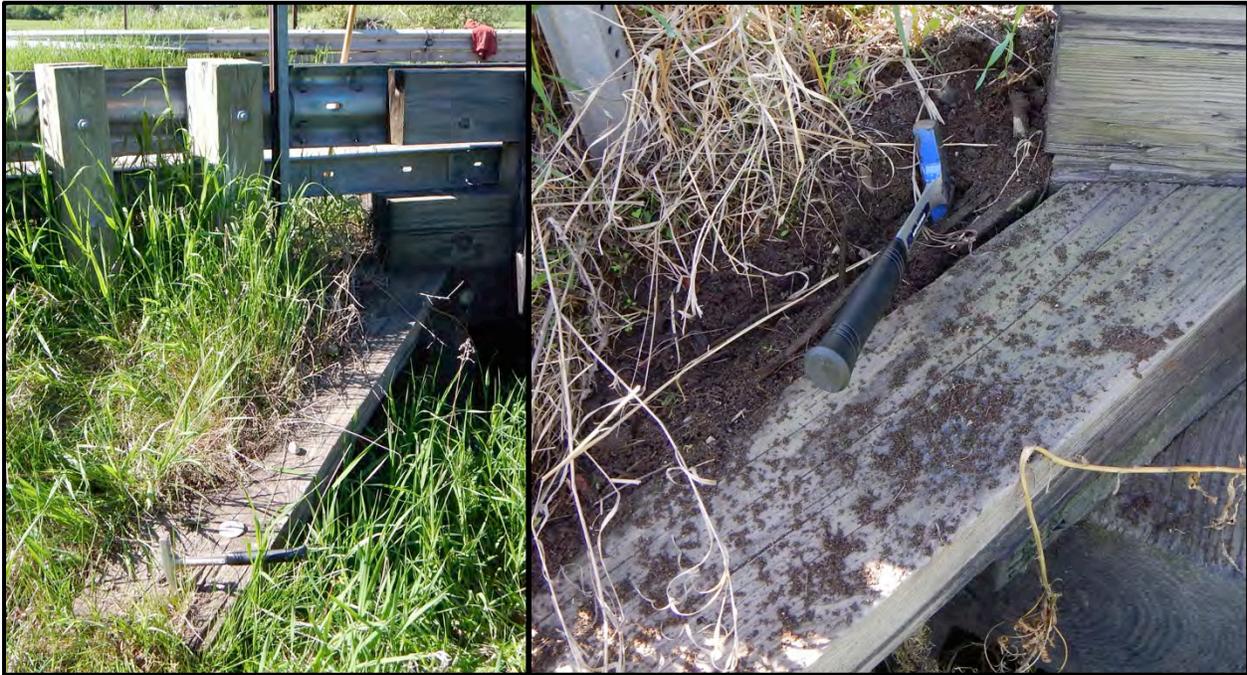
Figure 3.11. A wing wall timber abutment has substantial plant growth on the cap surface. Once removed, visual and probing inspection showed that 75% of the cap cross-section had been severely decayed. This will eventually result in damage to the wing wall pile elements.

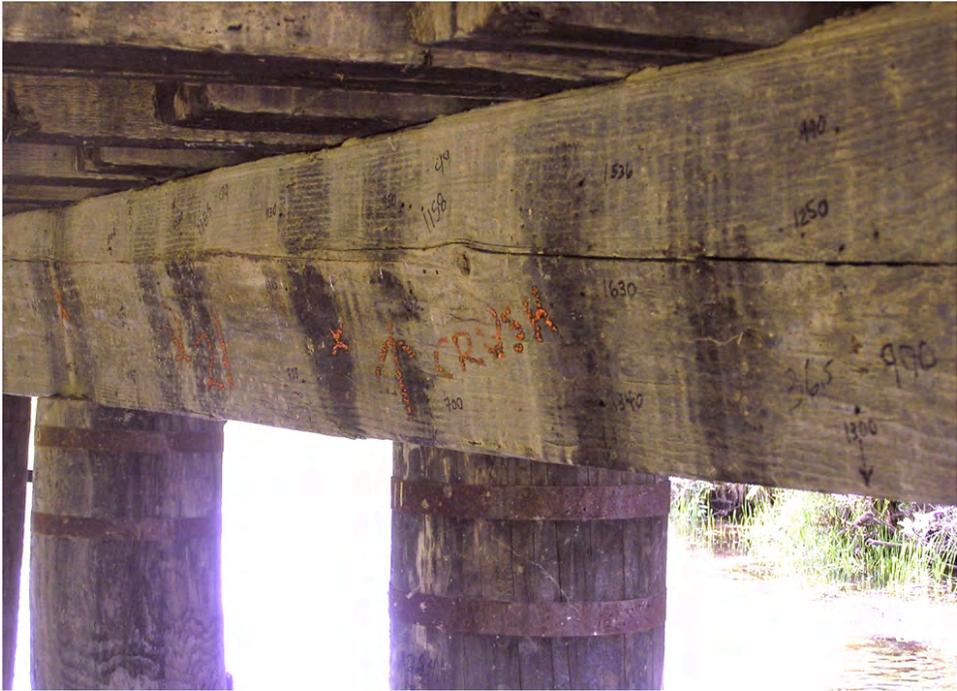
Figure 3.13. A long horizontal split provides an opportunity for moisture passing through the timber deck to enter the abutment cap, leading to substantial decay.

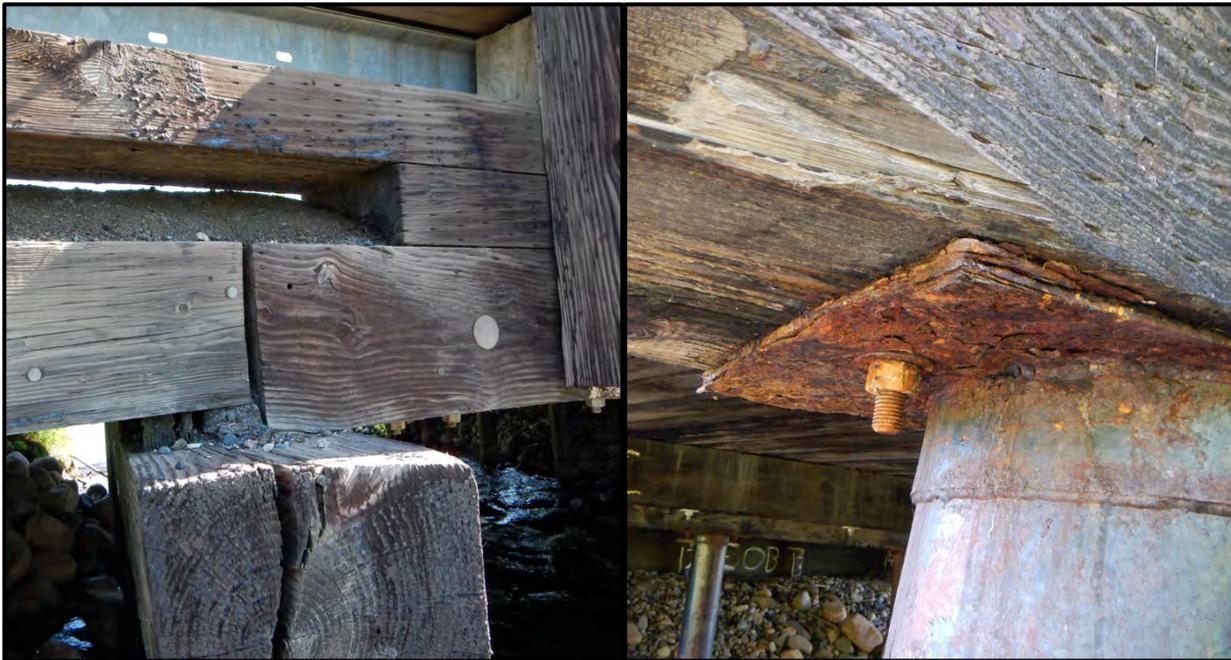
In **Figure 3.14**, a severe through split in an abutment cap provides an opportunity for moisture to absorb into the element, resulting in conditions that allow for potential decay as well as deterioration of the surrounding steel elements such as the CIP bearing plate.

Figure 3.14. Visual assessment of a pier cap split. The split allows moisture from the deck to enter the member beyond the protective layer of preservative treated wood, resulting in increased likelihood of future decay and allows for deterioration of hardware such as the CIP bearing plate that supports this element.

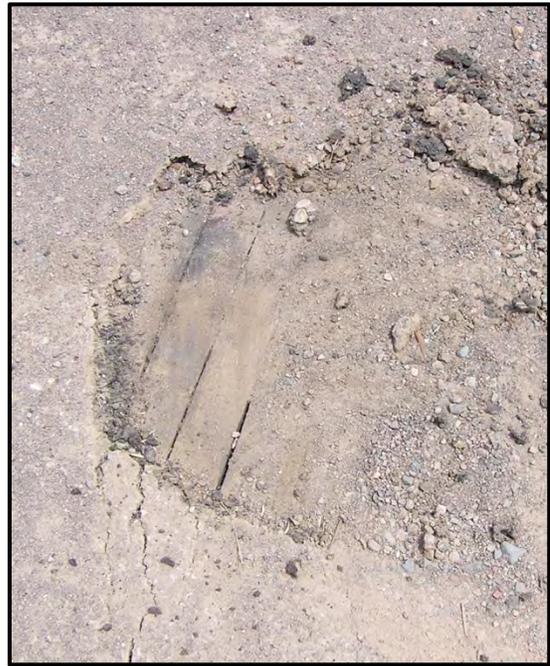
Figure 3.17 shows an exposed timber deck on the surface of a bridge where the wear layer has been completely removed. This creates an entry point for moisture infiltration into the timber decking, beams, abutments and piers.

Figure 3.17. The bituminous wear layer has deteriorated exposing structural timber decking to moisture and potential deterioration.

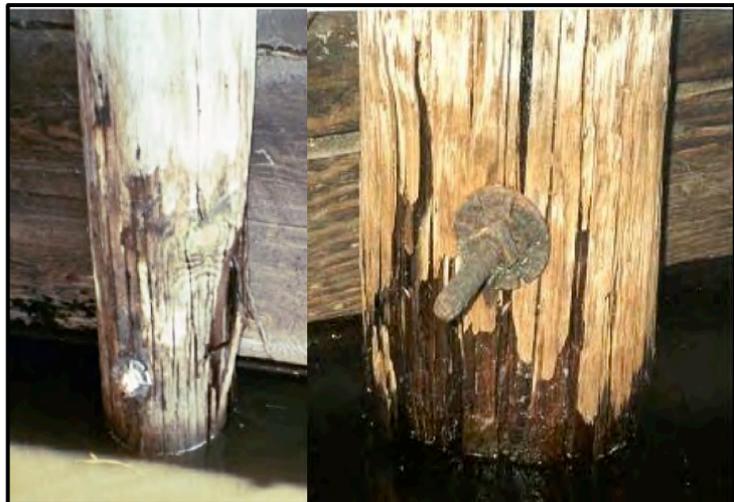
Figure 3.18. Shell damage to timber piling at or near the water line, often caused by freeze thaw cycles, ice damage or flotsam floating down the river.

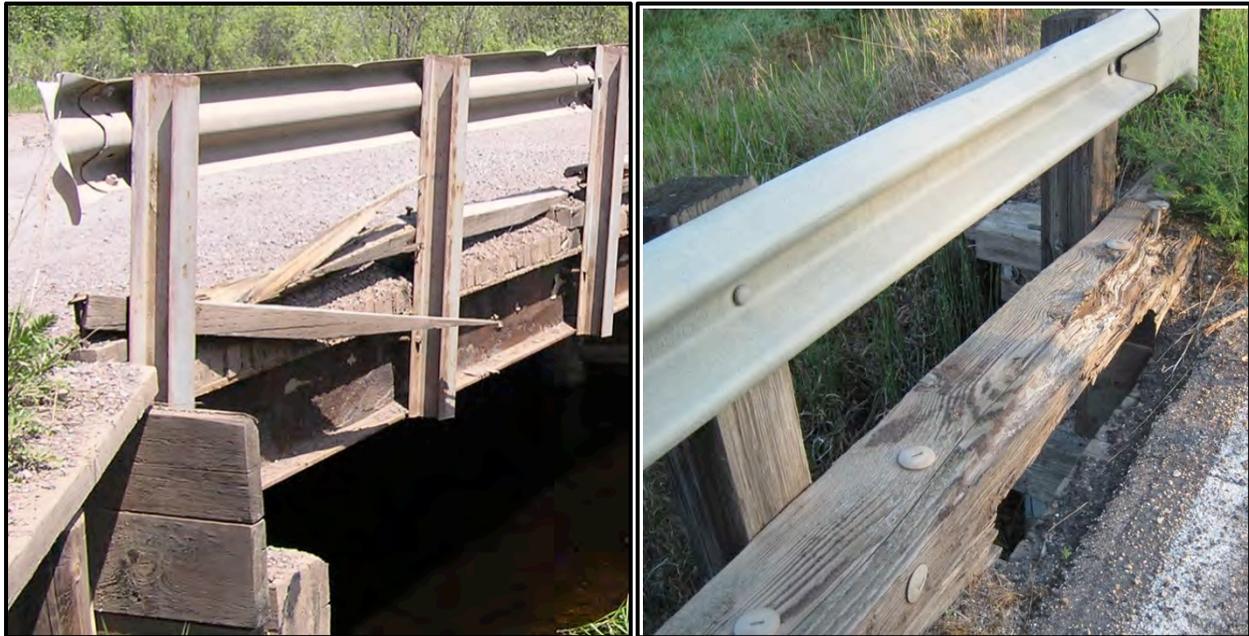
Figure 3.19. The timber curbs shown have significant damage from a snowplow or other vehicle exposing untreated wood to high levels of moisture.

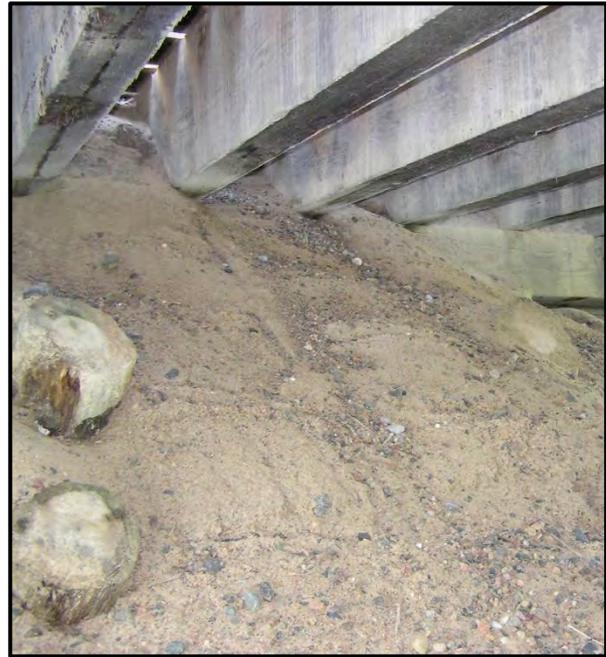
Figure 3.22. Sand and gravel are covering the timber abutment cap and the longitudinal timber beams, holding moisture against these elements.

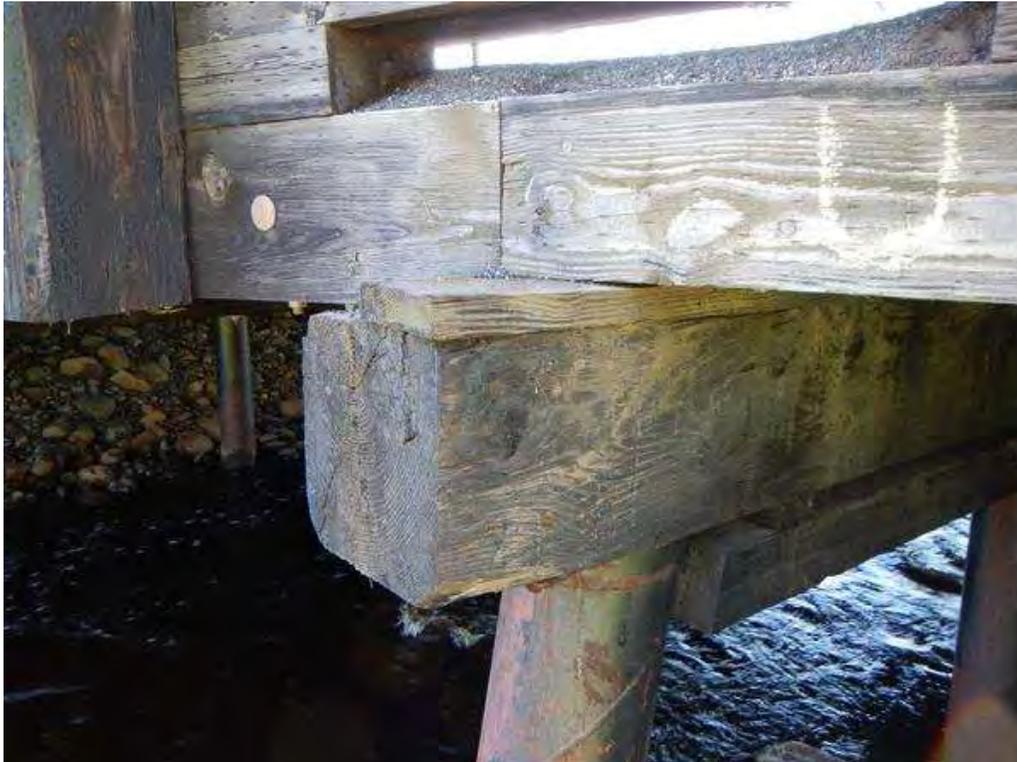
Photo 6 - Pier 1 - North End - Through split extending 80% of full length of cap. SWT over 500 but R drill showed only crack with no decay

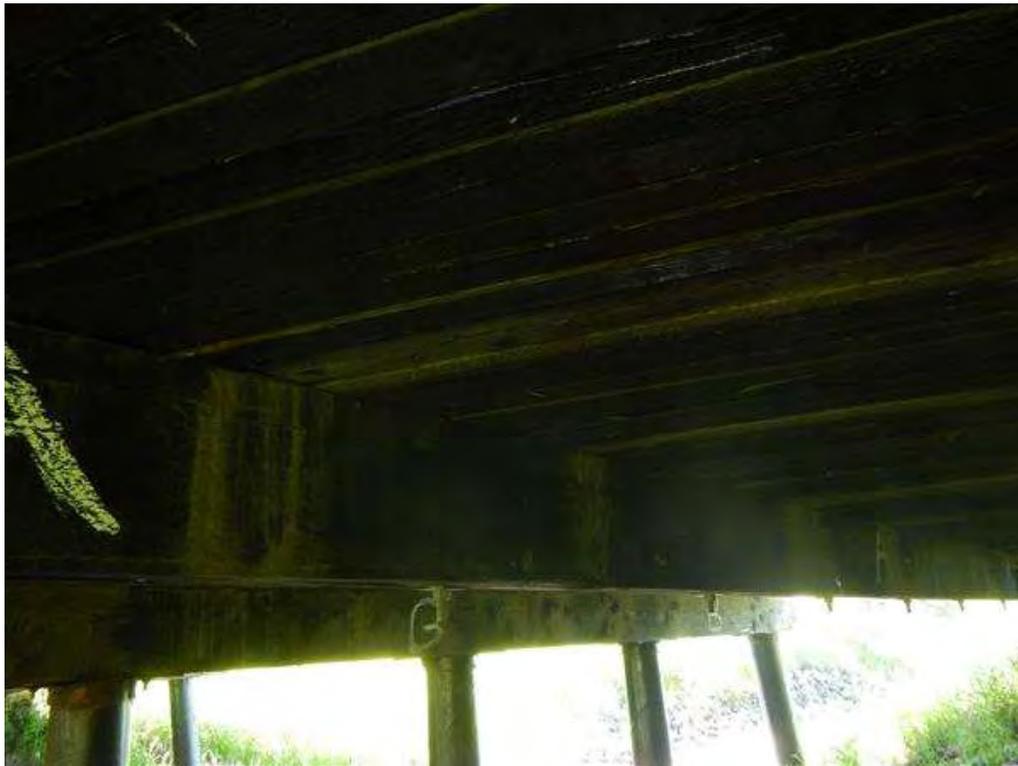
Photo 8 - Span 1 - Moisture pen. through deck.

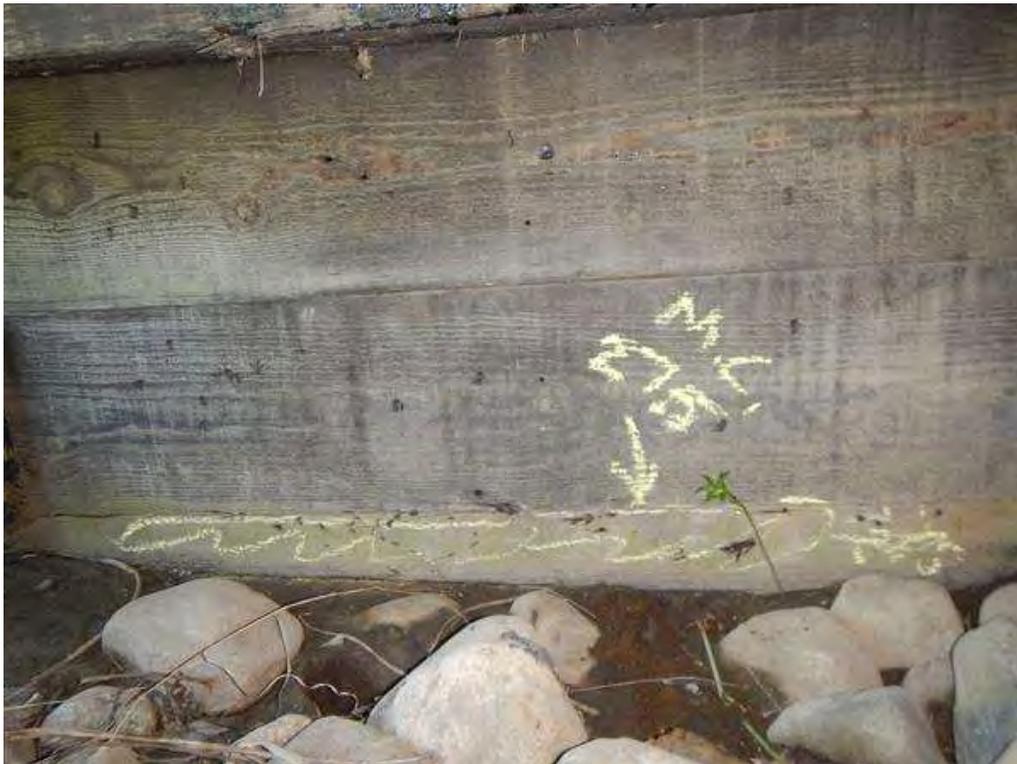
Photo 12 - High moisture abutment wall between piles 8 and 9. Moisture content over >25% but no decay present.

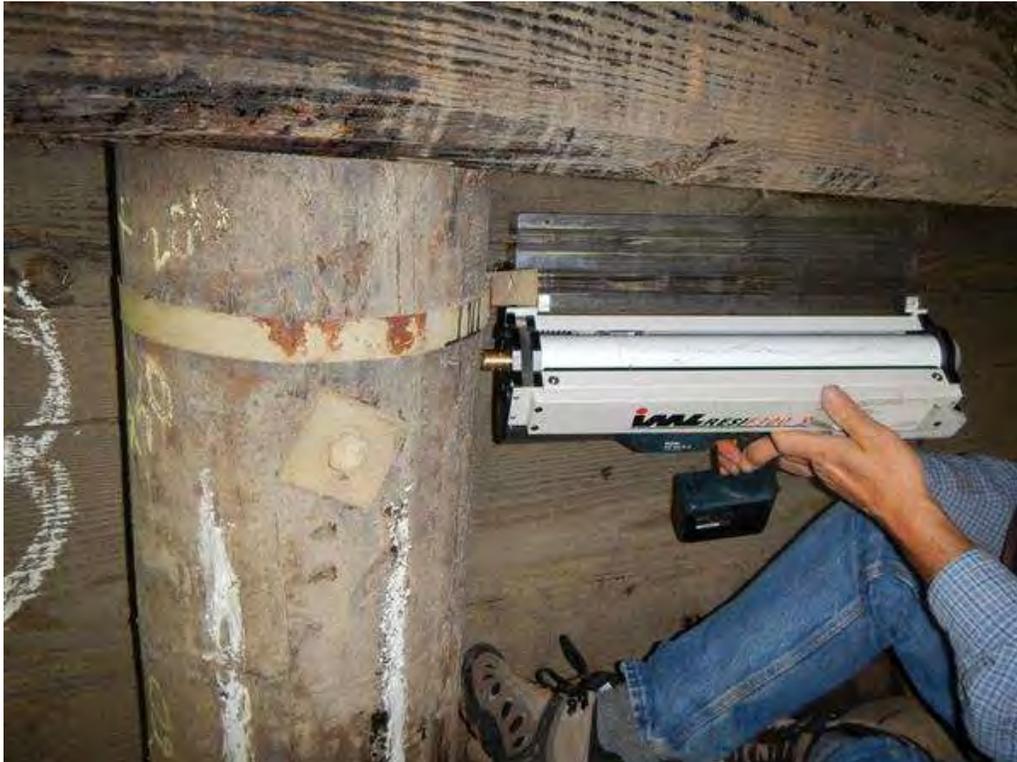
Photo 14 - E abut - Pile 11 - Sound condition

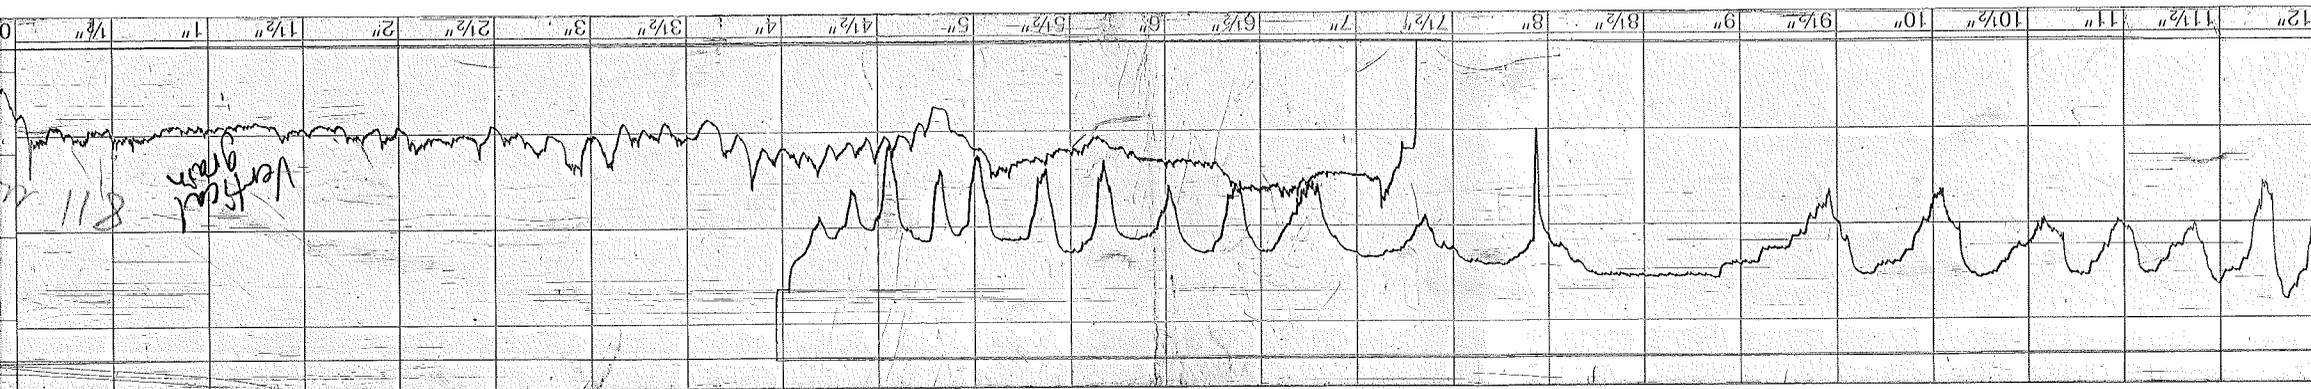
Bridge ~~821-1~~
 Deck Board
 5th in from UP (BOB)
 bounded a bit soft
 looks OK here w/
 Drill, Drilled vertical
 ~ 10 deep beam
