MnROAD
Safer, Smarter, Sustainable Pavements Through Innovative Research

NCAT/MnROAD Cracking Group Update

September 10, 2019

Cracking Group Experiment

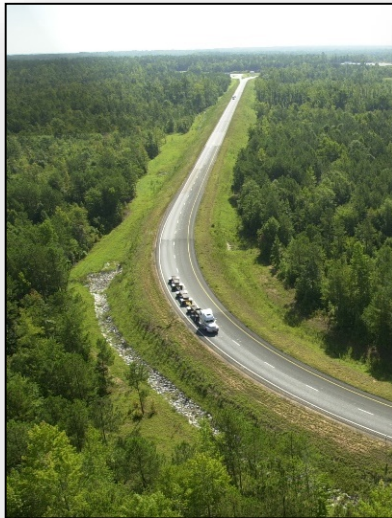
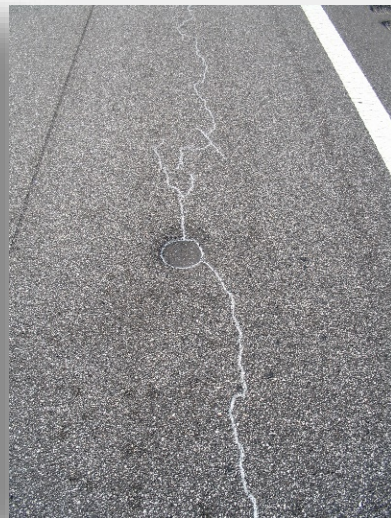
NCAT Test Track

Top-down cracking

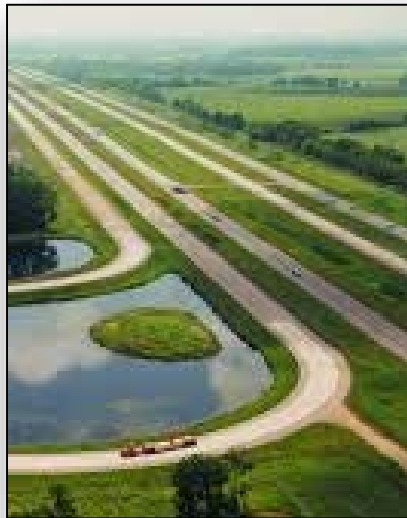
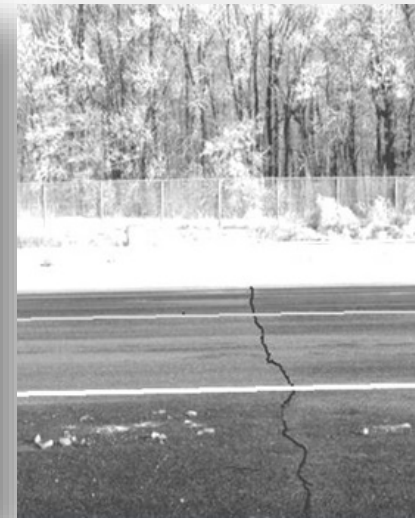
MnROAD

Low-temperature cracking

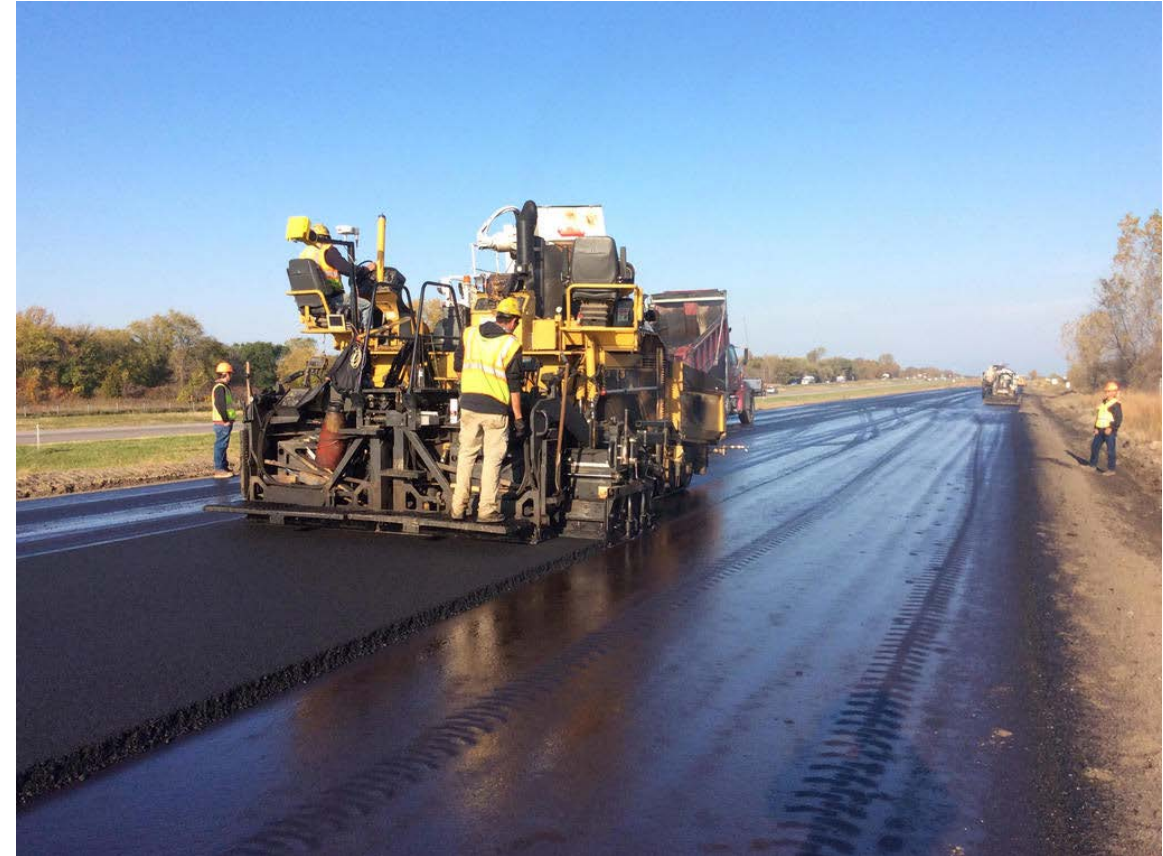
HMA Mixtures

- Mixtures selected to achieve range of low-temperature cracking (LTC) potential
 - Based on input from pooled-fund sponsor states
- Contractor selected, procured materials, submitted to NCAT
- NCAT performed mix designs
- Contractor produced/placed mixture

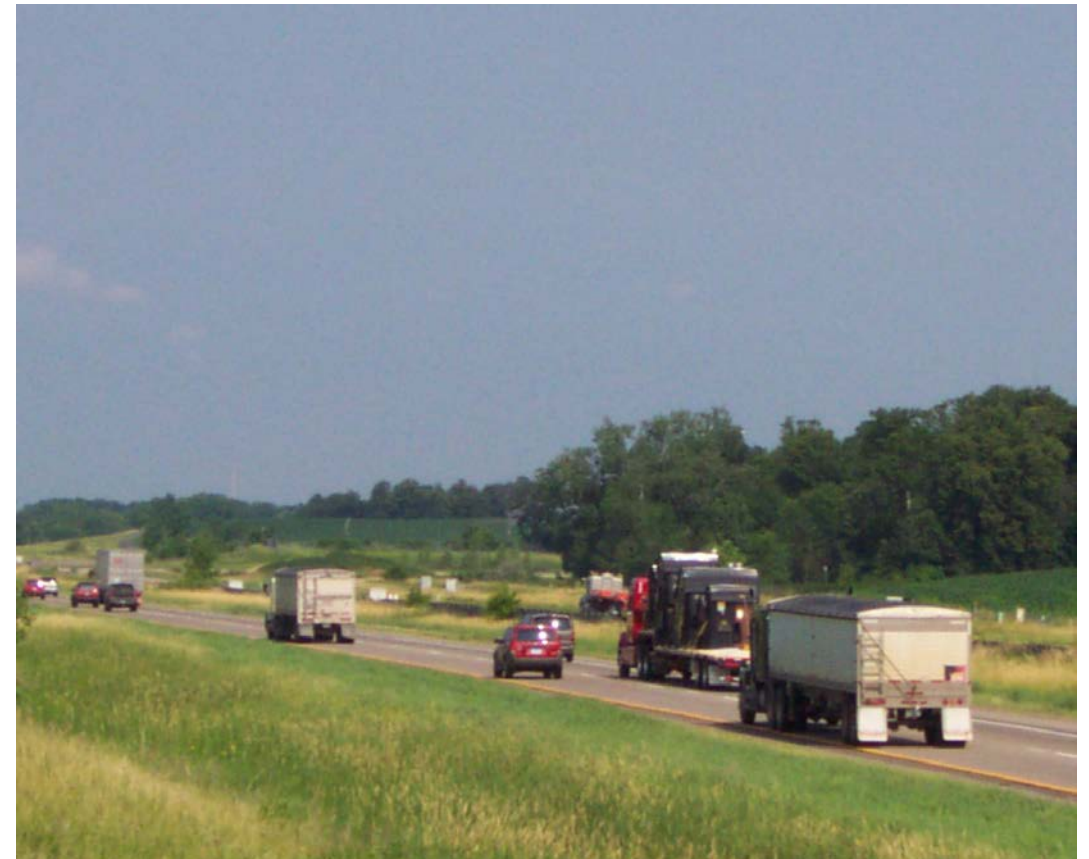
Pavement Design Inputs

- WB I-94 average daily traffic volume
 - ~30,000 vehicles
 - ~13% HC
- Flexible ESALs
 - ~800k per year (design lane)
 - ➔ Traffic level 5
- Soils:
 - USDA – Clay Loam, Loam
 - AASHTO – A-6
 - USCS – Lean Clay (CL)
- Expected life ~10 yrs

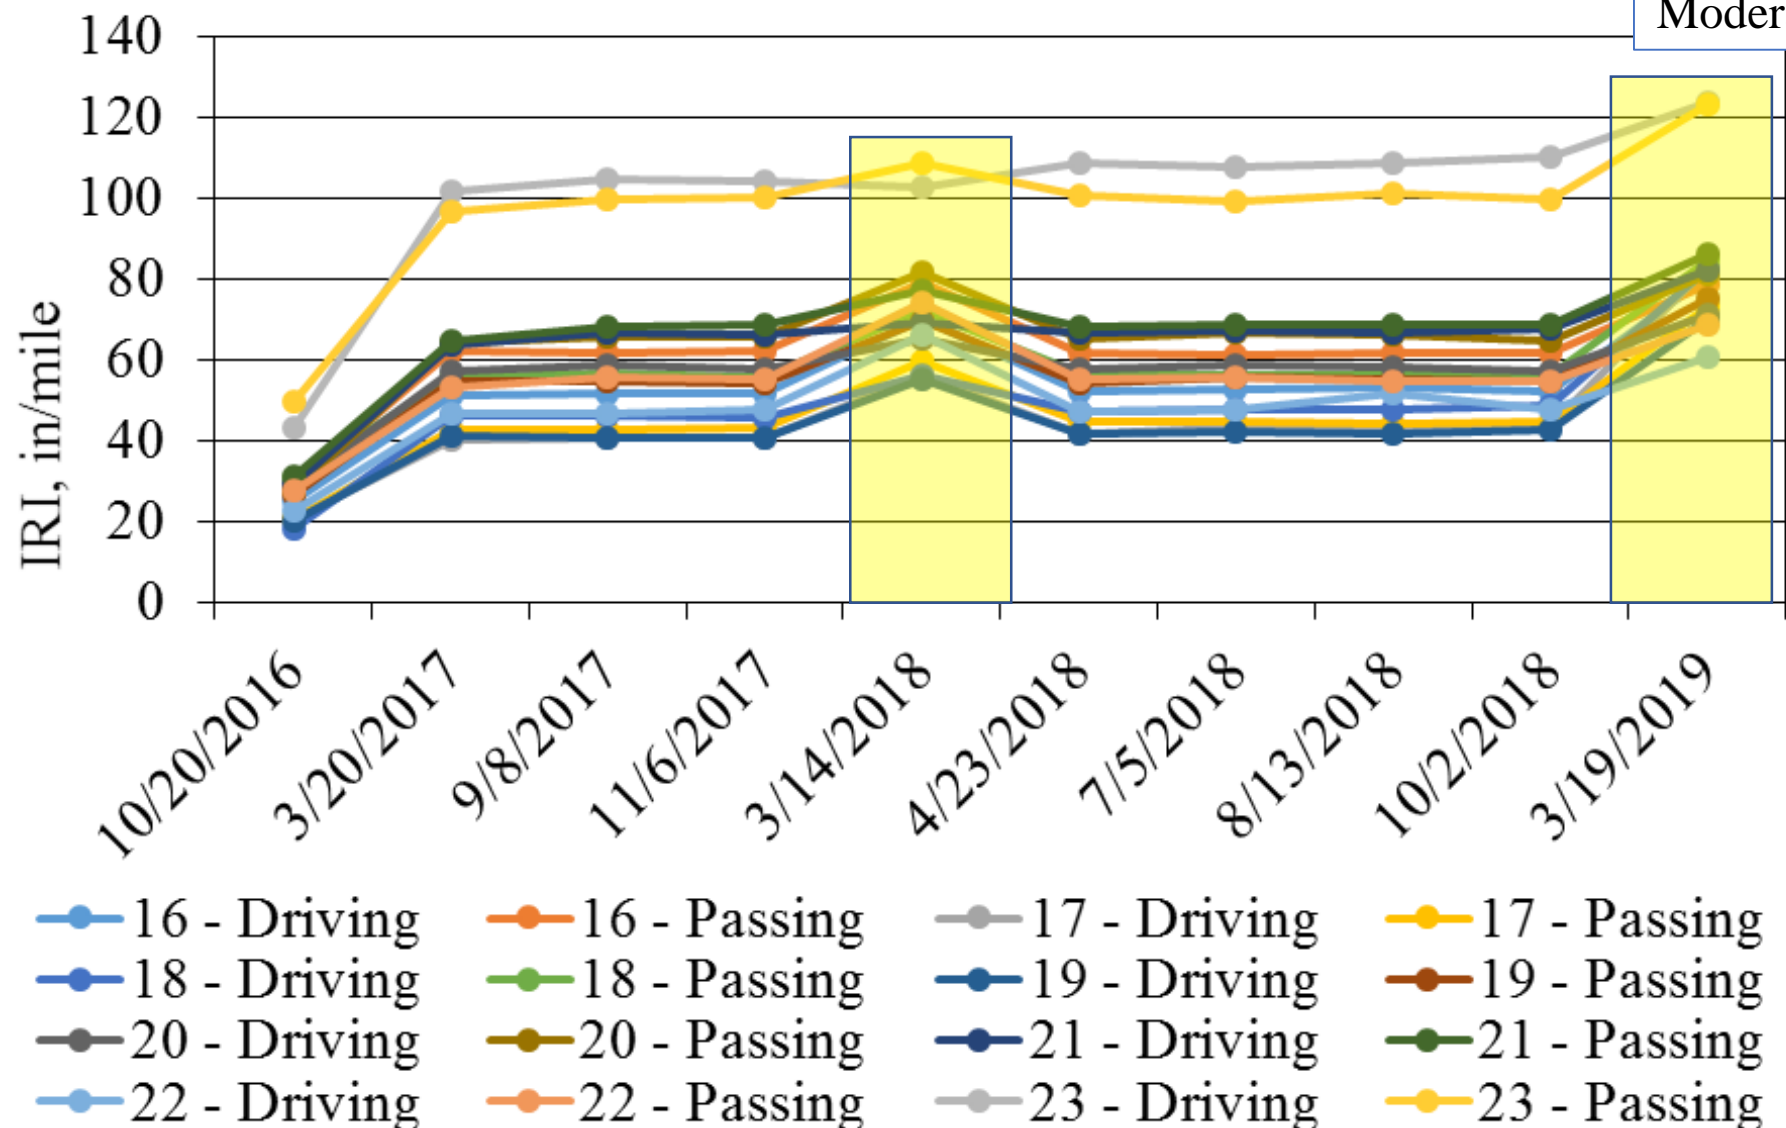
Performance - Ride

Cell 23

Moderate RAP, Highly mod. binder

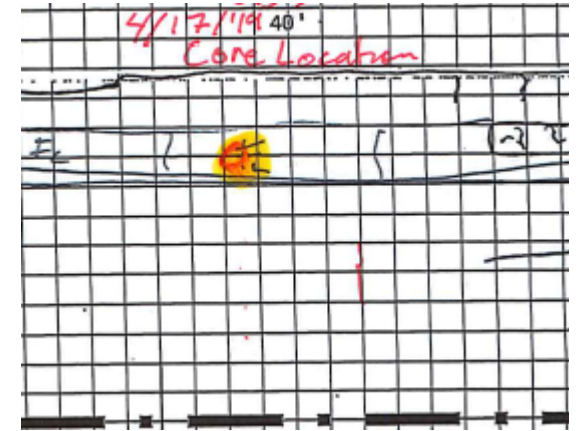
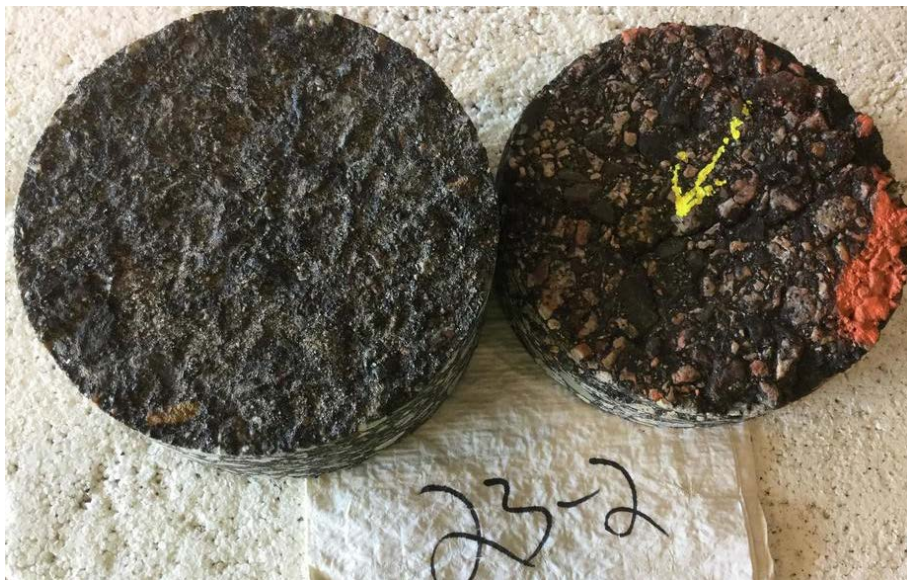
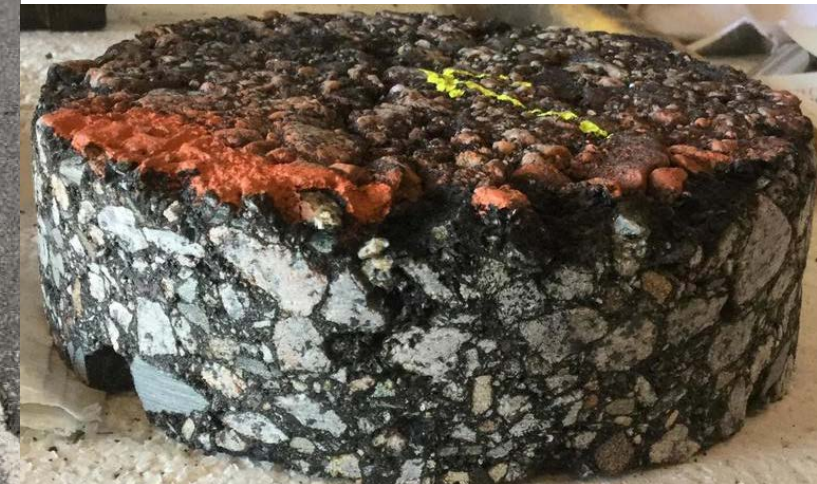
Performance – Cell 23

- Largest amount of load related distress
- Delamination under surface lift (2/3 cores)
- Lower lift has no signs of distress in cores

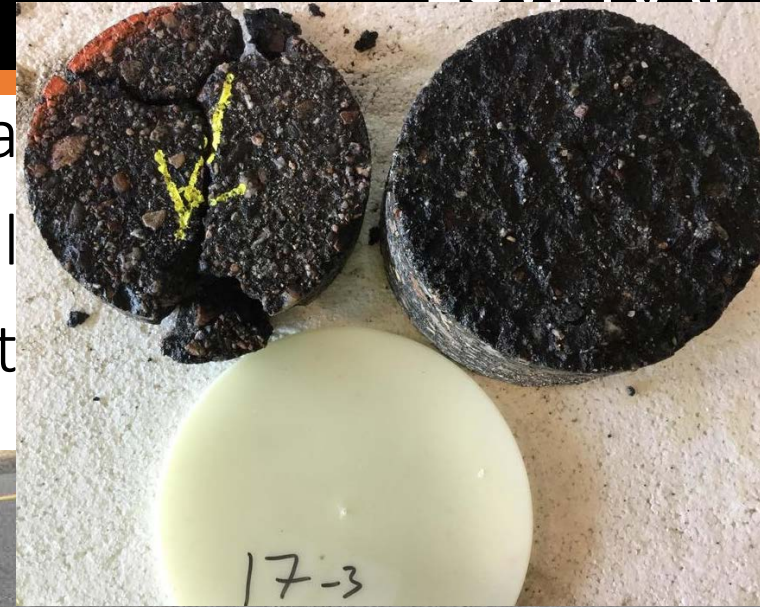
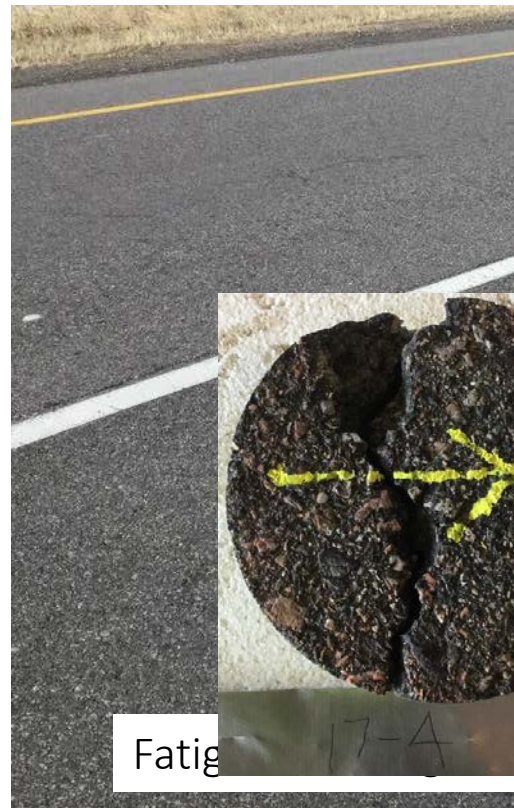
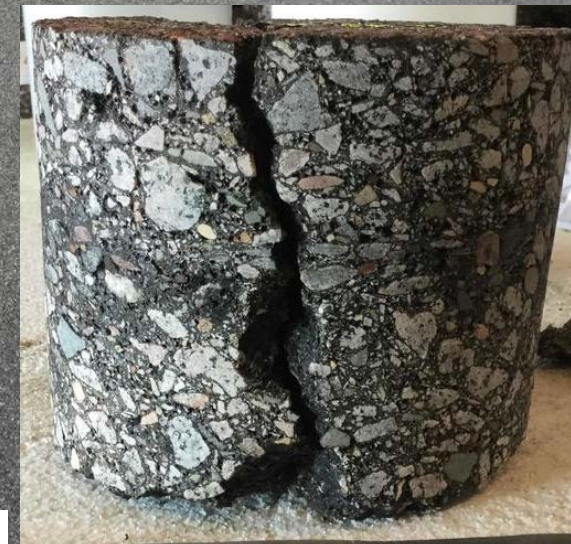
Performance – Cell 17

- Largest amount of LTC and fa
- Delamination under surface l
- Lower lift has no signs of dist

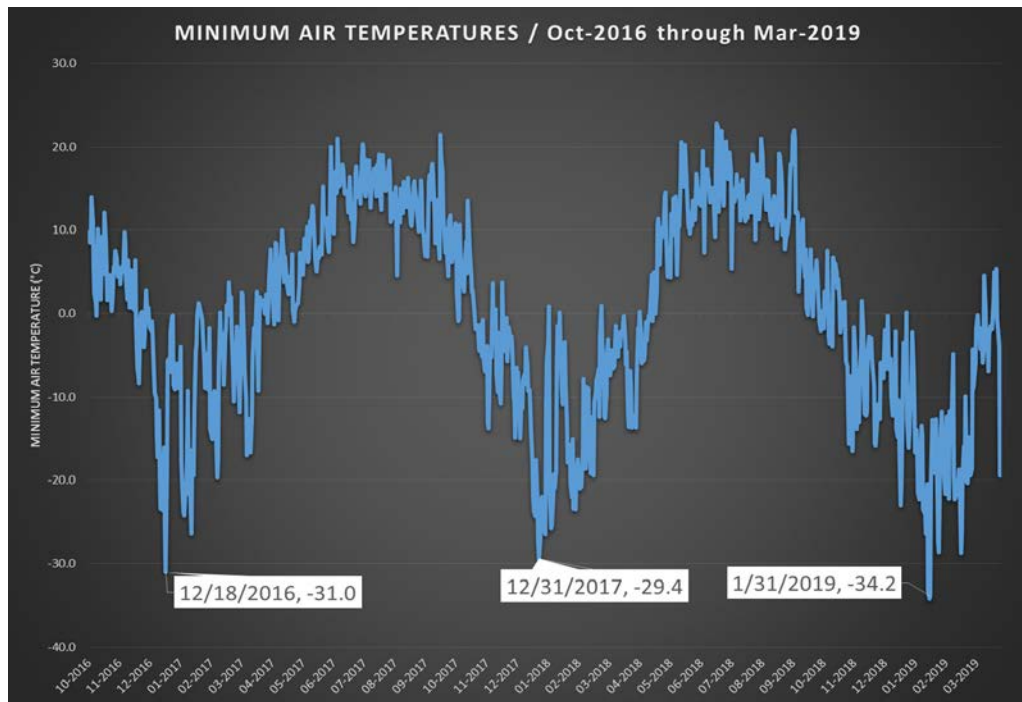
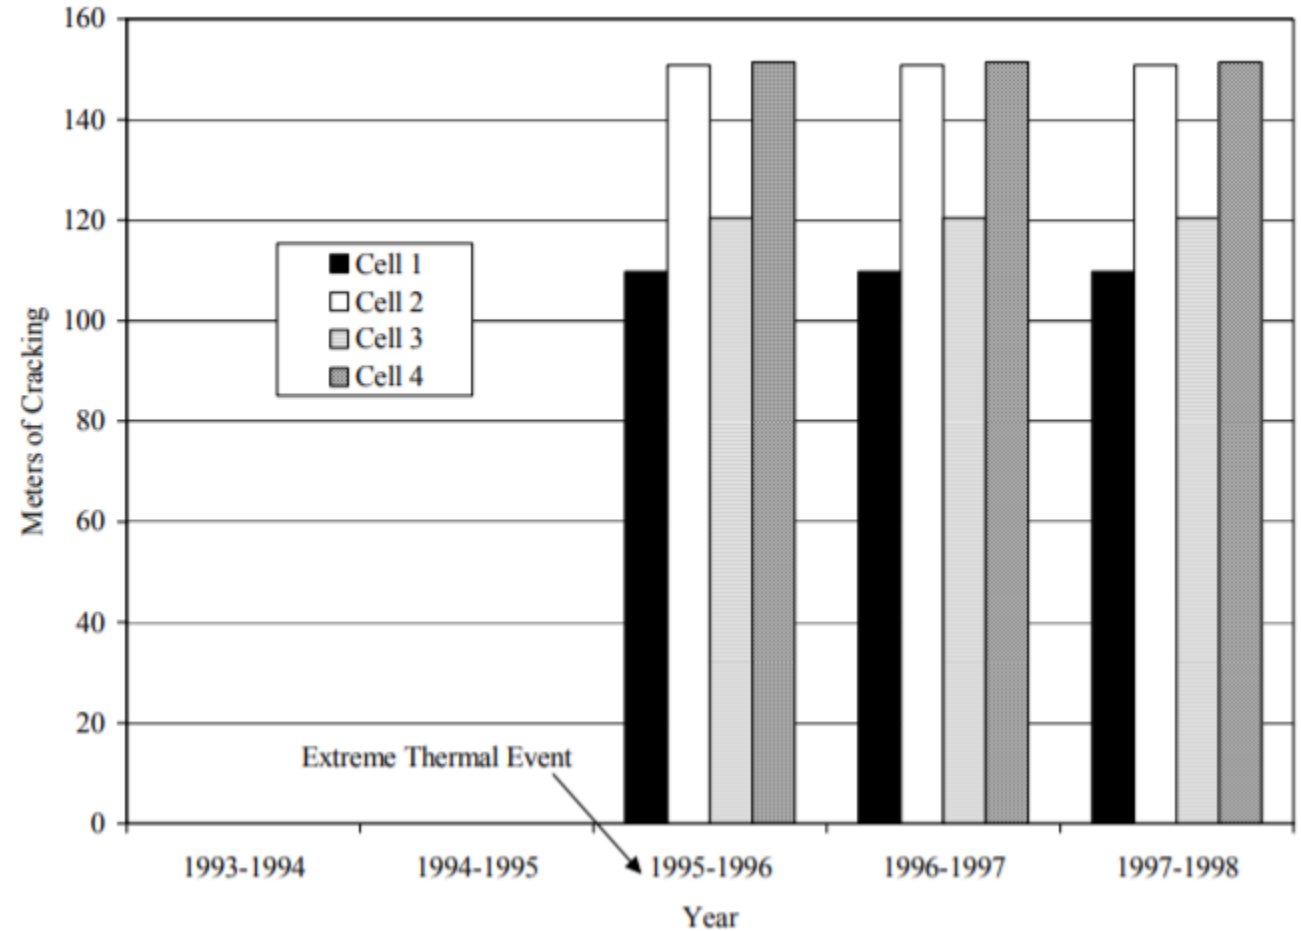
Previous Low Temperature Cracking Studies at MnROAD

- Cells constructed in 1992
- Thermal occurred in 4th winter

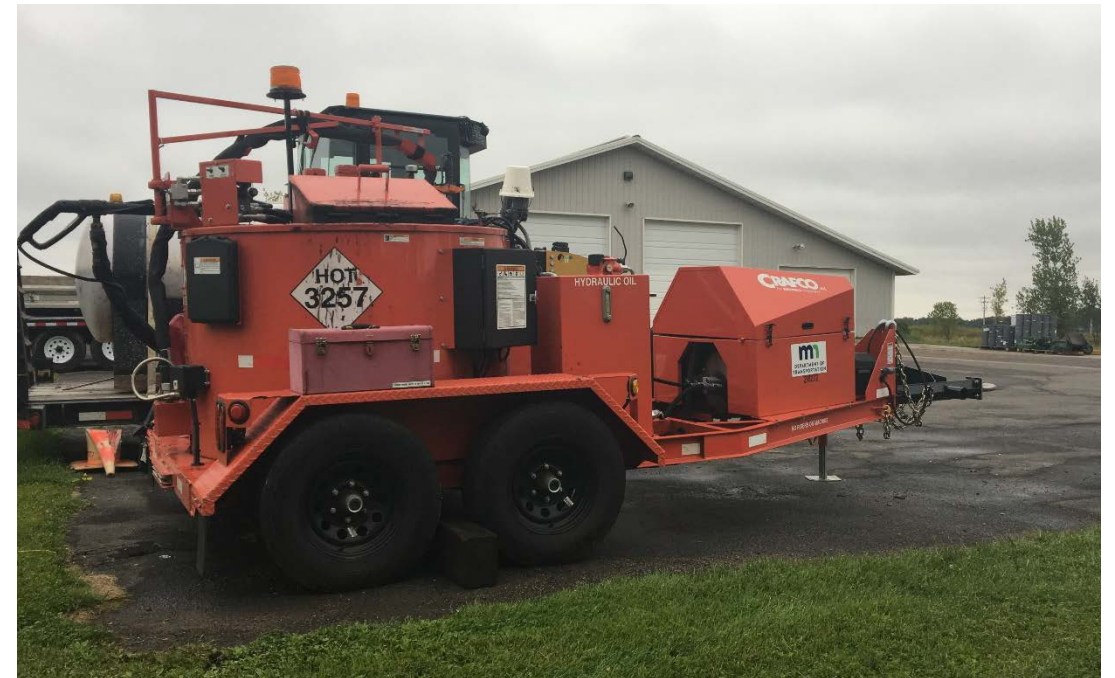
Crack Sealing on Longitudinal Joint

- Crack sealing on longitudinal cracks due to construction joints
 - Fall 2019
 - All cells 16-23
 - Centerline and Driving lane edge stripe

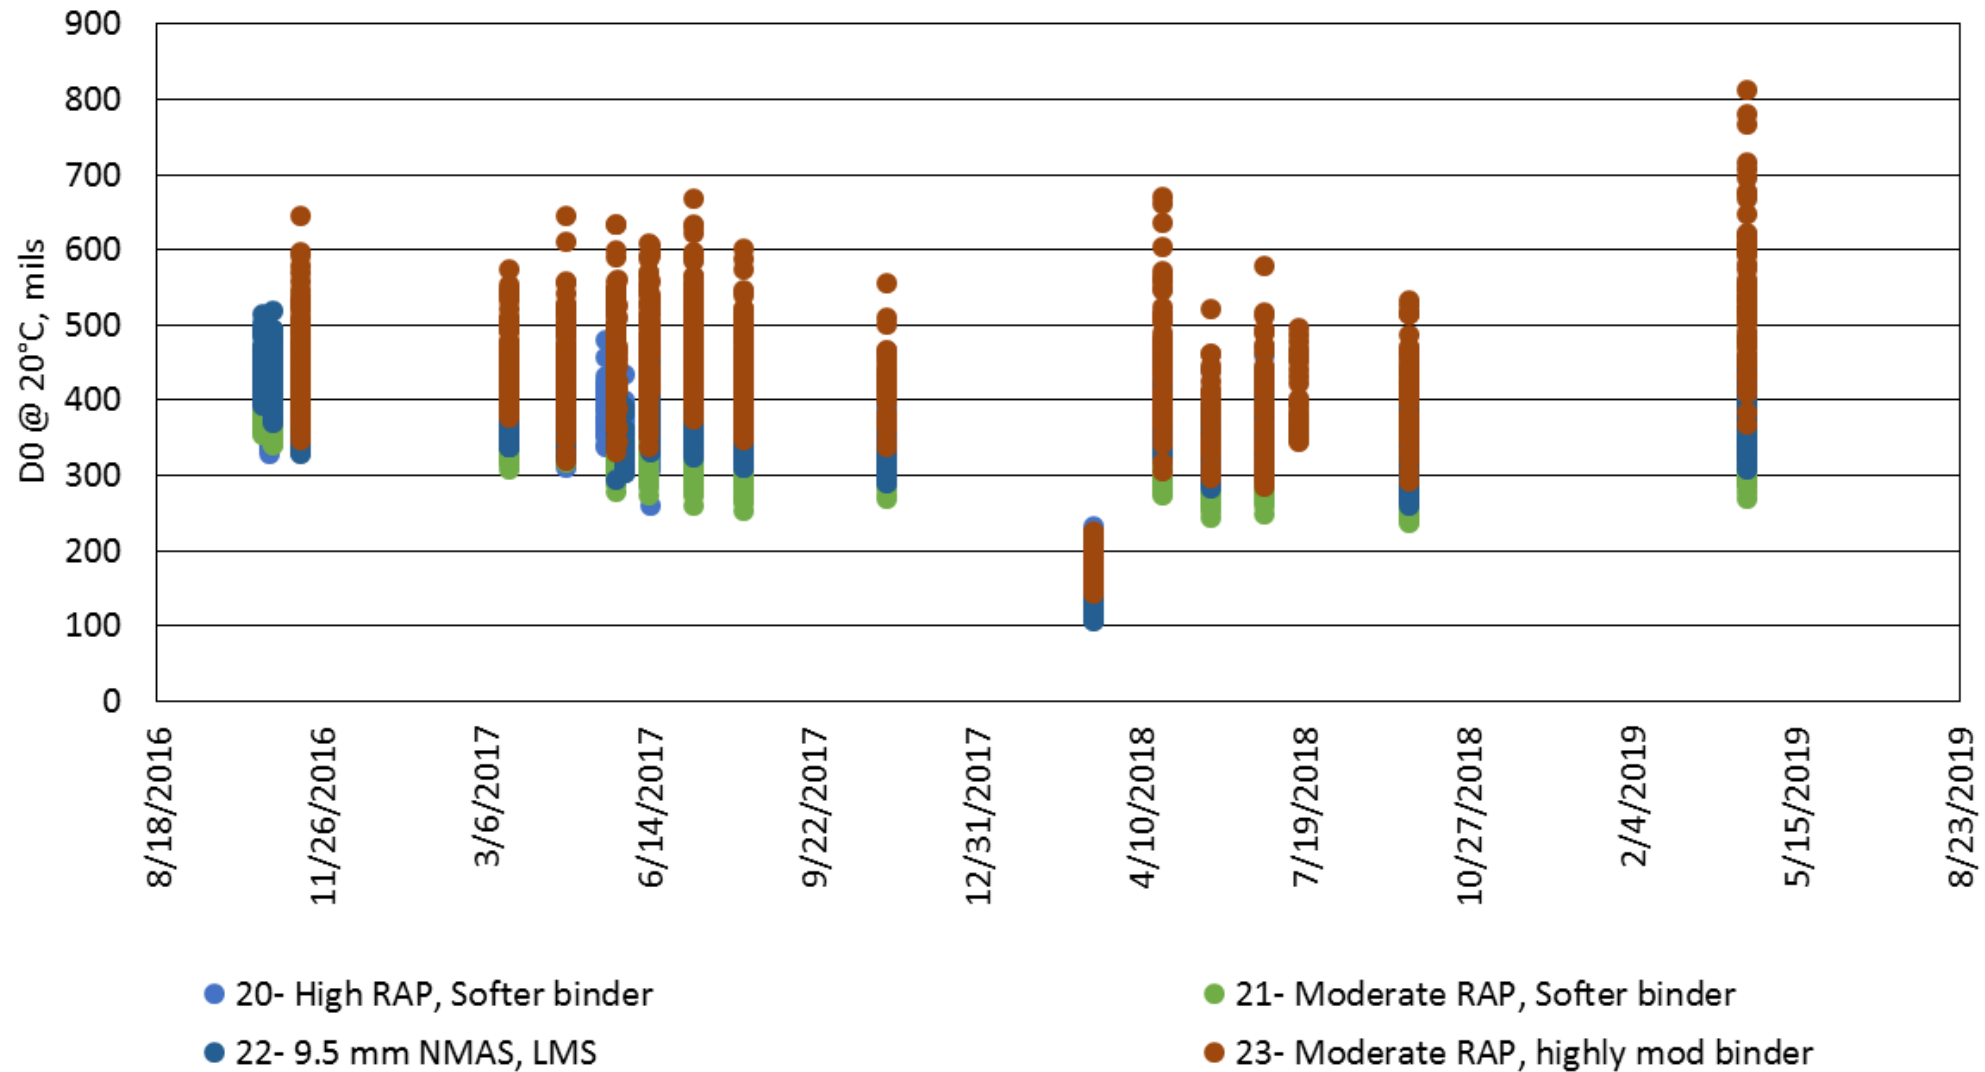
Deflection Analysis

Other Deflection Basin

Parameters

tell show same trends:

- Cell 23 has largest magnitude
- Cell 23 has largest spread in data

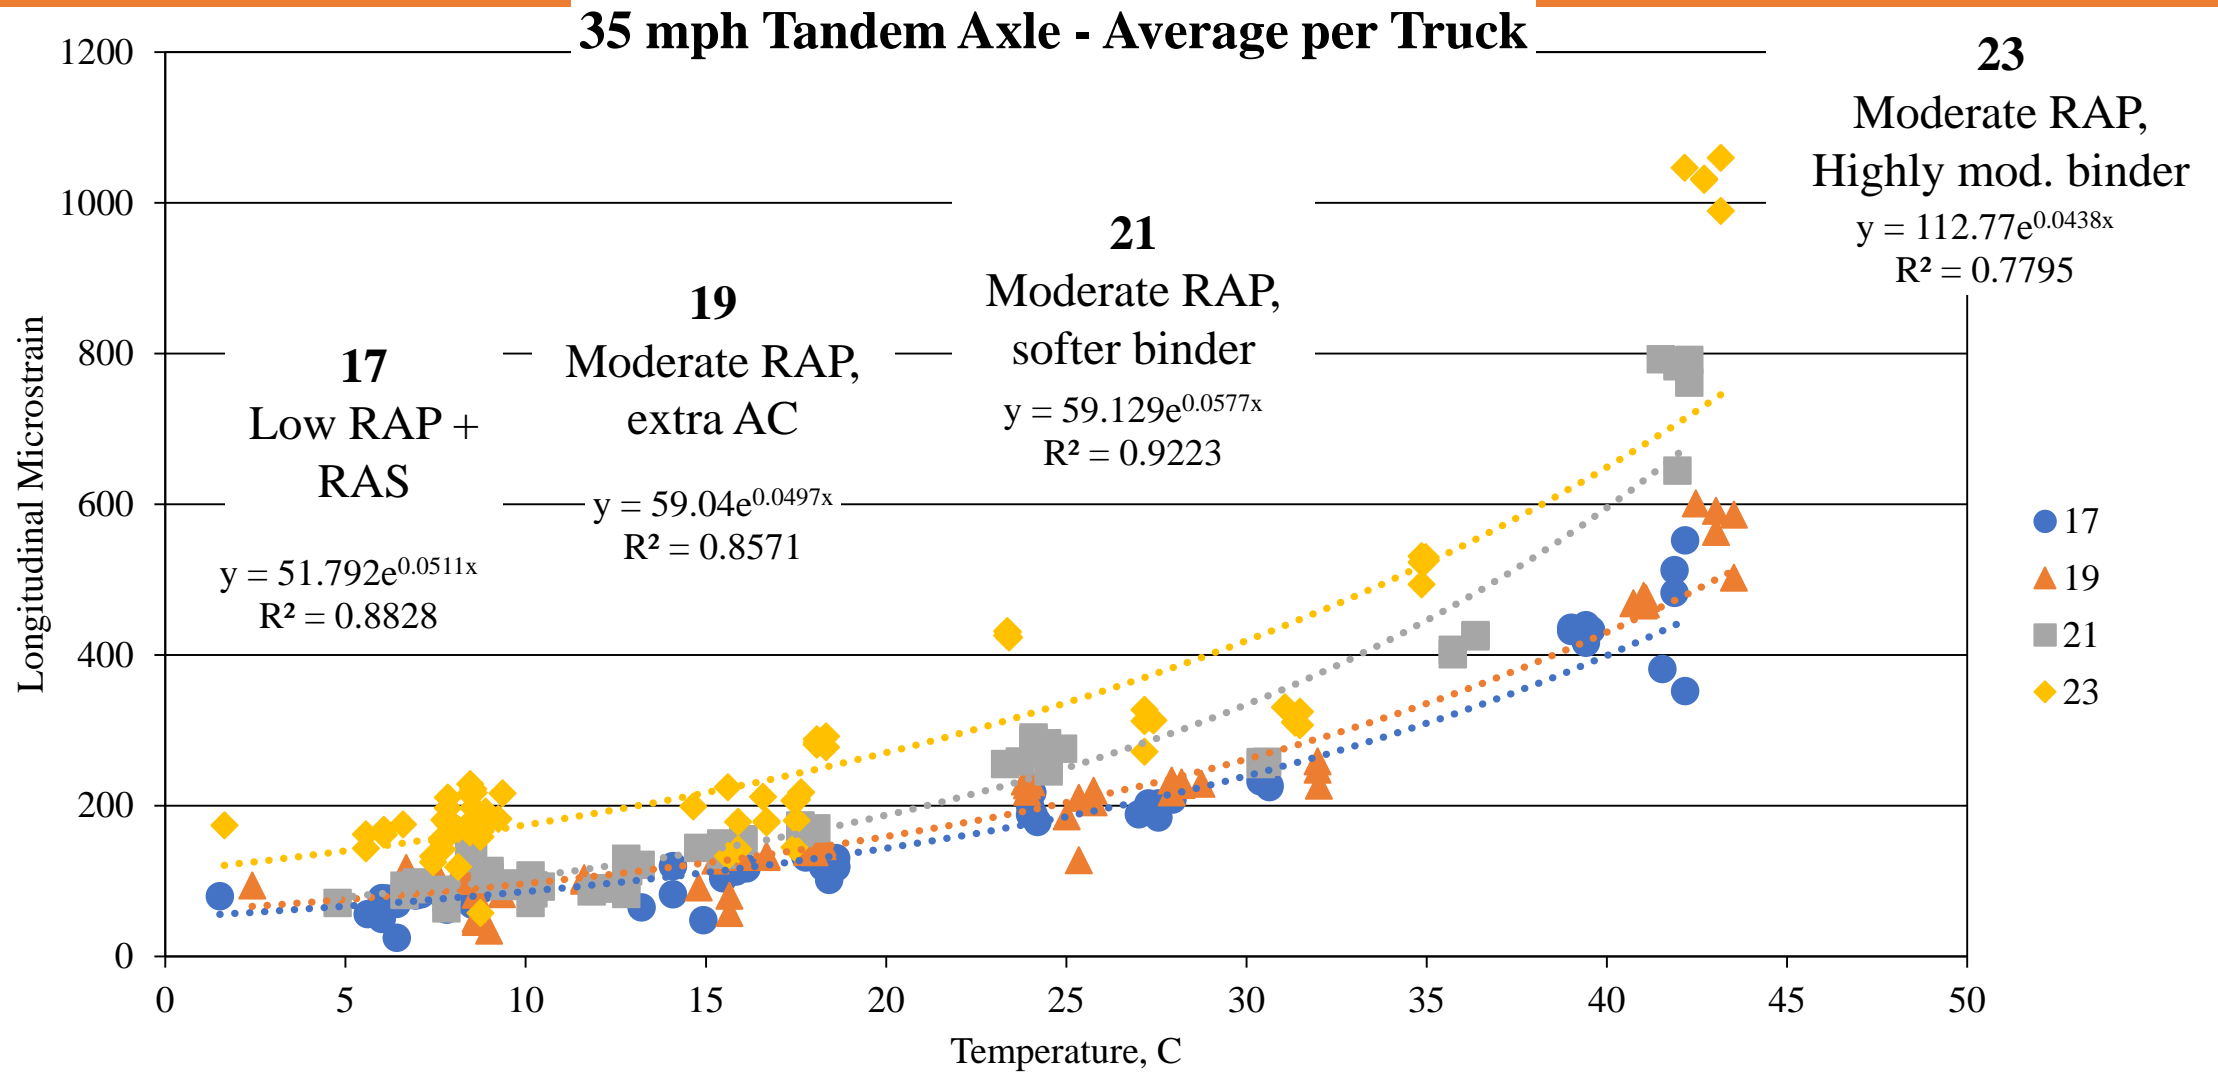
MAX STRAIN vs. SCI

Horizontal Strain

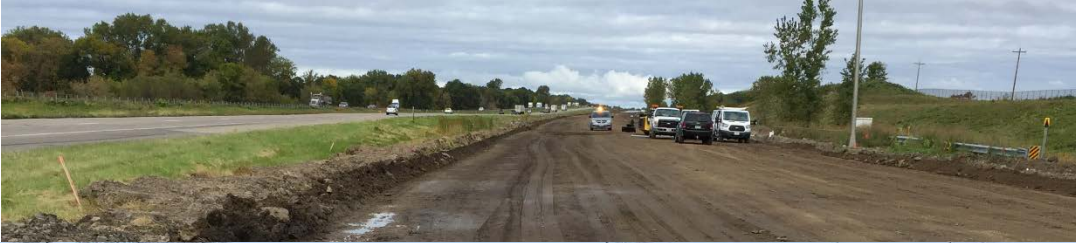
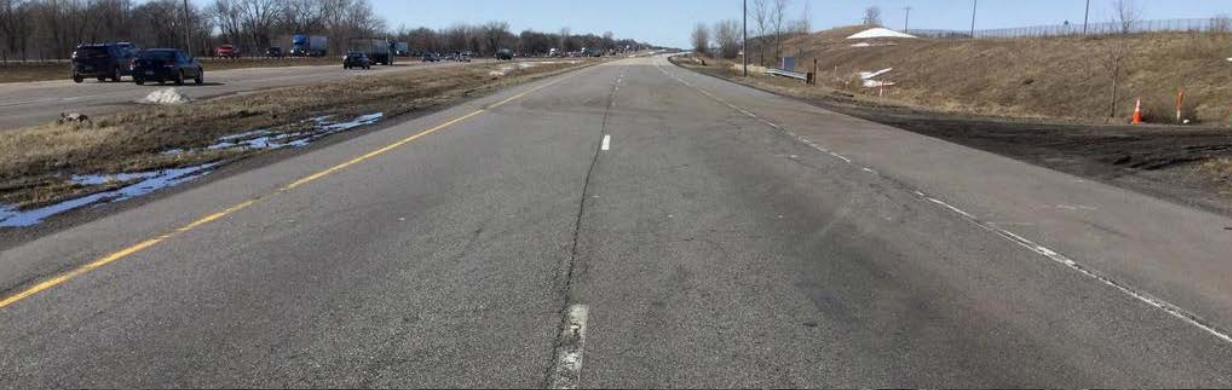
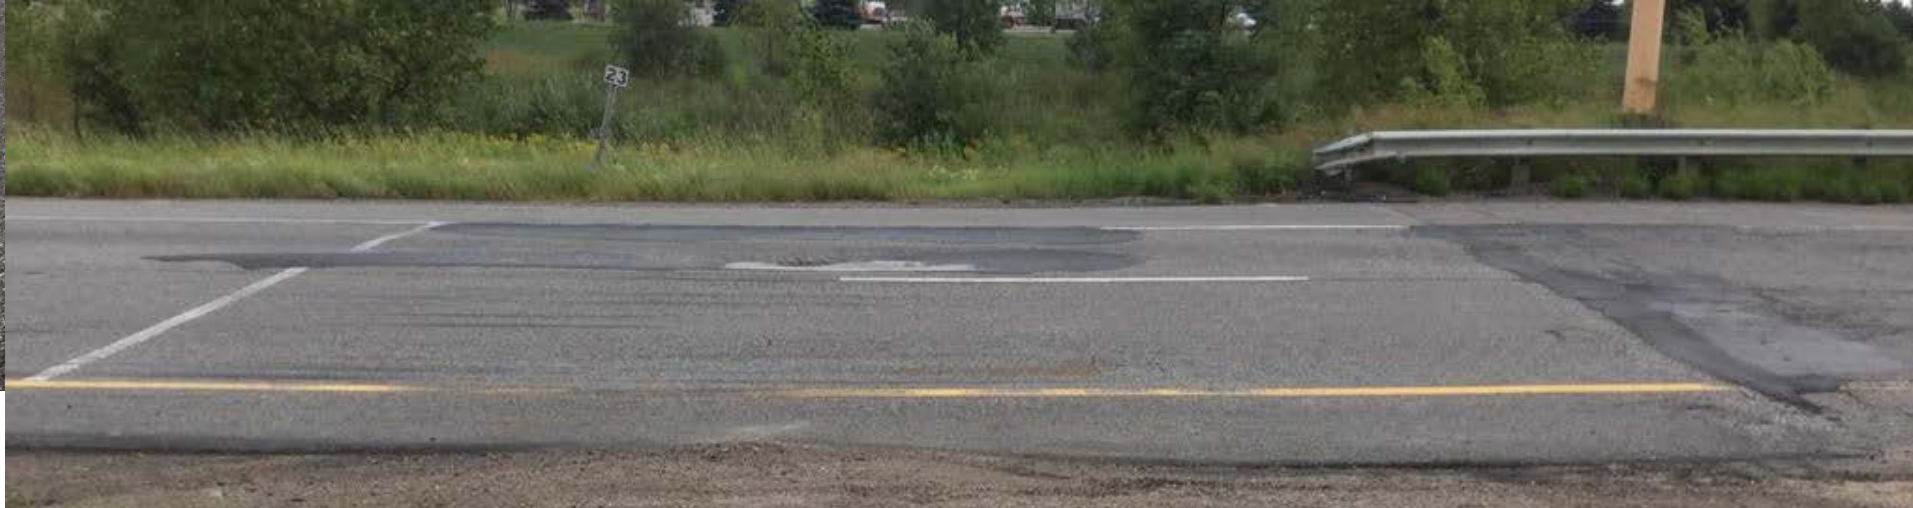
Cell 23

- Moisture issues during construction
- Less drainage available
- Large “dip” in transition prior to section
 - Continuously patched through 2018
 - Removed October 2018 during MnROAD transition reconstruction

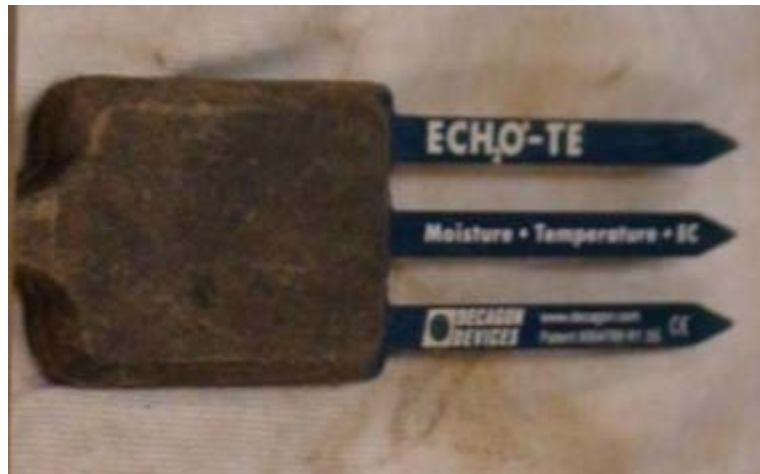
Moisture Sensors

- Is Cell 23 performance due to high moisture contents in granular layers?
- Decagon Moisture gauges used in all instrumented cells (17, 19, 21,23)
- Comprehensive review of moisture data
 - MnDOT's new Geomechanics Research Engineer, Dr. Raul Velasquez
