TECHNICAL SUMMARY

Cost-Effective Strategies for Repairing Grout in Post-Tensioned Bridges

This Technical Summary pertains to Report 2017-04, “Considerations for Development of Inspection and Remedial Grouting Contracts for Post-tensioned Bridges,” published January 2017. The full report can be accessed at mndot.gov/research/TS/2017/201704.pdf.

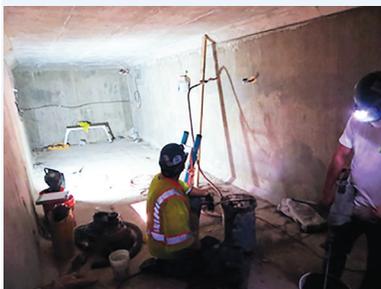
Following bridge inspections, about one-third of discovered grout voids were filled using vacuum-assisted or pressure grouting repair techniques.

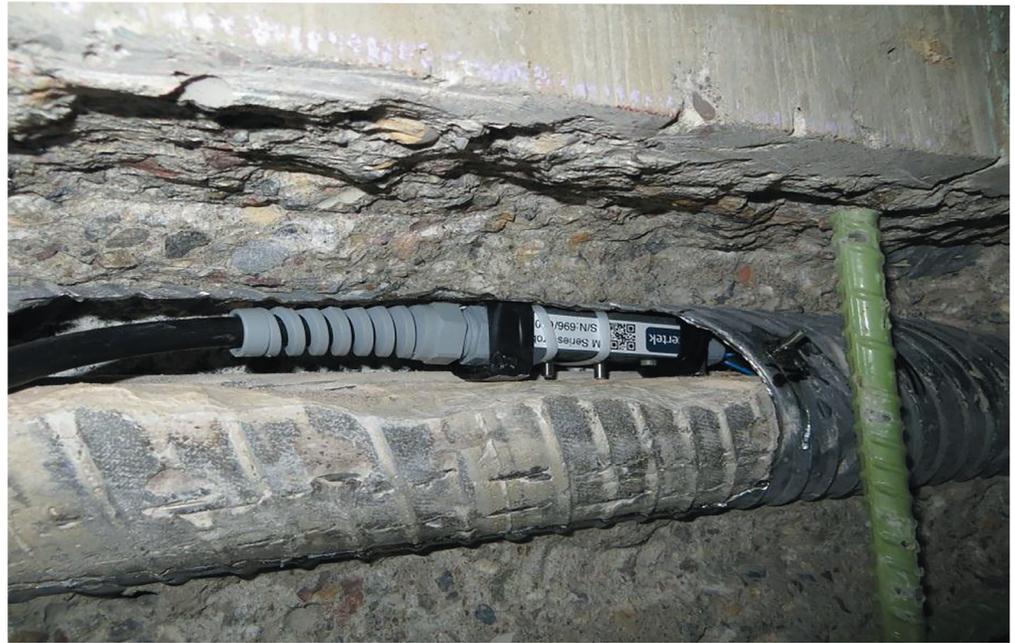
Researchers installed corrosion-monitoring sensors within grout voids at two locations. Measurements are taken manually using a handheld data collection unit and patch cable.

In 2013, researchers inspected three spans on two Minnesota bridges for voids around post-tensioning strands. They began the project by using ground penetrating radar to map the location of the ducts. Once the ducts were located and mapped, researchers used a borescope to visually inspect the duct interiors at locations where voids were likely to be present. When they found voids, they documented the percentage of the duct filled by grout and the extent of corrosion in the post-tensioning strands within the ducts, if any. Following inspection, researchers filled the voids with grout and installed sensors within the voids at two locations to monitor the long-term corrosion of post-tensioning strands.
