**GRACEVILLE HISTORICAL MARKER**

**SHPO INV. # BS-GRA-017**

**MNDOT HISTORIC ROADSIDE DEVELOPMENT  
STRUCTURES INVENTORY**

BS-GRA-017  
CS 0605  
Graceville Historical Marker

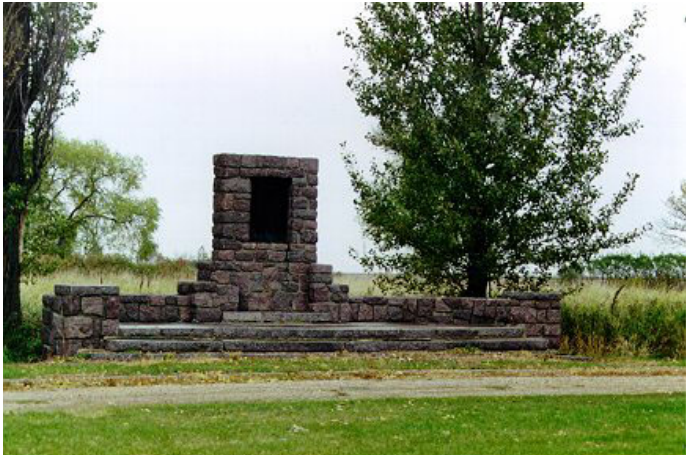
1. South Elevation looking North

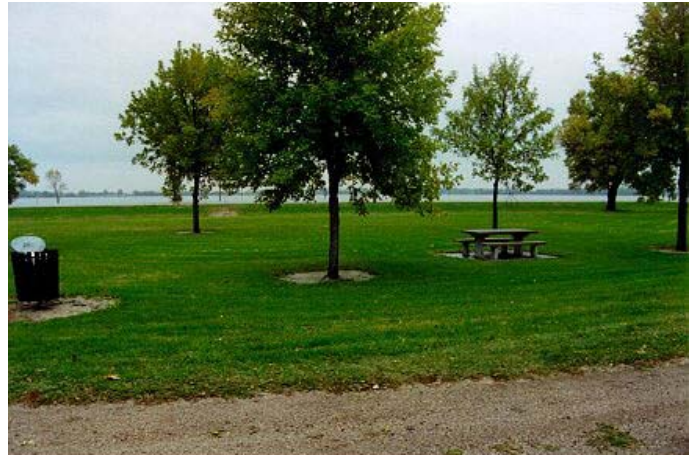
The site retains its original, significant view of Lake Toqua and lakeshore parkland to the southeast. The lake is mentioned in the marker text. Views to the west (toward the gun club) and to the northeast are screened by trees and shrubs.

2. Grass Island looking South (Lake Toqua in the background)

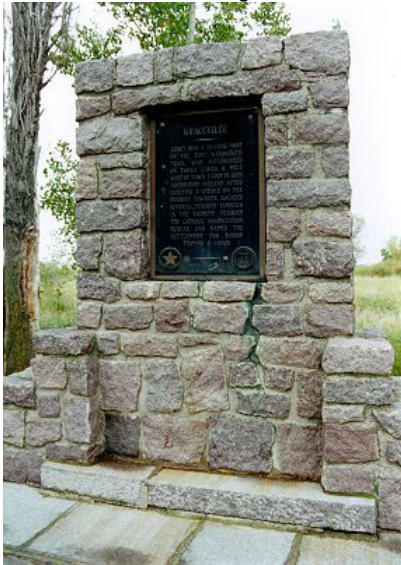
- **Assessment:** The majority of the mortar joints have failed due to settling and a lack of regular maintenance. Especially bad are the steps, which slope toward the riser causing the collection of water at the step joints, thus weakening them. The elevated, horizontal flagstone surface has settled creating drainage problems and weakening the mortar joints. The wall joints are in poor condition and show evidence of recent repairs. Two (2) holes exist in the back of the marker wall (North Elevation)--cause and/or reason unknown.

3. South View of Marker  
*(note: stone joint deterioration)*

**Stabilization/Preservation/Restoration:** Remove all walking surface stones and flagstone, marking each stone before removal to facilitate proper replacement. Add new compacted fill. Reinstall the existing stone and flagstone in their original locations. Remove all stone joints and replace with new mortar in accordance with the specifications. **Work Period:** 1 - 3 years.

Complete masonry repointing is recommended for the stone marker. The horizontal stone surfaces shall be temporarily removed, marked per their locations, cleaned and reinstalled following the installation of additional compacted sand fill. This will restore the gradient for proper drainage and safe pedestrian usage.

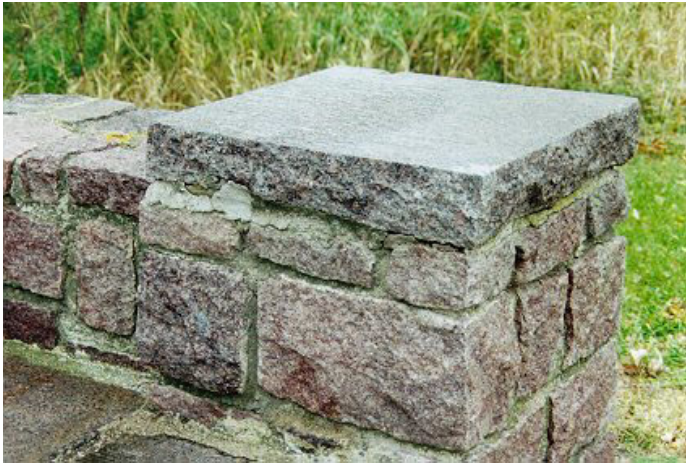
8. Close-up of Pier (Note: mortar patching)

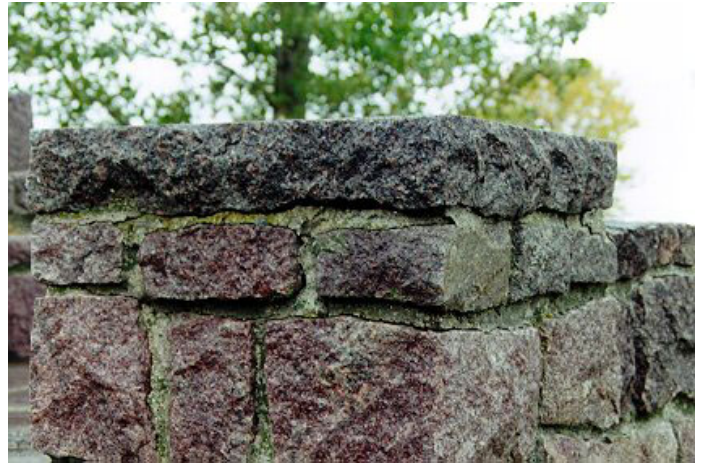
9. Close-up of Pier (Note: spalled cap stone and decaying mortar)

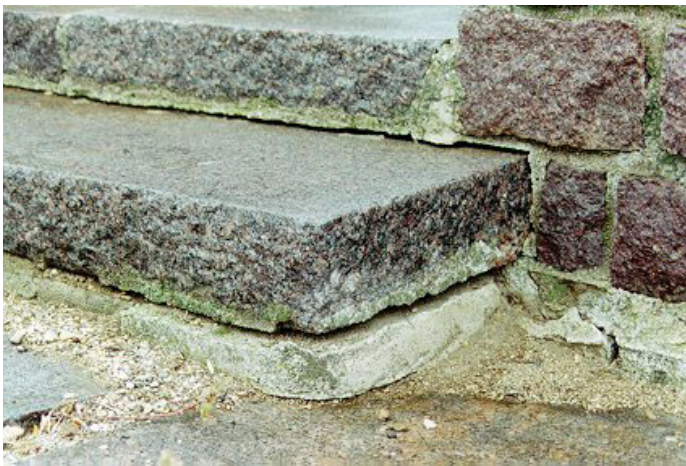
- Assessment: The site is basically flat. The grade has settled around the marker.

10. Granite step at East End (Note: grade settlement from excess mortar fill)

Stabilization/Preservation/Restoration: Add fill soil around the marker. Work Period: 1 - 3 years.

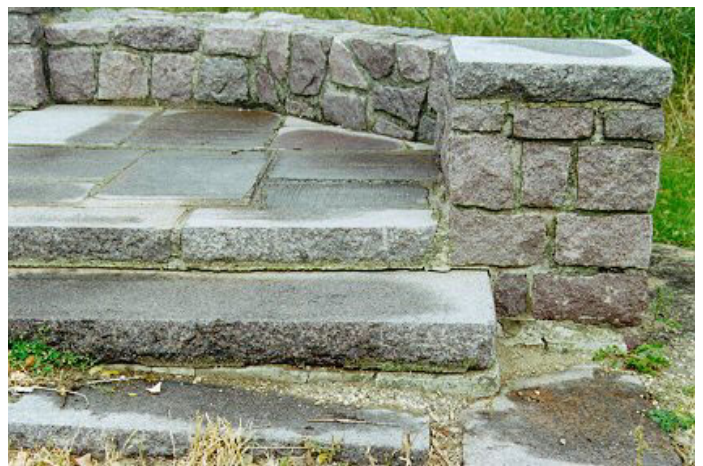
13. East End of Marker Steps (Note: joint conditions, mortar cracks and invasive turf)

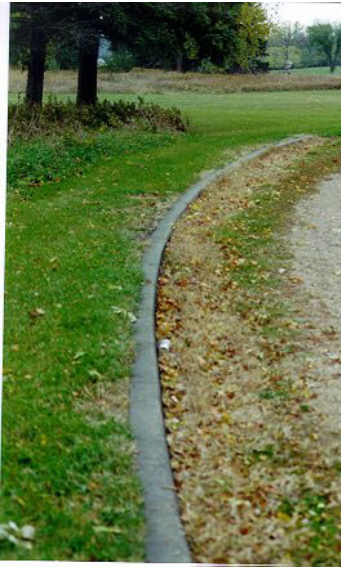
- **Assessment:** Original 6" thick concrete curb is intact; however it is obscured by overgrown turf on both the pedestrian walk and driving surface sides. No handicapped accessible curb exists.

14. Curb & Drive looking East (Note: overgrown turf)

**Stabilization/Preservation:** Remove all overgrown turf. Stabilize sections that have settled and fill expansion joints with expansion material as required. **Work Period:** Turf removal--ASAP; other work--1 - 3 years.

**Restoration:** Remove all overgrown turf. Remove all curbing and replace with new concrete curbing to match the original design. Provide handicapped curb cuts--one at each end of the pedestrian walk. Provide a weathered finish on the concrete to blend with the marker's age. **Work Period:** ASAP--turf; other work--3 - 5 years.

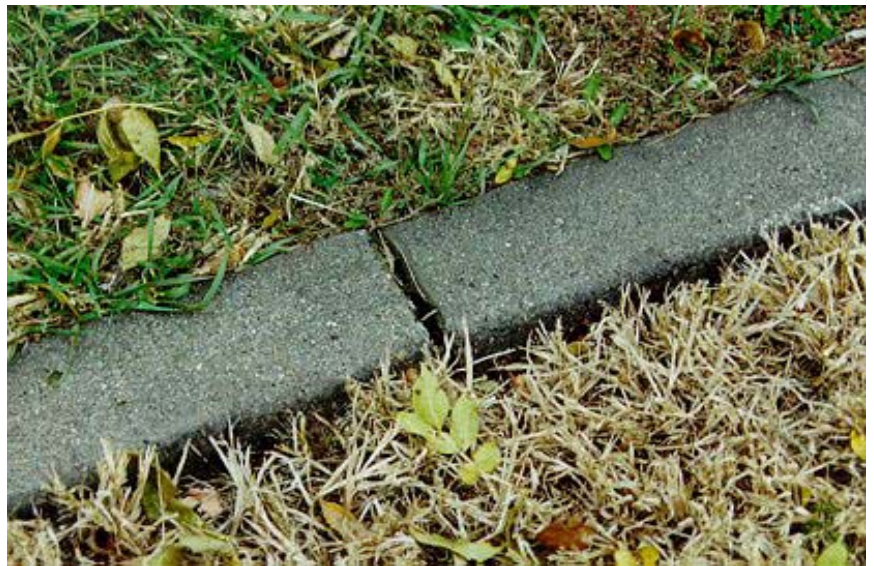
15. Close-up of Concrete Curb showing overgrown turf

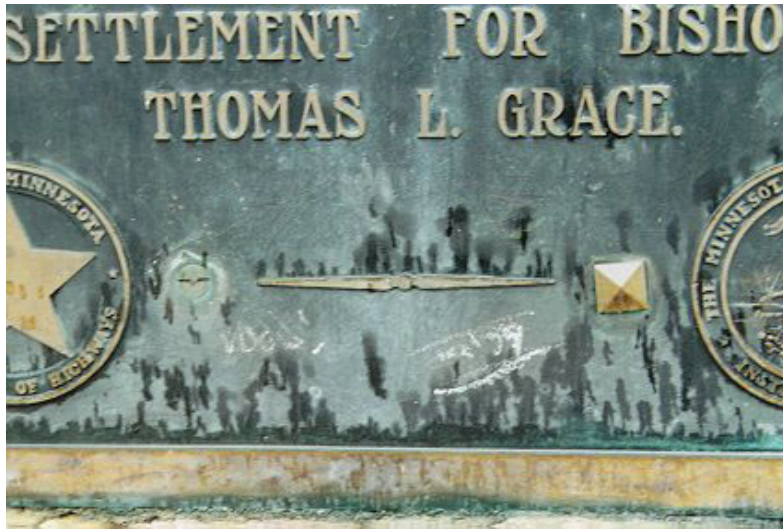
- **Assessment:** This is very dirty and stained--streaks run across its face. The lower left anchor escutcheon is missing.

16. Bronze Plaque showing missing escutcheon and staining

**Stabilization/Preservation/Restoration:** Remove plaque to clean it off-premises to remove

the staining and graffiti. Reattach it following its repair. The surface color shall retain its patina, not become a shiny bronze color! Work Period: 1 - 3 years.

The bronze plaque must be cleaned to remove the staining, but without removing its patina. A new anchor escutcheon that matches the existing shall be installed over the anchor.

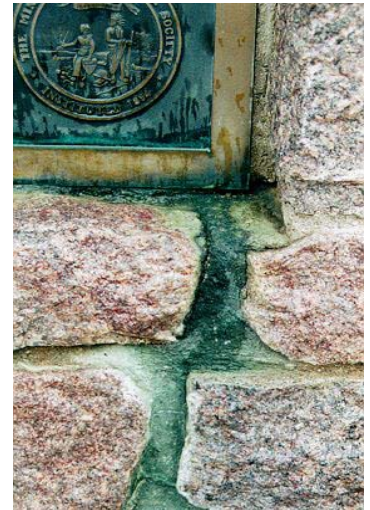
17. Stained Mortar Joint @  
Bronze Plaque

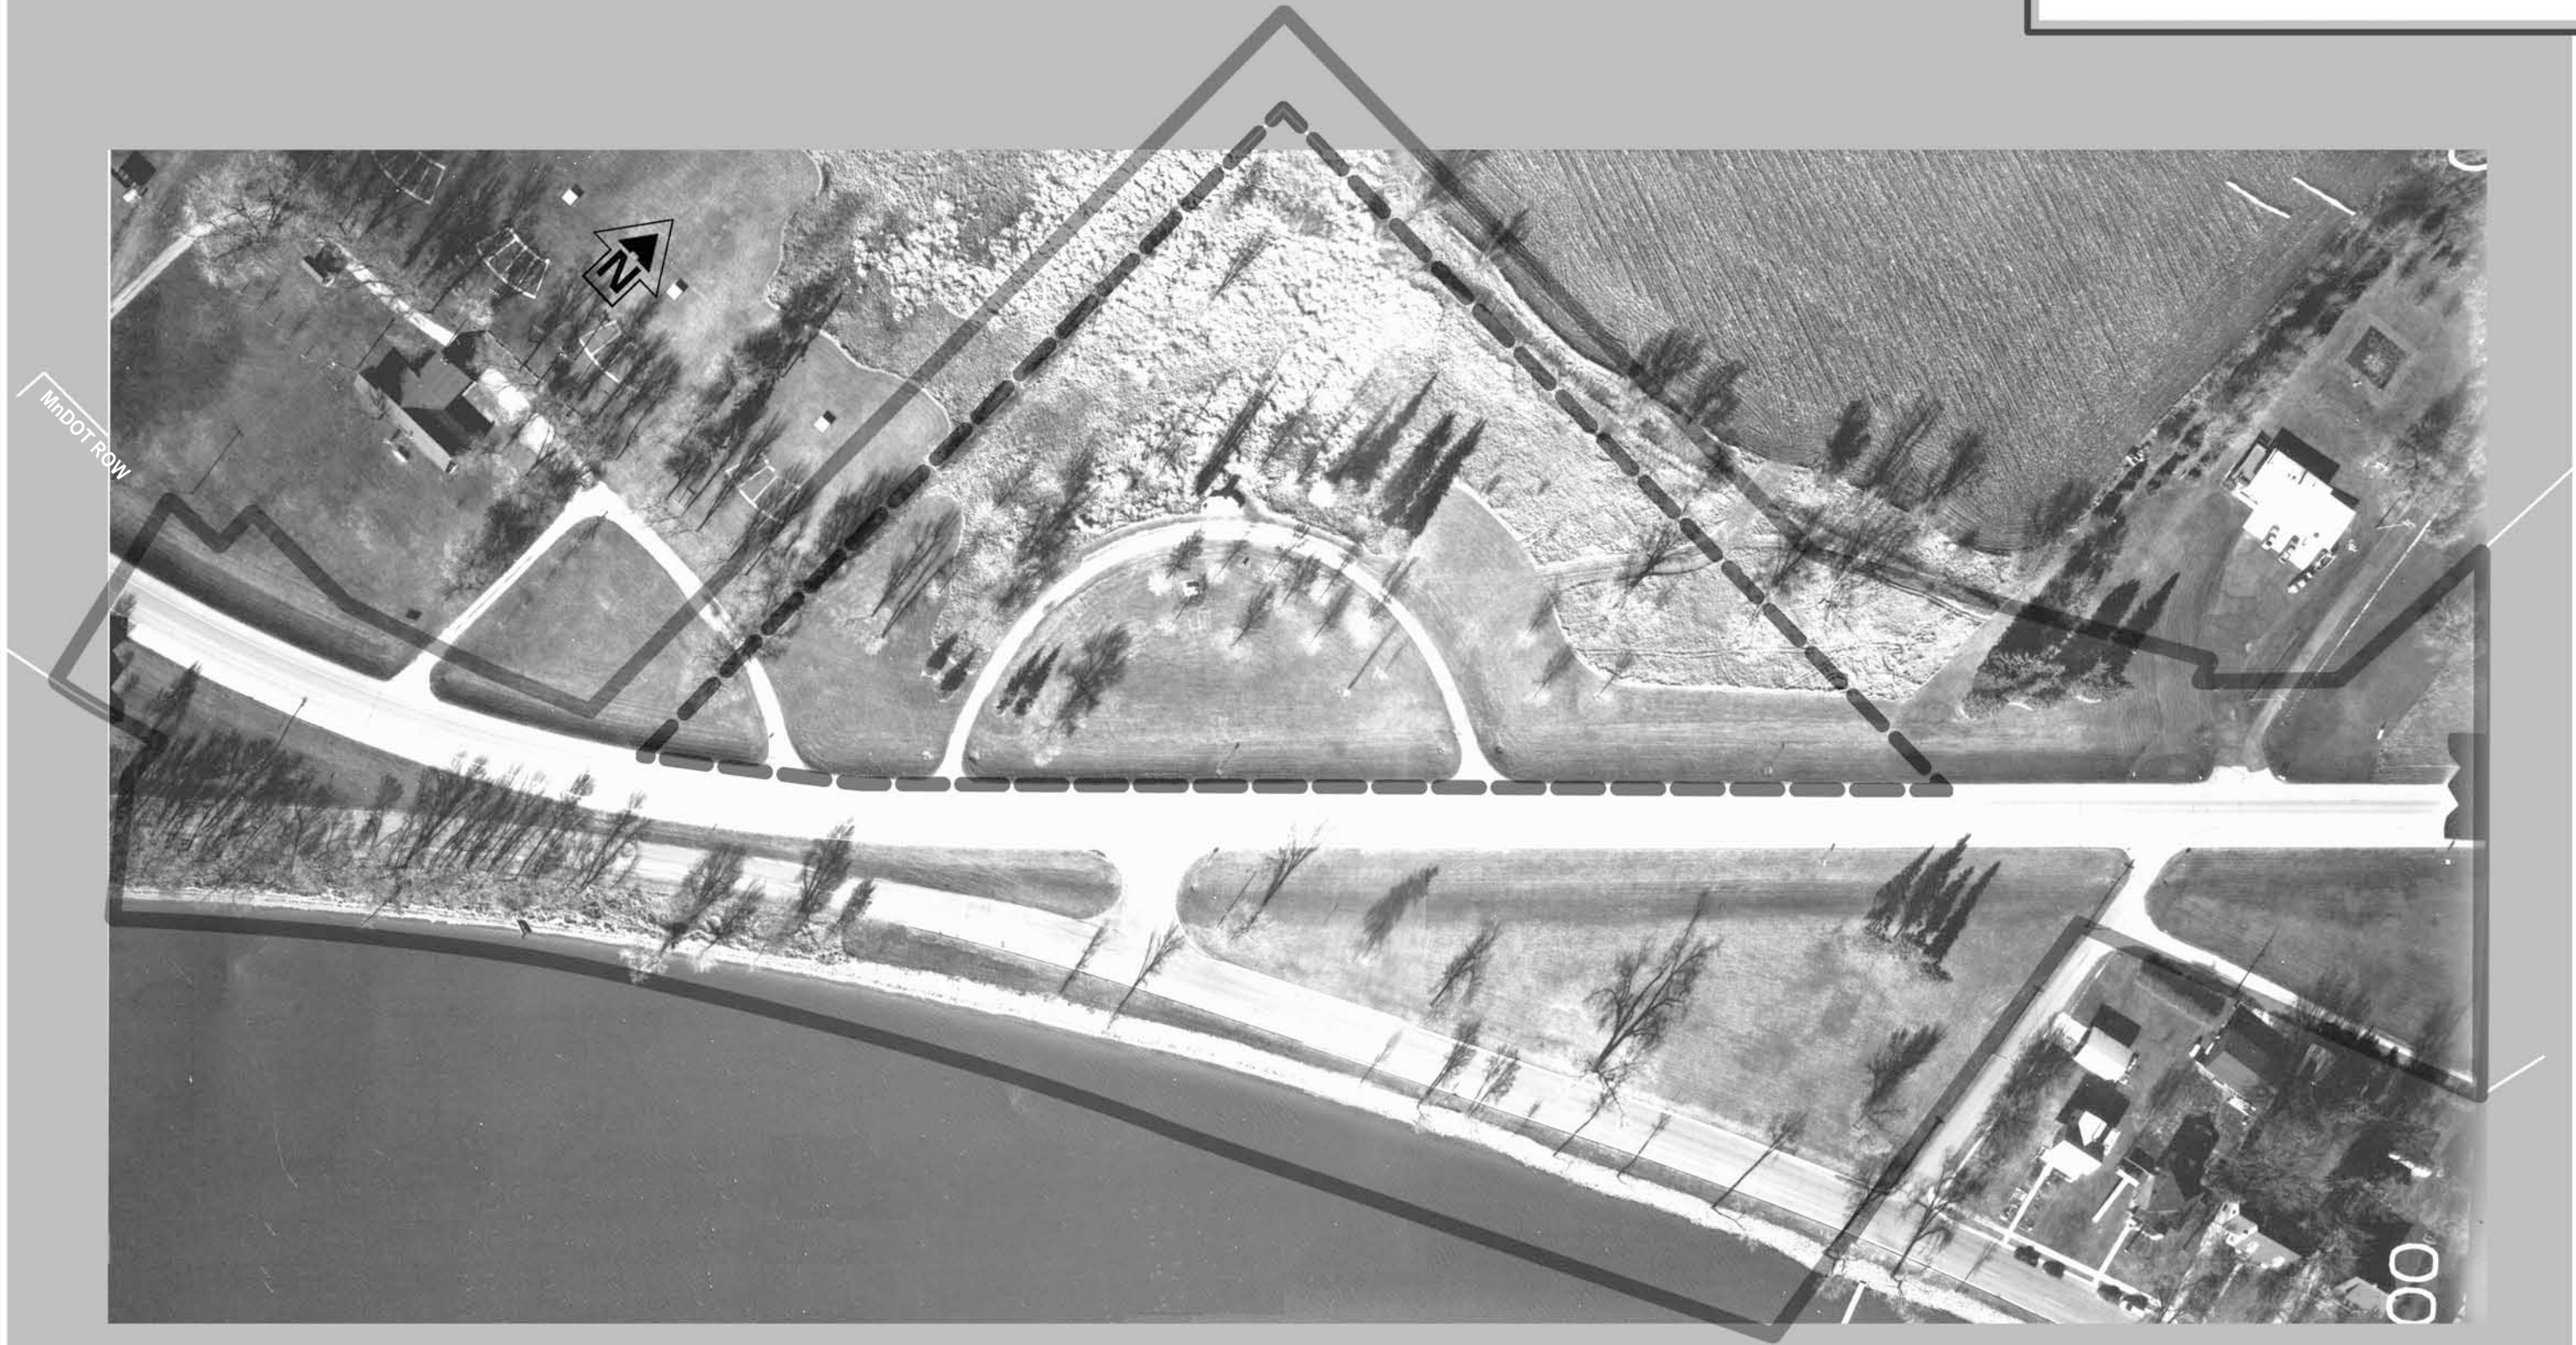
**Graceville Historical Marker  
Site Boundaries**

The recommended boundary of the Mn/DOT Historic Site Conservation Zone is also shown on the accompanying sheets. The Conservation Zone encompasses both the National Register-listed property, marked by the dashed line, and adjacent areas marked by the solid line.

— National Register-listed Property  
— Historic Site Conservation Zone  
Conservation Zone includes the  
National Register Property

West and north of the National Register-listed property, it is recommended that the Conservation Zone extend to a line 50' from the National Register property. East of the National Register-listed property, it is recommended that the Conservation Zone extend to the shore of Lake Toqua so that it includes Mn/DOT and City-owned land that comprises Toqua Park. This park land was landscaped as part of the Roadside Development project that created the wayside rest and forms a visual and physical connection between the wayside rest and Lake Toqua. (The lake is also mentioned in the text of the wayside's historical marker.) Southwest and northeast of the National Register-listed property, it is

recommended that the Conservation Zone include all Mn/DOT right-of-way along the trunk highway extending 400' southwest and 400' northeast of the National Register-listed site.
