1 **CONSTRUCTION OF SUSTAINABLE PAVEMENTS: TWO-LAYER**
2 **CONCRETE PAVEMENTS AT THE MNROAD FACILITY (11-0769)**
3
4

5
6
7 Paper revised 15 November 2010 for
8 Transportation Research Board 90th Annual Meeting,
9 23-27 January 2011

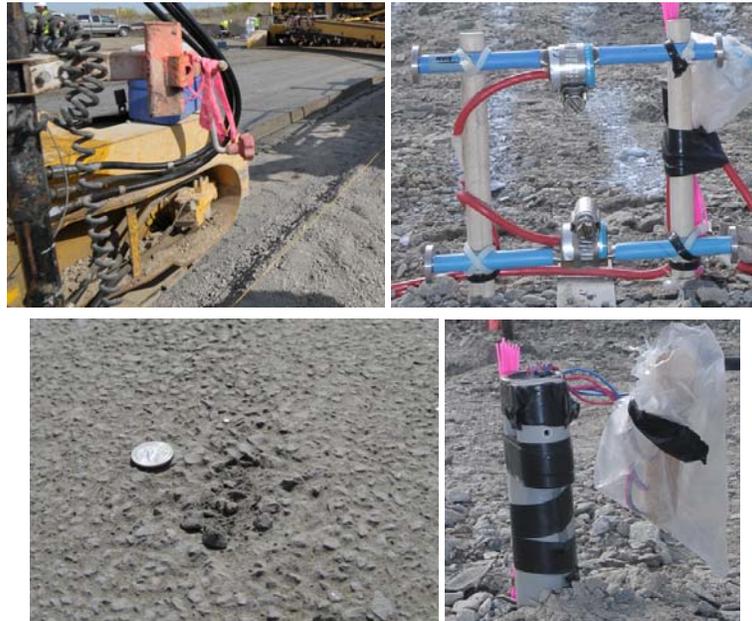
4 **Figure 1. Project construction concerns at a glance (clockwise from top-left): layer**
 5 **placement, two sensor installations, EAC**

1 the research team met frequently to discuss shared concerns in regard to the following key areas
 2 (illustrated in Figure 1).

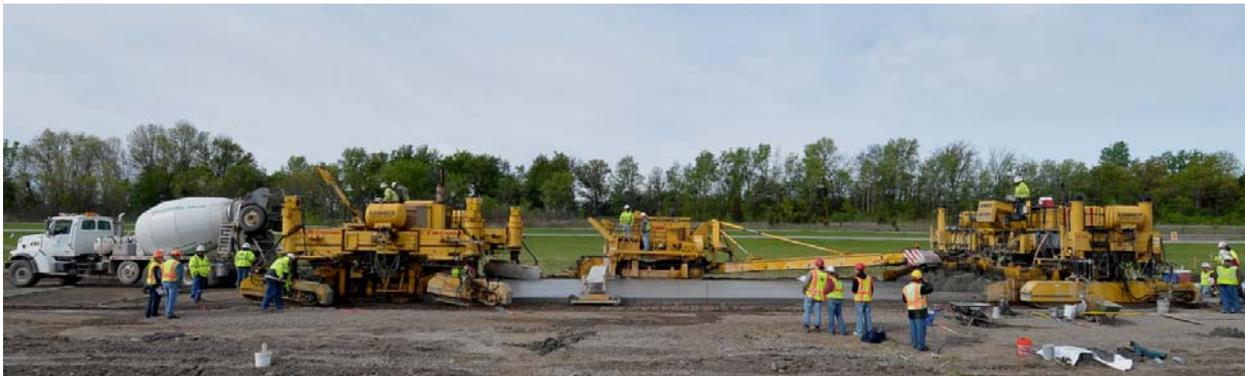
Figure 2. Paving train constructing R21 research sections along I-94 at MnROAD (from left to right, the mixer truck, first paver, material transfer device, and second paver)

Paving operations for the R21 test sections at MnROAD began on 28 April 2010 with the construction of a 200-foot demonstration slab and concluded on 10 May 2010 with the completion of 1000 feet total of test sections along the mainline (I-94) test area. The two-lift paving utilized two GOMACO model GHP2800 pavers and a material transfer device spaced between the two pavers to place fresh mix for the upper lift.

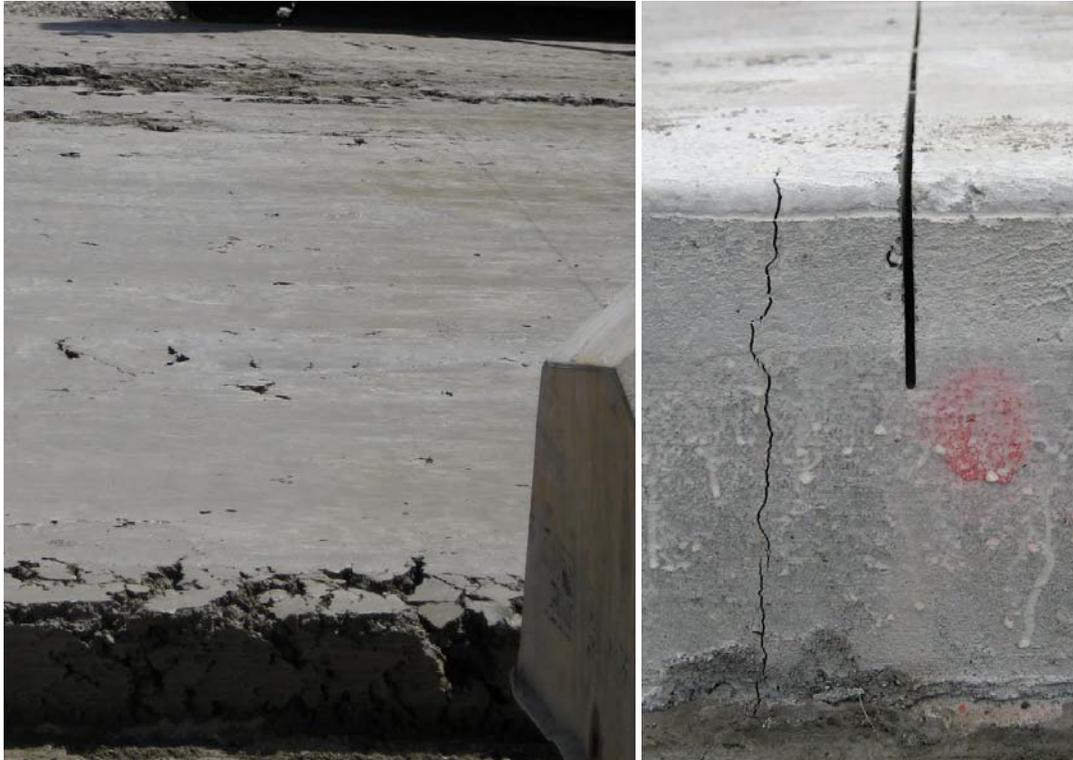
11 **Figure 3. At left, “torn” edges and surface due to concrete setting on profile pan; at right,**
12 **shrinkage crack in the lower lift propagated out and upward**

3
4 These delays resulted in a few problems that could be appreciated immediately on site during
5 paving. The most apparent was the setting up of concrete in the grout box and on the profile pan
6 of the paver. Frequent delays allowed this concrete to hydrate and attach to surfaces, normally
7 assumed to be smooth, that physically form the slab. When paving resumed after long delays,
8 concrete that had clung to these surfaces would “tear” at the freshly paved concrete, resulting in
9 the need for additional finishing. Figure 3 illustrates the tearing discussed above.

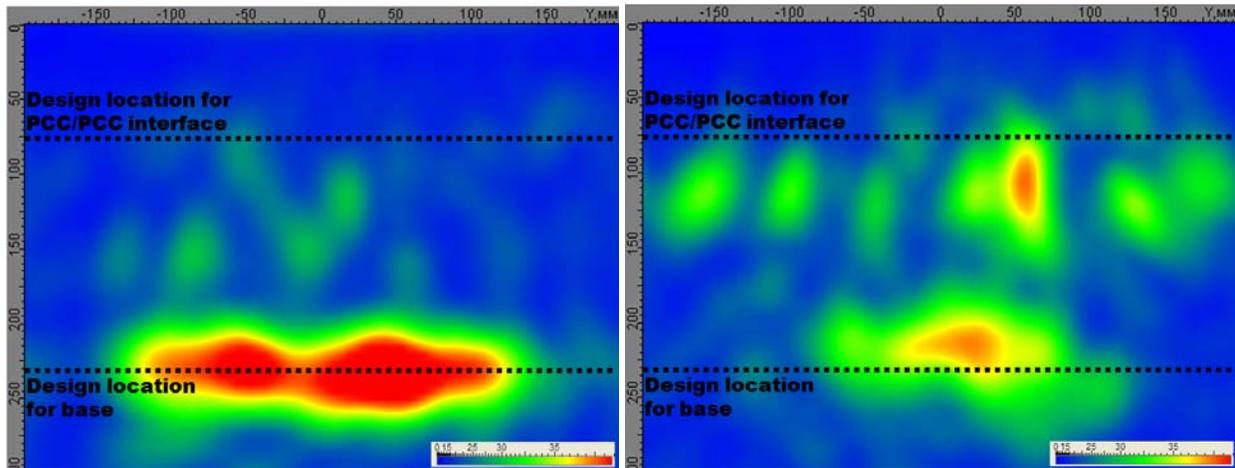
5 **Figure 4. At left, a typical tomogram from the PCC/PCC demonstration slab at MnROAD;**
 6 **at right, tomogram with ultrasonic reflection near the depth of the PCC/PCC interface**

1 ultrasonic scans at the transverse joints and at midslab of selected slabs. Tomograms from two
 2 representative scans are illustrated in Figure 4.

8 Ultrasonic reflection occurs only noticeably at the start of the base layer (measured as
 9 approximately 8 in.) in the tomogram at left in Figure 4. In the tomogram at right, however,
 10 significant ultrasonic reflections are measured at a depth of approximately 4 in., near the
 11 interface of the two PCC layers. This reflection near the interface may be indicative of a poorly
 12 developed bond between the two layers of PCC, or it may be indicative of other problems in the
 13 pavement. The figure at left is further evidence that the composite layers, from the view of the
 14 tomogram, are a unified layer, whereas the reflections in Figure 4 at right suggests the possibility
 15 of internal distress (these conclusions were confirmed by cores taken from the demonstration
 16 slab). There is great potential for non-destructive testing devices such as ultrasonic tomography
 17 in quality assurance for PCC/PCC, especially when debonding at the interface is a concern.

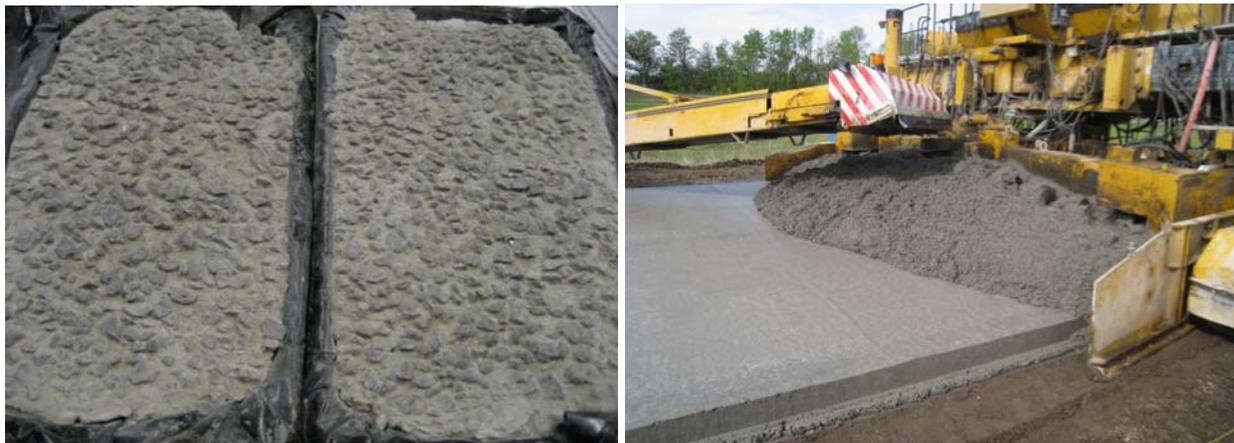
27
28 **Figure 5. At left, EAC specimens cast by the research team in preparation for the paving**
29 **and brushing of the PCC/PCC demonstration slab; at right, EAC mix being placed in front**
30 **of the second paver on site at MnROAD**

18
19 Both the use of high-fraction SCM replacement and RCA came with the challenges discussed
20 above, and the contractor met these challenges with a preliminary batch of each design in the
21 laboratory. As a result of these tests, the contractor adjusted the cement content of the EAC mix
22 and adjusted amounts of admixtures for all mix designs. The contractor also had difficulty
23 meeting the specified gradation curve for aggregate in the EAC mix, and as a result the EAC mix
24 design was the last of the mixes to be finalized. Figure 5 illustrates a preliminary batching and
25 brushing of the EAC mix conducted by the research team.

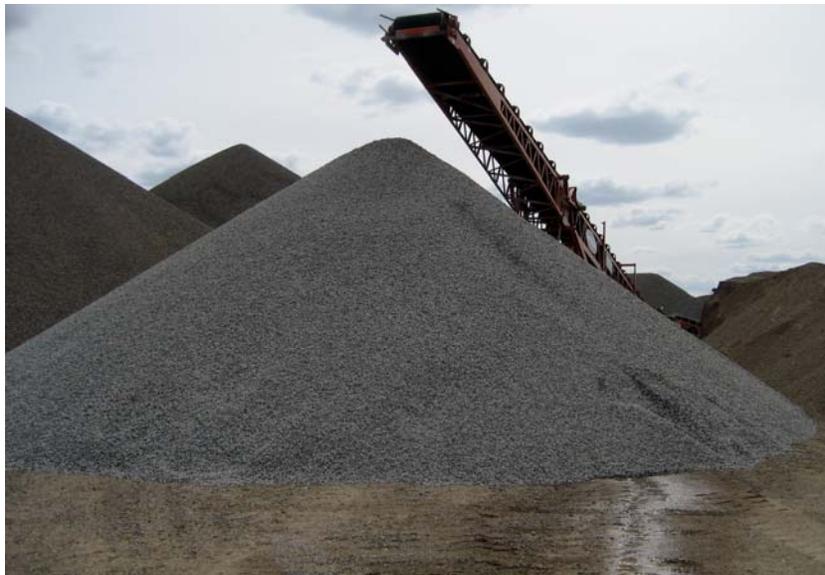
20
21 **Figure 6. RCA stockpile being processed and saturated at a concrete recycling facility**

12
13 Furthermore, as noted in reporting prior to the construction, the use of RCA required close
14 attention. The contractor had secured RCA of a known source and had washed the RCA of fines,
15 however the preparation of the RCA for batching – most notably, its degree of saturation – was
16 not consistent. One explanation of the inconsistency from batch to batch, as evident in the
17 variable slump, is the inadequate maintenance of the RCA stockpile (Figure 6). It is possible that
18 the stockpile had been allowed to dry.

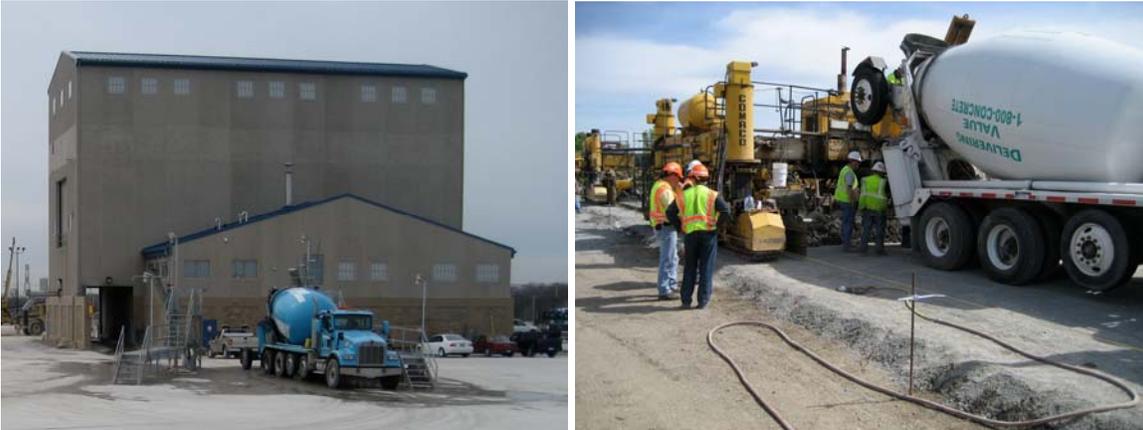
4
 5 **Figure 7. At left, a ready-mix batching plant similar to the plant used for the R21**
 6 **PCC/PCC construction; at right, mixer truck used for delivery**
 7

27
28 A final challenge in meeting the mix design for the PCC/PCC pavements was the use of a local
29 ready-mix supplier for the PCC/PCC concrete. This decision led to the use of a local ready-mix
30 plant – instead of the contractor's mobile batching plant – and the use of one plant instead of two
31 (as observed in Europe). Furthermore, mix delivery was accomplished through mixer trucks
32 instead of dump trucks (again, as in Europe). Both the batching plant and mixer trucks are

1 demonstrated in Figure 7. The contractor's decision was based solely on cost: given the limited
 2 size of the project, using one or more mobile batching plants was not feasible.
 3

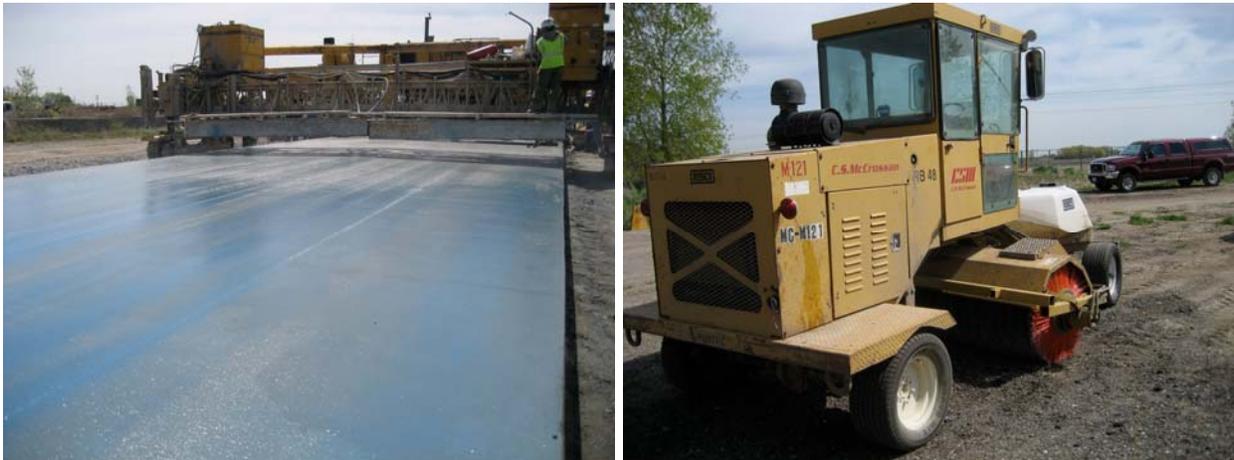
21
22 **Figure 8. Treated surface and finishing platform (at left); equipment for EAC brushing (at**
23 **right)**

3
4 The finishing platform used for the construction was a GOMACO model TC600 with Power
5 Pavers Inc TC 2700T spray attachment. After paving, a compound was applied to the surface
6 that both acted as a moisture barrier (curing agent) and as a retarder of hydration in the concrete
7 at the surface. This curing/retarder compound was MBT Reveal from BASF Building Systems.
8 Early applications of the surface treatment were delayed due to mechanical problems on the
9 finishing platform, which provided insufficient pressure to the spray nozzles. The treatment
10 (Figure 8) was intended to be applied almost immediately after finishing of the placed second
11 lift, however due to frequent delays, the treatment was applied anywhere between 60 and 90
12 minutes after the completion of paving a given segment.

24
25 The brushing itself was accomplished using a small front-end loader with rotating wire brush
26 attachment (Figure 8). The brushing was complicated by the inability for the operator to know
27 the depth of texturing with any kind of precision. Hence, the brushing was done in multiple
28 passes to gauge the level of cement removal between the aggregates, thus slowly revealing the
29 EAC texture in pass after pass (Figure 9).
30

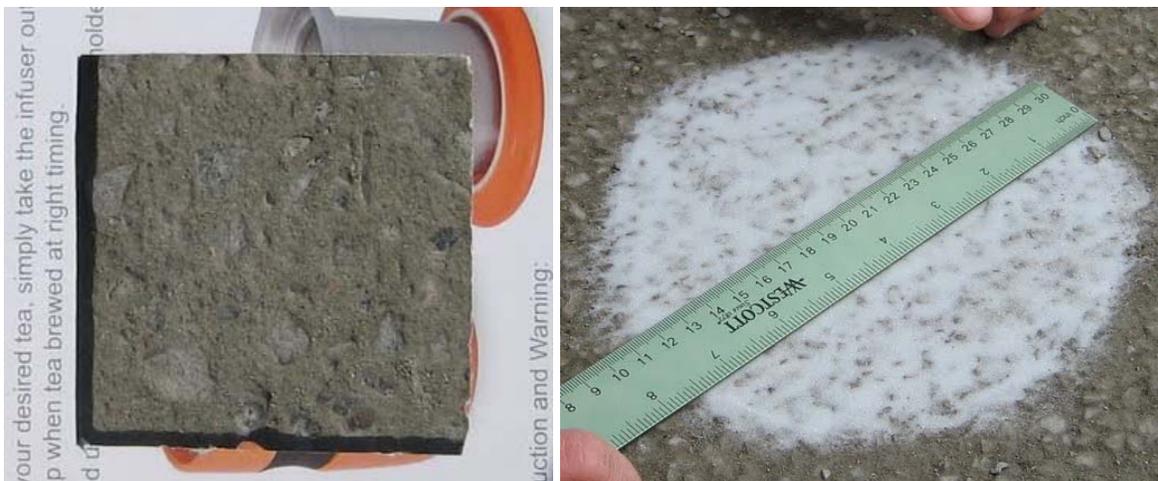
13
14 **Figure 10. Quality control tests for brushing: at left, 25 cm² test to count aggregate peaks,**
15 **and at right, sand patch test to determine texture depth**
16

4 The extent of brushing was determined using a combination of a sand patch test and an aggregate
5 peak counting test (Figure 10). More detail on these techniques can be found in Tompkins et al,
6 Weinfurter et al, and Fick (1,6,8). Though not specified, the aggregate peak counting test was an
7 informal quality control for the brushing adapted from Austrian methods. It aimed for a count of
8 anywhere between 40 and 50 aggregate points per 25 cm² (3.88 in²), according to Haider et al
9 (11). The sand patch test was conducted according to ASTM E965 at intervals as a quality
10 control measure during brushing to ensure that the depth of brushing was between 0.8 and 1.2
11 mm (0.03 to 0.05 inches).
12

17 This range for texture depth originated in the specifications for the EAC texturing, which
18 required a uniform texture depth of 1.0 mm with an allowable range of 0.2 mm either shallower
19 or deeper. This target was based in part on German and Austrian specifications for texture depth
20 (0.6-0.8 mm and 0.8-1.0 mm respectively) (1). The completed mean texture depth for the EAC
21 surfacing on the R21 sections at MnROAD was reported by Mn/DOT to be 0.76 mm (0.030
22 inches).
