# Pavement Condition Report

## Pine River Regional Airport (PWC)

**December 2016**

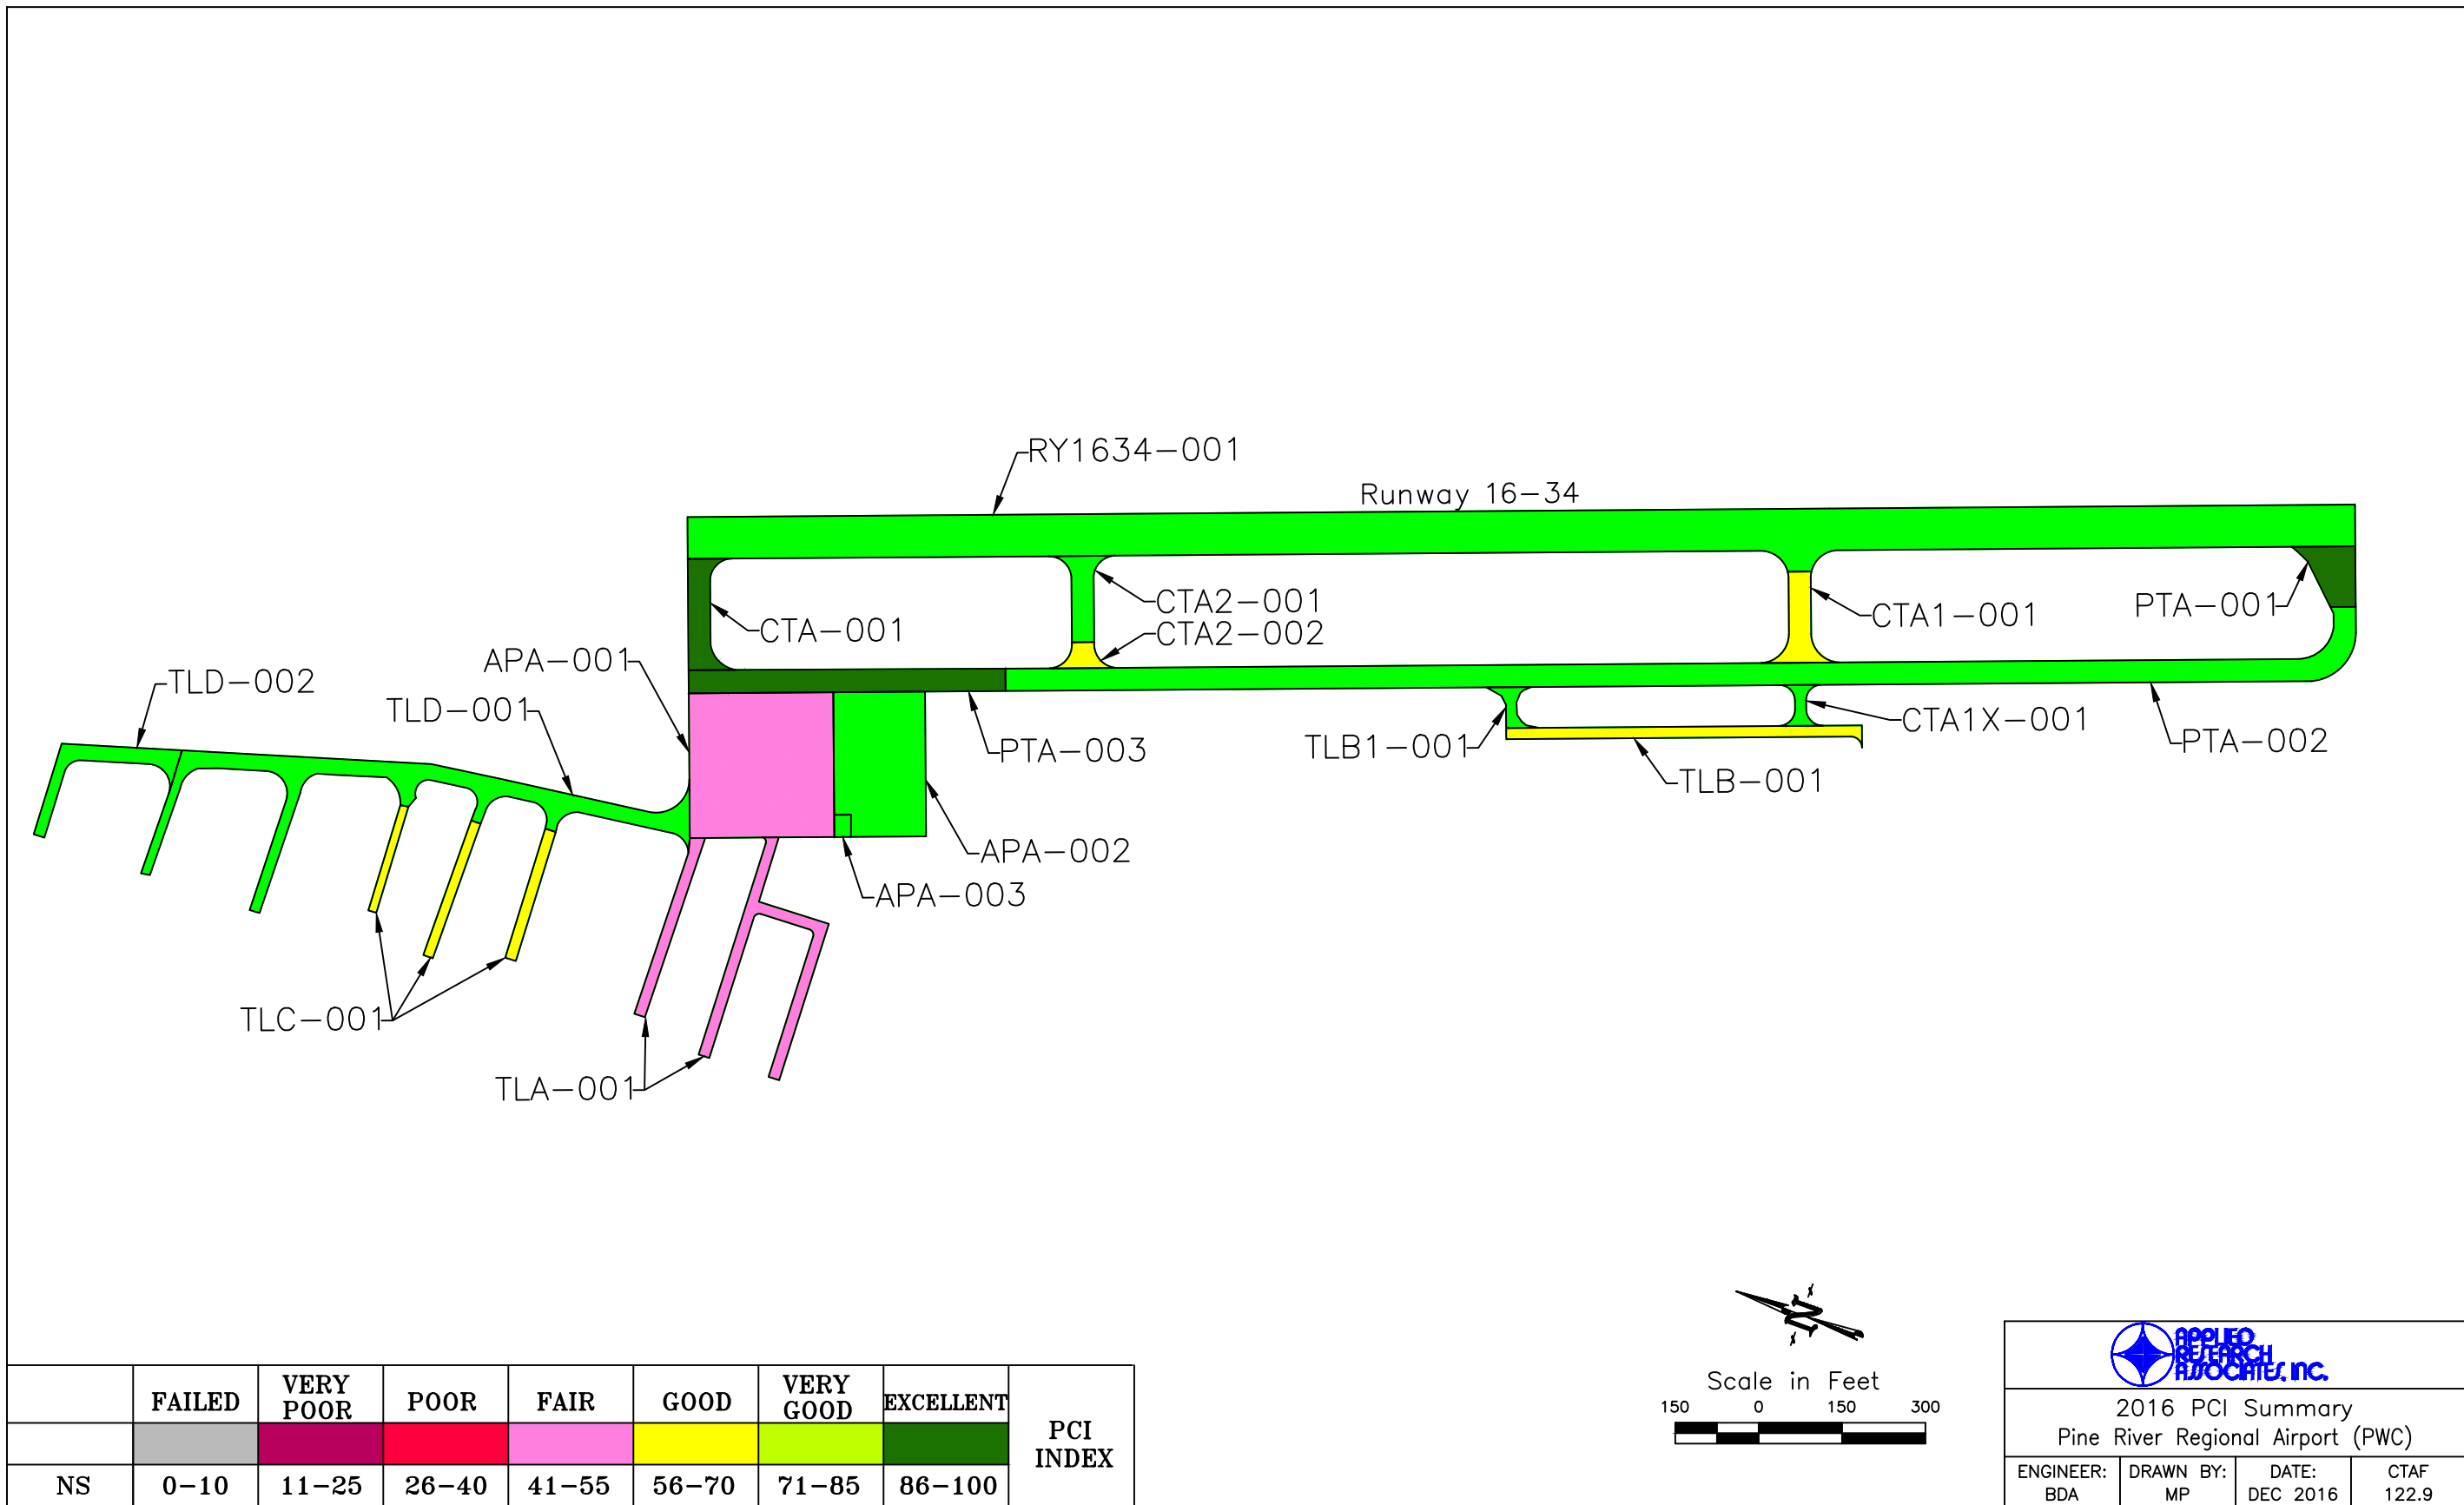
Figure 4. 2016 Pavement Condition Index Rating at Pine River Regional Airport (PWC).

The results of the 2016 PCI inspection are presented in figure 4. The overall area-weighted, inspected PCI for PWC is 73. When summarizing PCI values, an area-weighted calculation is used instead of a straight mathematical average because the area-weighted calculations eliminate the skewing of the PCI due to the disparity of the section sizes.
