# Pavement Condition Report

## Baudette International Airport (BDE)

**December 2017**

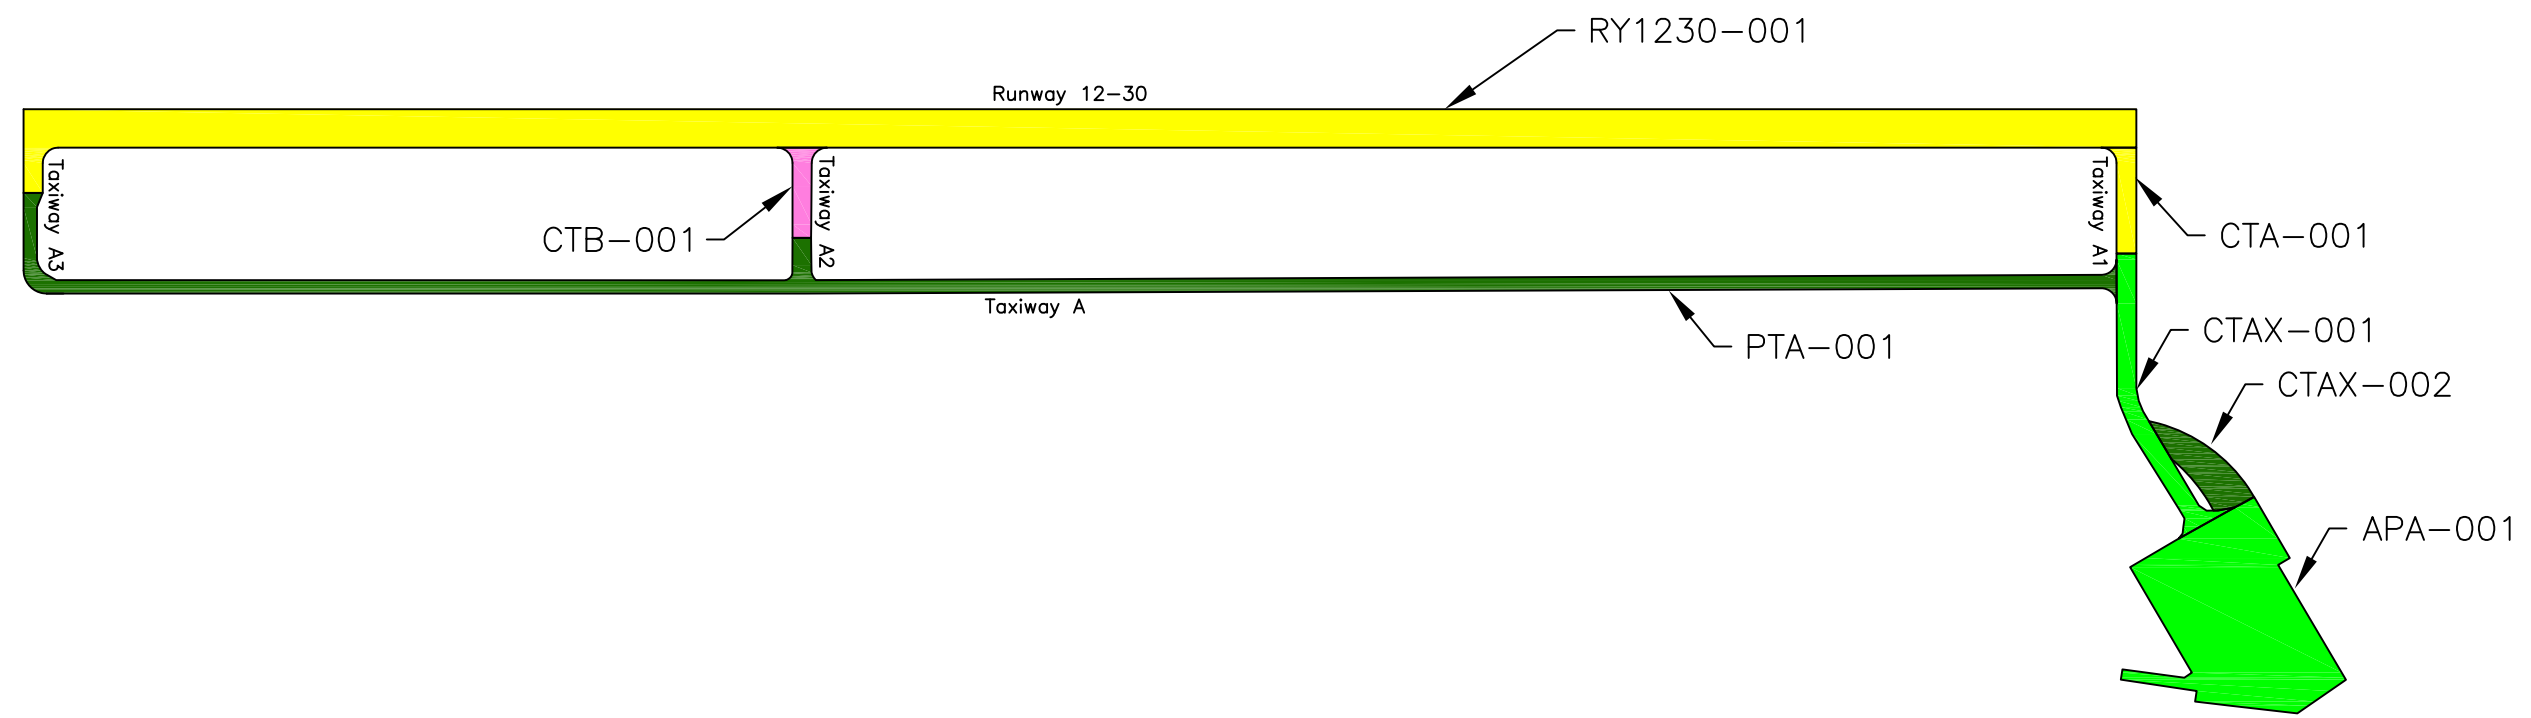
Figure 4. 2017 Pavement Condition Index Rating at Baudette International Airport (BDE).

The results of the 2017 PCI inspection are presented in figure 4. The overall area-weighted, inspected PCI for BDE is 73. When summarizing PCI values, an area-weighted calculation is used instead of a straight mathematical average because the area-weighted calculations eliminate the skewing of the PCI due to the disparity of the section sizes.
