Pavement Condition Report

Willmar Municipal Airport - John L. Rice Field (BDH)

December 2017

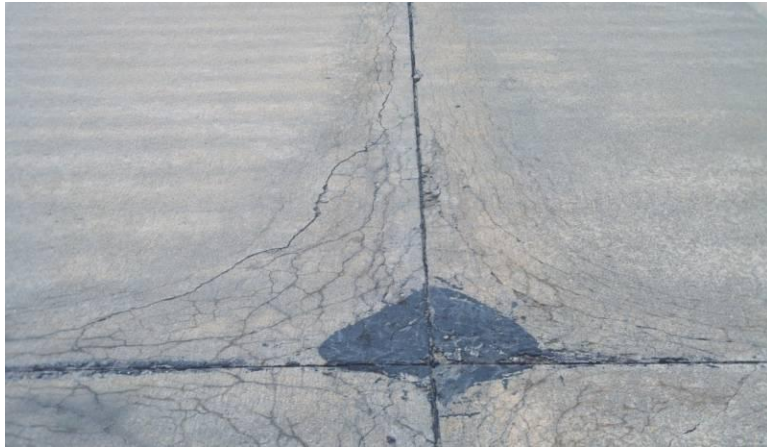
Example of Durability Cracking

Durability cracking (D-cracking) is caused by environmental factors, the most common of which is freezing/thawing. It usually appears as a pattern of hairline cracks running parallel to a joint or crack, or in a corner, where water tends to collect. This type of cracking eventually leads to disintegration of the pavement, creating FOD potential. At low severity, D-cracking is evident, but no disintegration has occurred. As the distress advances to medium severity, the distress pattern is evident over a significant area of the slab, and some disintegration and FOD potential exists. High severity durability cracking is evidenced by extensive cracking with loose and missing pieces and significant FOD potential.
