Special Bridge Inspection Report

Bridge #38010

Mn Hwy 61 over the Gooseberry River (Gooseberry Falls)
(Mn/DOT District D1-A - Duluth)

Inspection Date: August 6, 2007

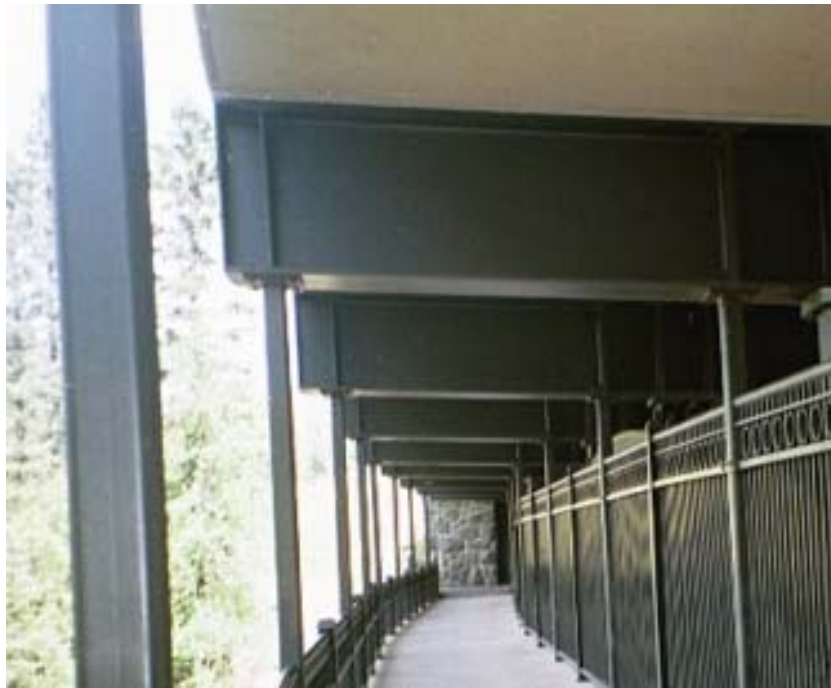
Suspended Pedestrian Walkway: There is a pedestrian walkway suspended from the bridge running along the exterior of the west arch. The walkway is supported by steel hanger tubes (4" x 4" x 1/2") - these are bolted to the bottom flange of the spandrel columns & pier caps. The hangers support the sidewalk floor system (transverse floorbeams and longitudinal beams). The concrete sidewalk slab is 6" deep. The walkway is connected (pinned) to the west arch rib in two locations to provide lateral support.

Suspended sidewalk (looking north)

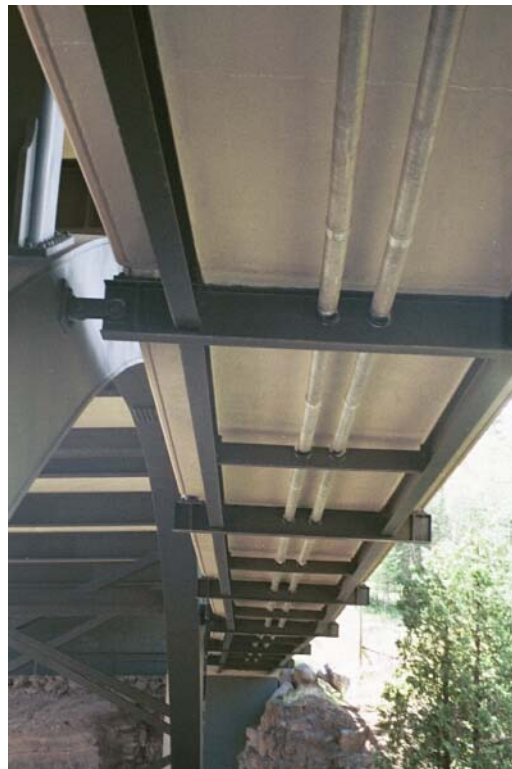
Underside view of sidewalk

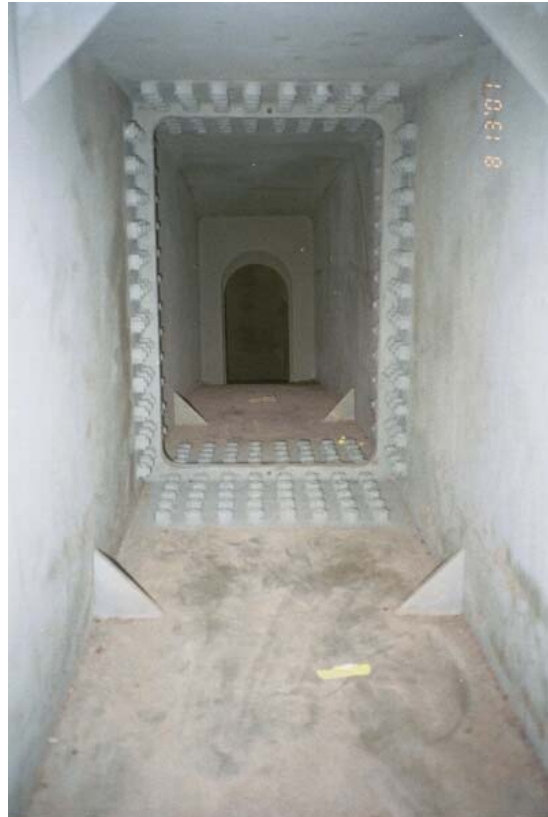
Arch interior - view of splice (top of arch)

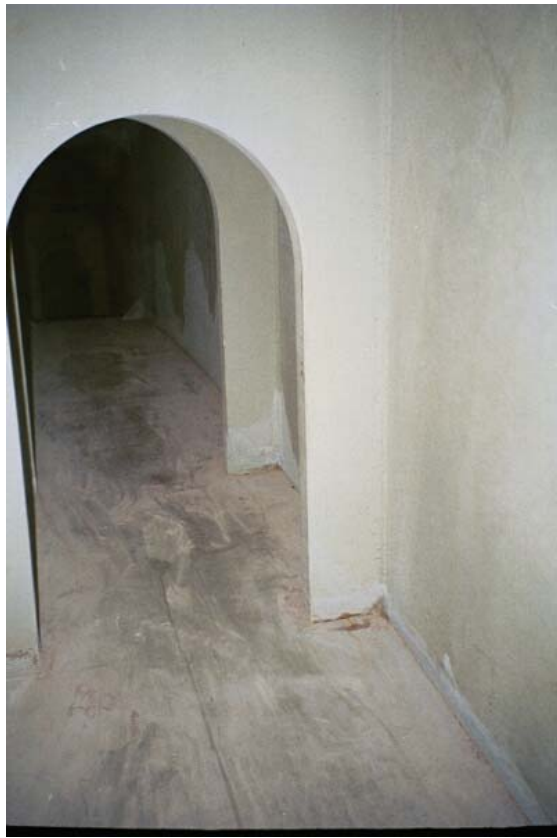
Spandrel #2: The west arch strut connection has missing bolt (never installed, as the internal arch stiffener plate interfered).

Arch interior - internal stiffeners at spandrel connections
