# Evaluation of the SafeLane™ Overlay System for Crash Reduction on Bridge Deck Surfaces

Minnesota  
Department of  
Transportation

John F. Evans, Principal Investigator  
Department of Chemistry and Biochemistry  
University of Minnesota Duluth

Research Project  
Final Report #2010-13

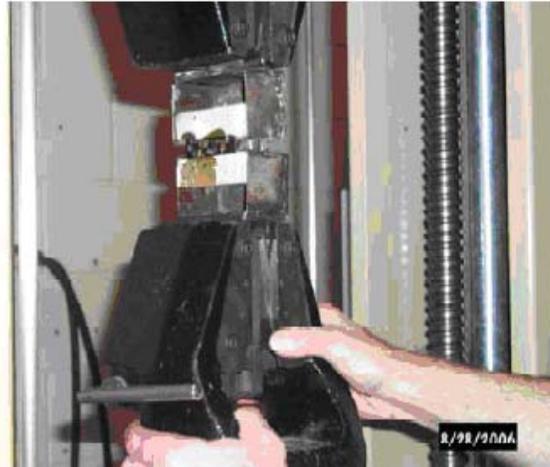
Figure 3.2. Pull out machine employed.

The test specimen was placed in the standard housing and the grip of the bond pull out machine (Fig. 3.2) and pulled out at a loading rate equivalent to a deformation rate of 0.1 inch/min until the maximum load was attained.

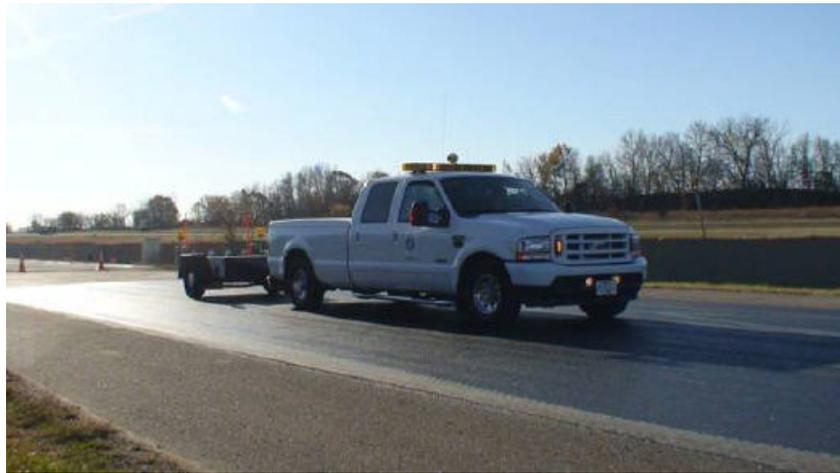
Figure 5.2. KJ Law (Dynatest) skid trailer.

Skid tests were performed on the overlay installed at the Hibbing site using the KJ Law skid trailer (Figure 6.1) over the course of three years. The results are plotted in Figure 6.2.
