**2016 MnROAD/NCAT Cracking Group Construction
Weekly Construction Update
For the week of July 25, 2016**

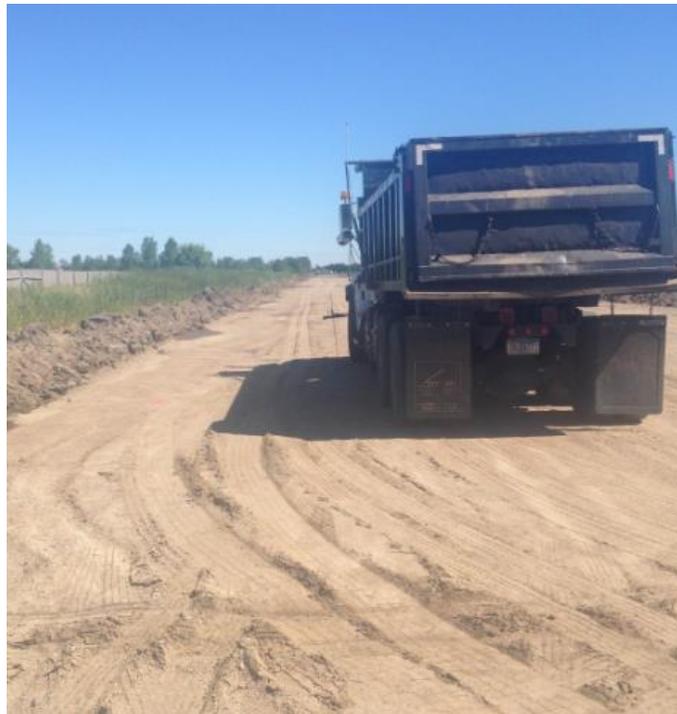
Test rolling was completed with the 10-ton test rolling (TR10) setup conducted on Friday, July 29. The test roller was weighed and documented with Kory Eichhorst present. Testing was done from shoulder point of intersection (PI) to opposite shoulder PI. Approximately 10% of the area between the PI and edge of pavement failed test rolling. These areas included the last 150 feet of the west side of the project and areas that were corrected on Thursday. It was found that all material within paving limits passed. It will be determined on Monday, August 1 how to proceed.

Figure 4: TR 10 Test Roller Setup
