## WILLOW LAKE ROADSIDE PARKING AREA

SHPO INV. #CA-TOR-002

**Architect's Survey Date:** September 16, 1999

FIELD SURVEY OBSERVATIONS / RECOMMENDATIONS

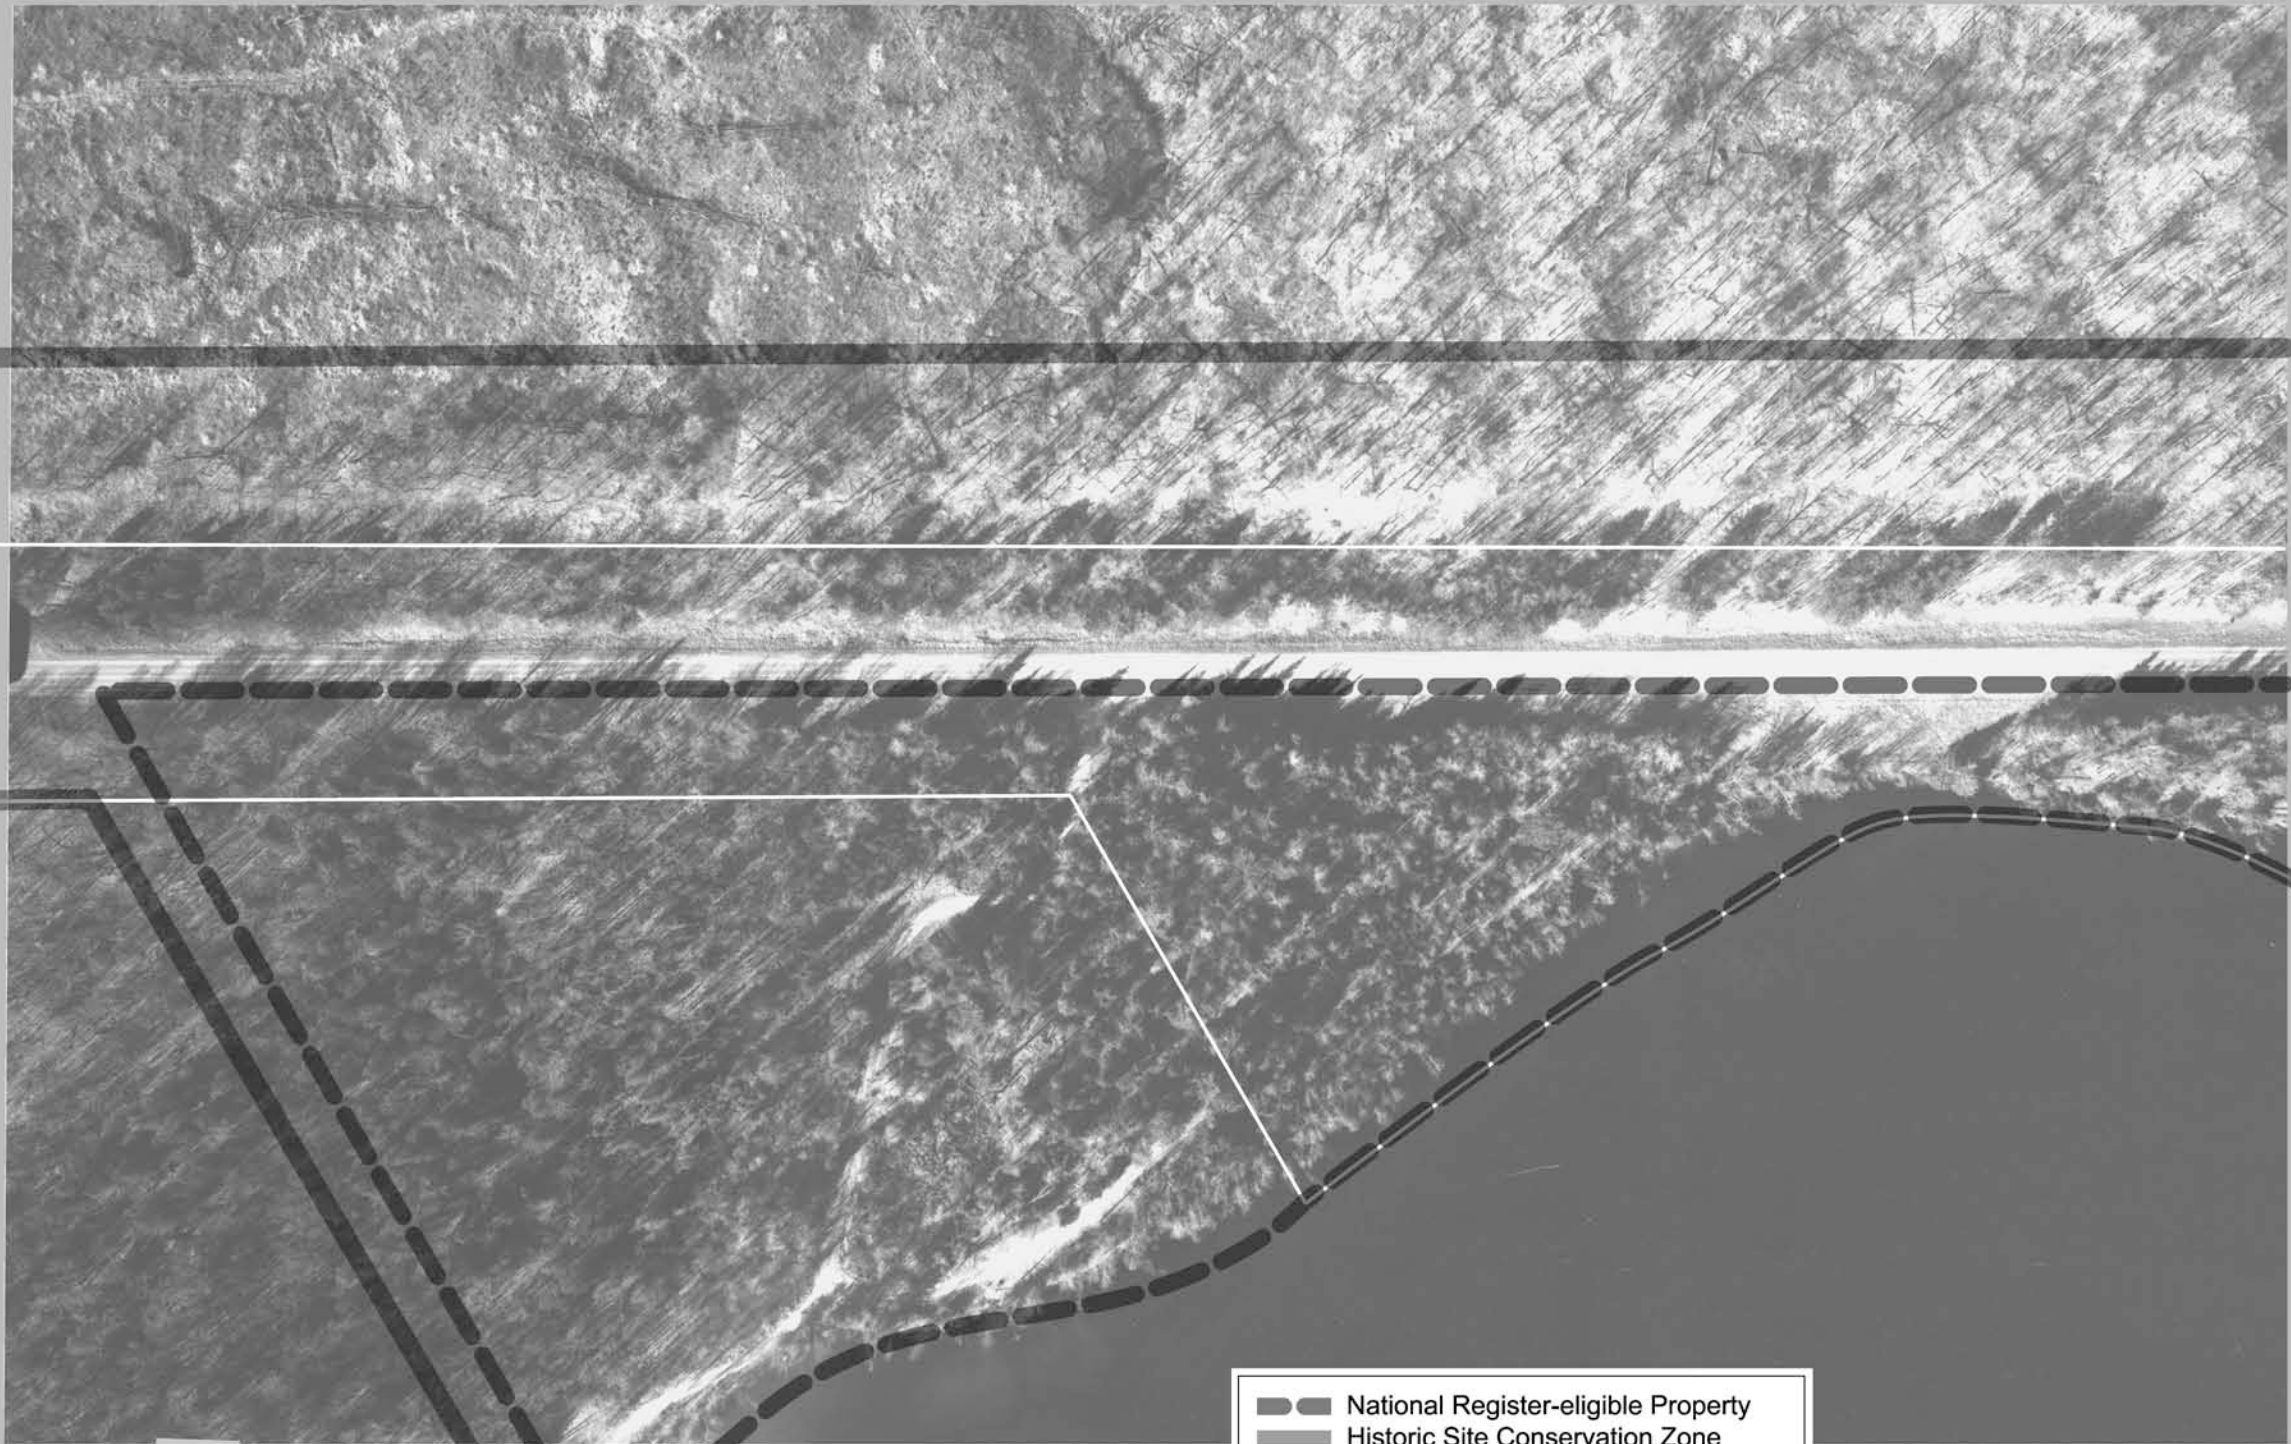
**Willow Lake Roadside Parking Area  
Site Boundaries**

The recommended boundary of the National Register-eligible property is shown by the dashed line on the accompanying sheets entitled "Willow Lake Roadside Parking Area Site Boundaries." The base maps for these sheets are a Minnesota Department of Transportation (Mn/DOT) Right-of-way Map and a Mn/DOT aerial photo.

The recommended boundary of the Mn/DOT Historic Site Conservation Zone is also shown on the accompanying sheets. The Conservation Zone encompasses both the National Register-eligible property, marked by the dashed line, and adjacent areas marked by the solid line.

North and south of the National Register-eligible property, it is recommended that the Conservation Zone include all Mn/DOT right-of-way extending along T.H. 6 a distance of 400' north and 400' south of the boundary of the National Register-eligible site.

West of the National Register-eligible property, it is recommended that the Conservation Zone extend to a line drawn 150' west of, and parallel with, the Mn/DOT right-of-way line, as shown.
