Pavement Condition Report

Owatonna - Degner Regional Airport (OWA)

December 2016

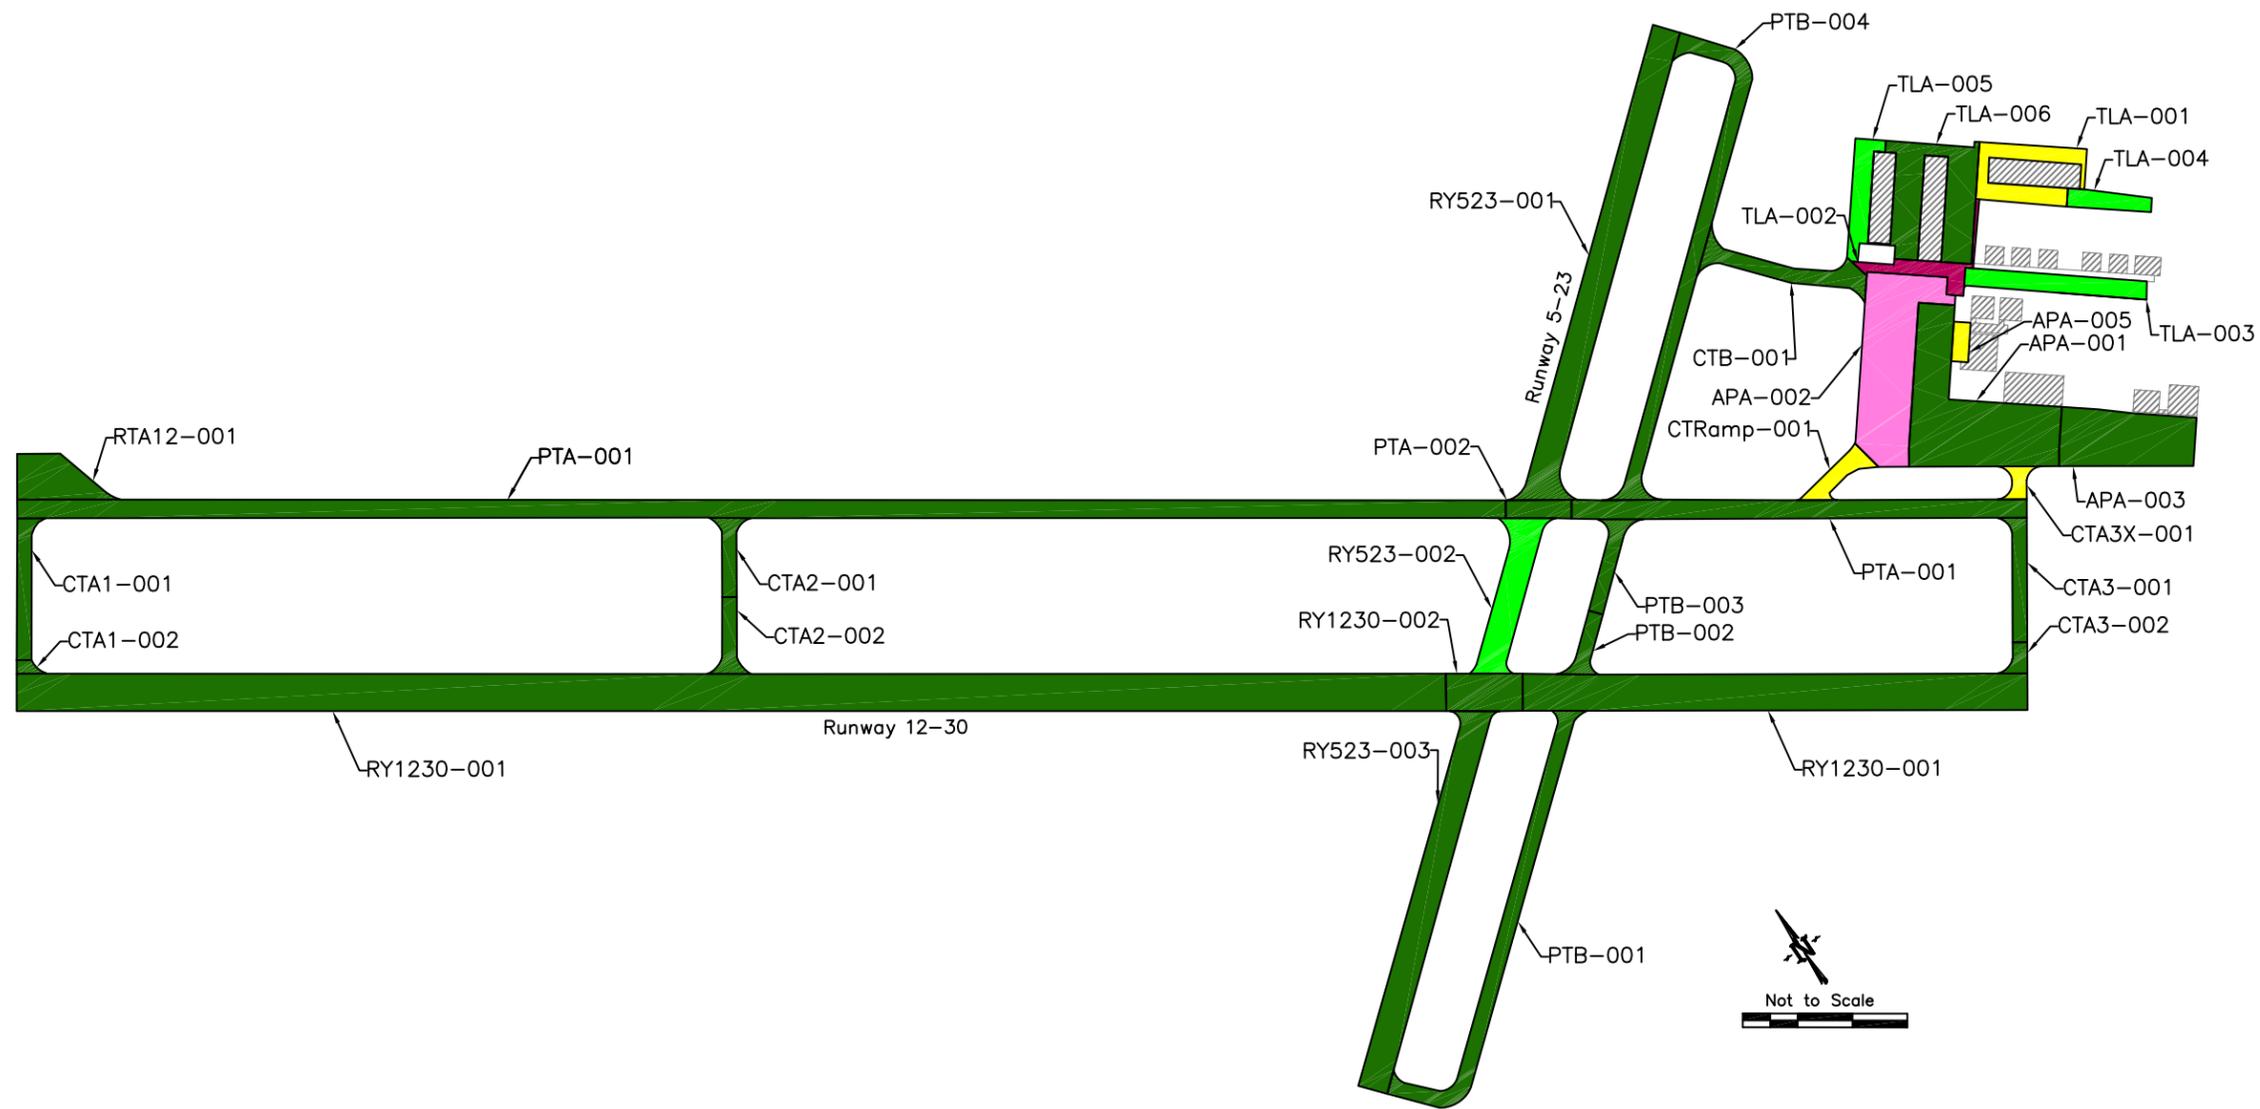
Figure 4. 2016 Pavement Condition Index Rating at Owatonna Degner Regional Airport (OWA).

The results of the 2016 PCI inspection are presented in figure 4. The overall area-weighted, inspected PCI for OWA is 90. When summarizing PCI values, an area-weighted calculation is used instead of a straight mathematical average because the area-weighted calculations eliminate the skewing of the PCI due to the disparity of the section sizes.

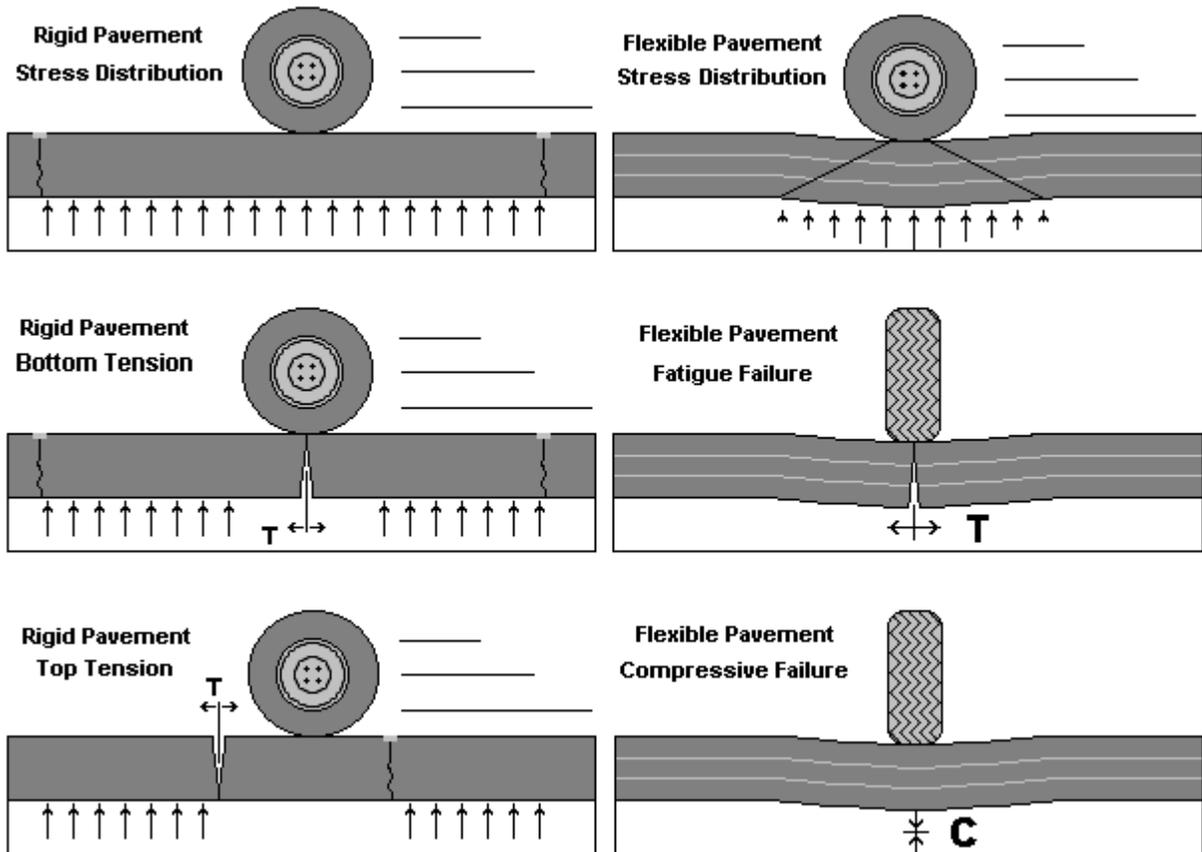
Figure 1. Pavement failure.

Load-related cracks can start at the top or bottom of a pavement section. In asphalt sections, load-related (fatigue) cracks start at the bottom. If a load-related crack reaches the surface, it usually indicates significant structural deficiency. In PCC pavement, corner breaks are caused by top tension, and the crack propagates downward. Mid-slab LTD cracks are examples of bottom tension.

Spalls can be caused by either wheel loads or environmental factors, anytime there is movement between adjacent slabs. If a small rock is allowed into a joint, a differential movement between adjacent slabs can cause a spall. Spalling can be minimized by keeping joint and crack sealant intact.
