# Pavement Condition Report

## Falls International Airport (INL)

**December 2019**

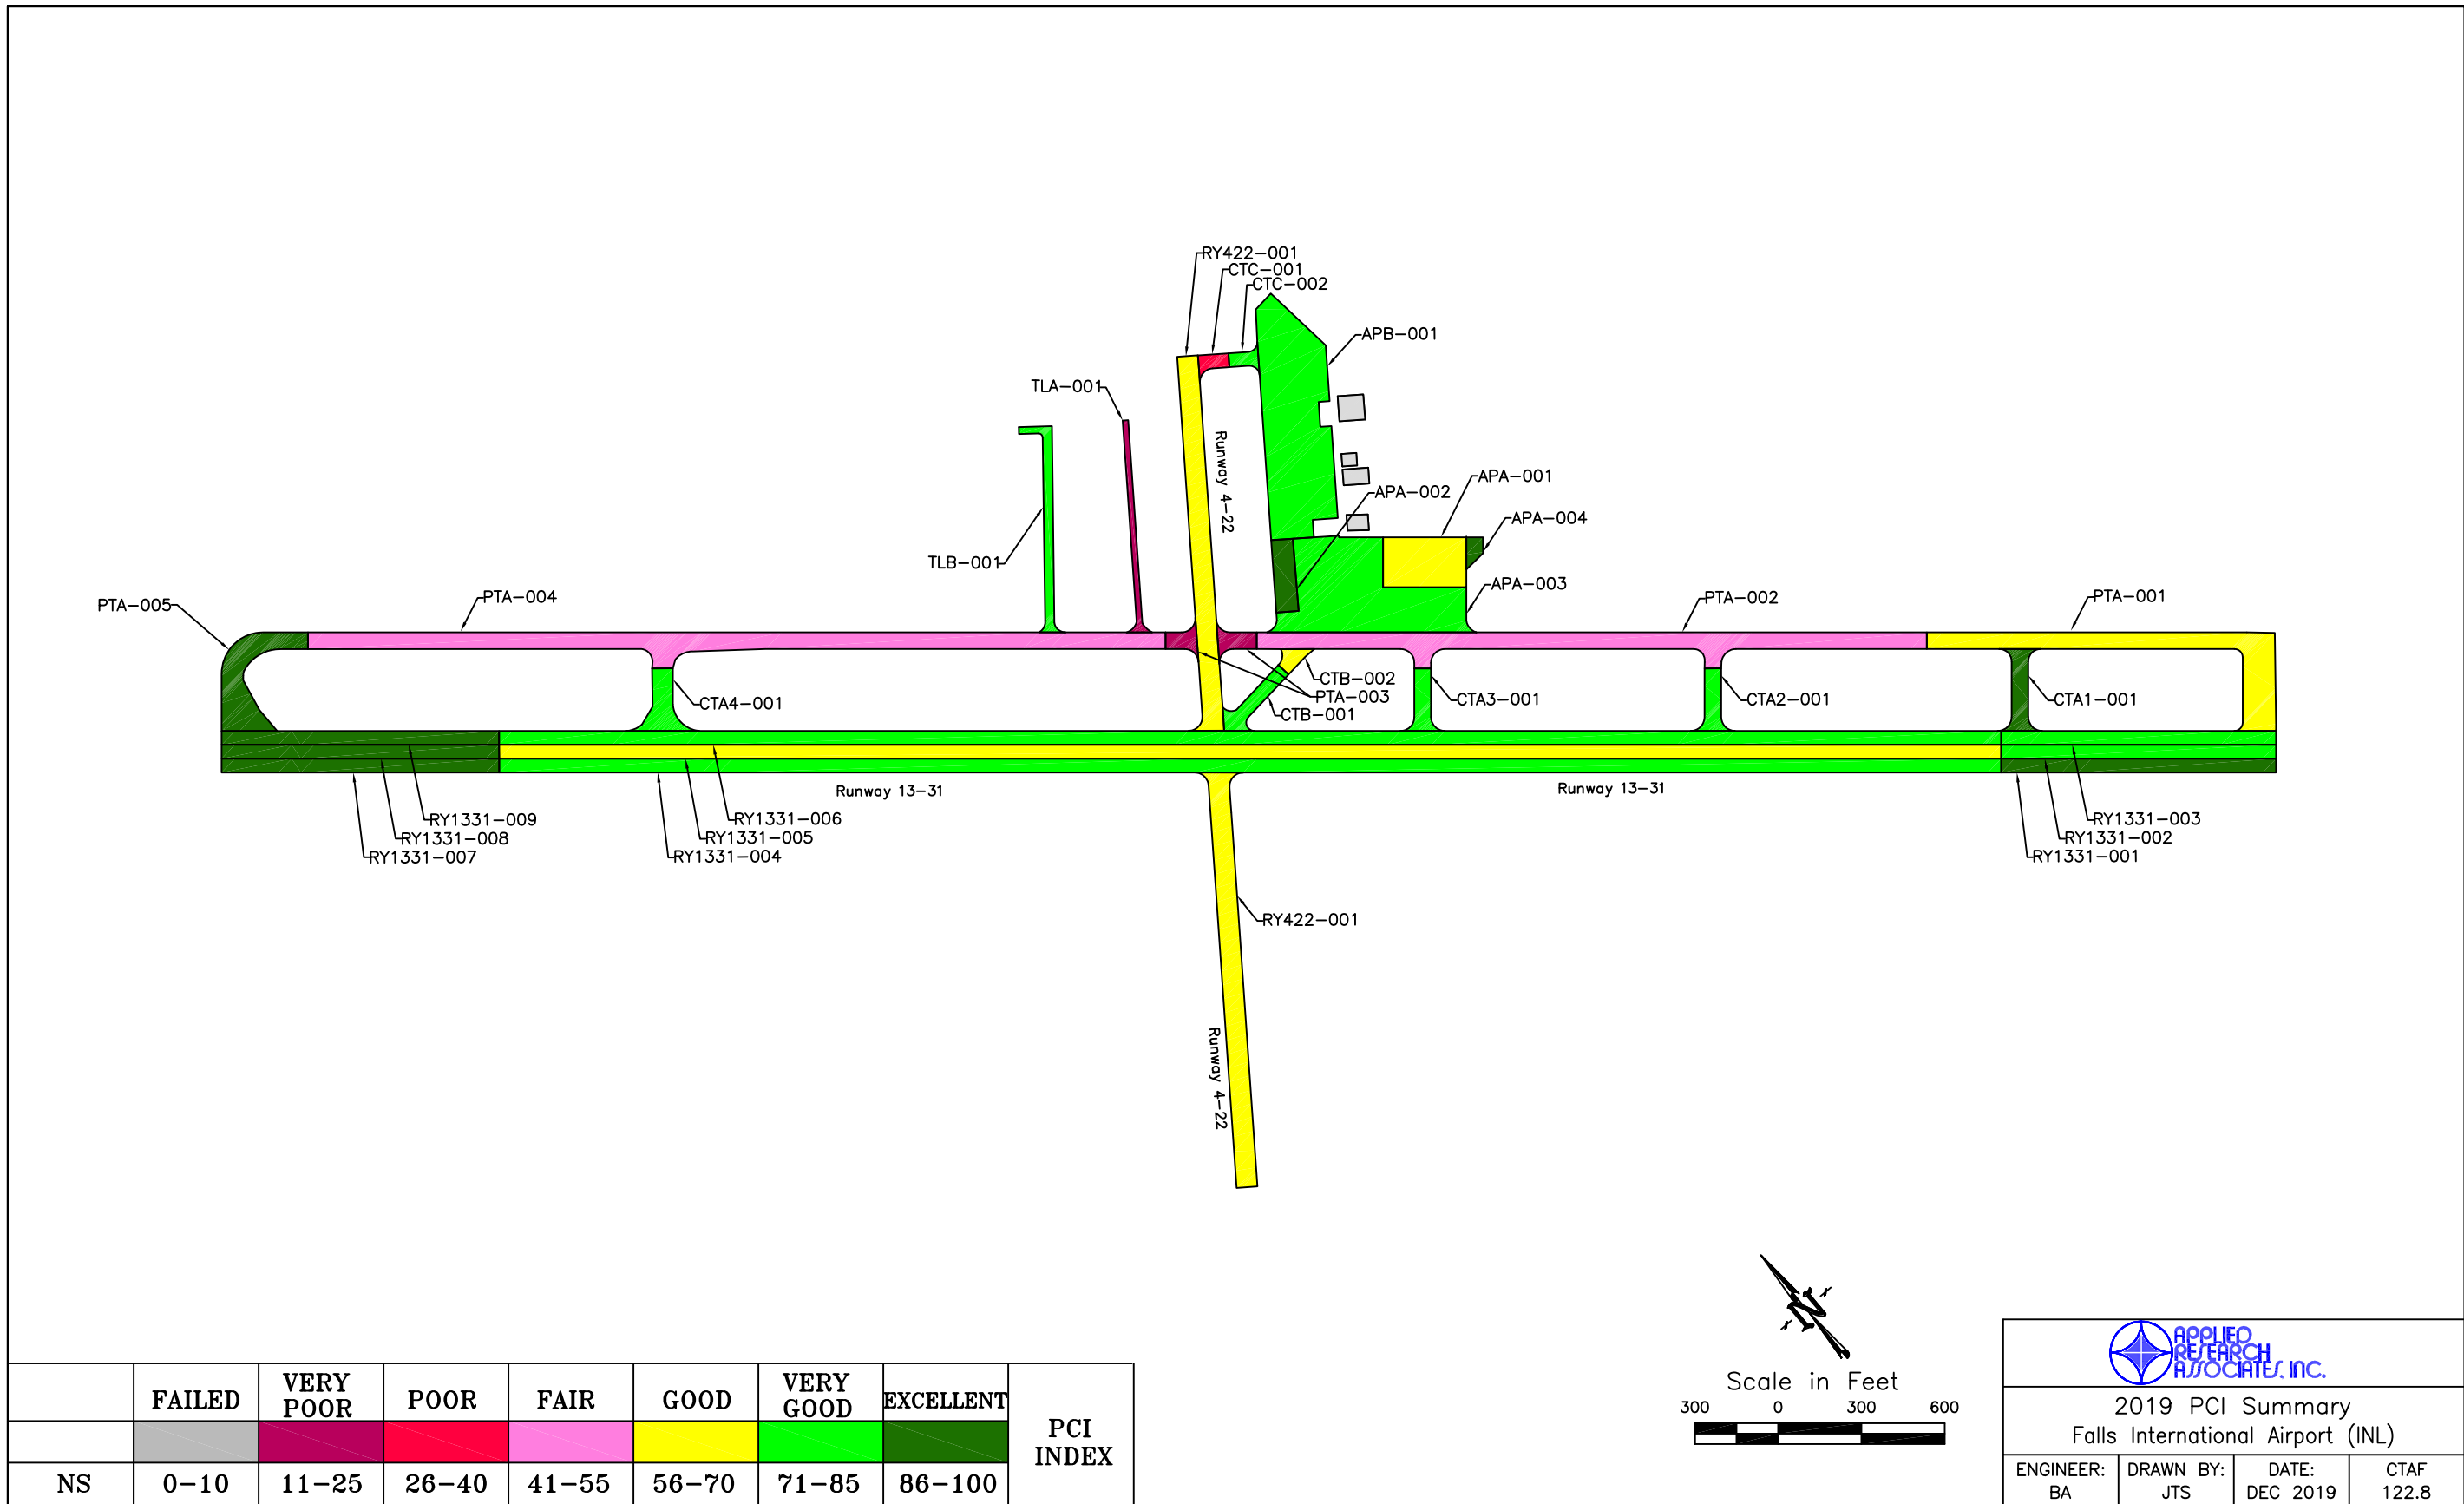
Figure 4. 2019 Pavement Condition Index Rating at Falls International Airport (INL).

The results of the 2019 PCI inspection are presented in figure 4. The overall area-weighted, inspected PCI for INL is 72. When summarizing PCI values, an area-weighted calculation is used instead of a straight mathematical average because the area-weighted calculations eliminate the skewing of the PCI due to the disparity of the section sizes.
