TEO Signal Committee Meeting Minutes
Meeting Date: 02/04/2016
Water's Edge Conference Rm 176
Meeting Time: 9:00am – Noon

Controller/Cabinet Committee Meeting Minutes 12/11/2015

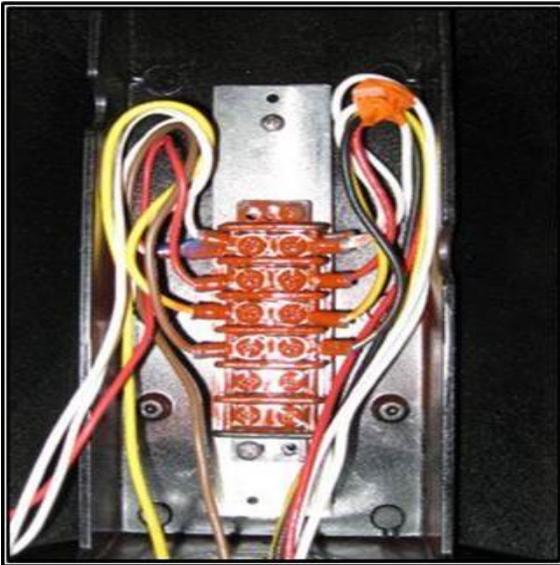
Pic 1: White plug on left

- 1) Plugs must be used on all open or unused hole slots. (See Pic 1 picture in attachments)
- 2) The wires in the signal indications must be installed with forks down and sprayed to prevent wicking (see Pic 2 picture in attachment)
- 3) Seals or grommets that come with the connector must be used.

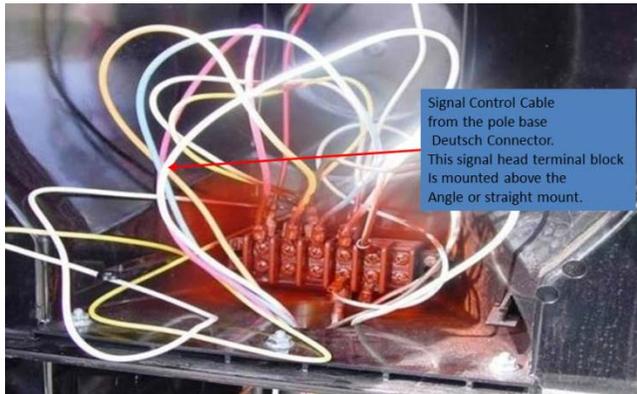
Pic 2: Wiring to prevent water wicking

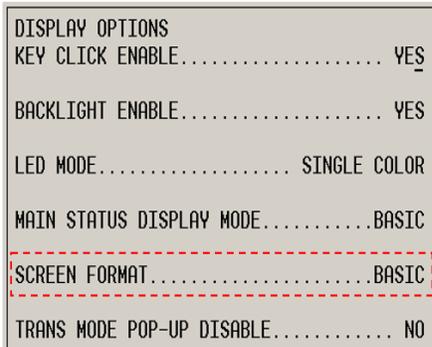
- **How do I enable the ASC3 "Basic View" screen format?**

To enable the "Basic View" screen format go to Main Menu 1,7,2 and change the setting "SCREEN FORMAT" to "BASIC" and cursor off of the setting. Then simply reboot the controller and your ASC3 will now be in the "Basic View" format

“Basic View” is an option for ASC/3 controllers. It allows only the most used data on the first few screens, then other less used data would be displayed on other screens. Districts have the option to use or not use the Basic View screen.

- *“Basic view” in controller. Basic view allows a simplified version of on screen programming options, pushing less used information lower on the screen. The committee suggested that if it was optional, meaning the operator could choose between basic view and the standard, we would use it. After further review, it was found that basic view is already an option in newer versions of software. If changing in the field, the controller would need to be rebooted, which would require putting the intersection into flash to make the change work. May need further discussion.*
