TECHNICAL SUMMARY

New Work Zone Signage and Devices May Improve Flagger Safety

This Technical Summary pertains to the LRRB-produced Report 2017-07, “Flagger Operations: Investigating Their Effectiveness in Capturing Driver Attention,” published February 2017. The full report can be accessed at mndot.gov/research/reports/2017/201707.pdf.

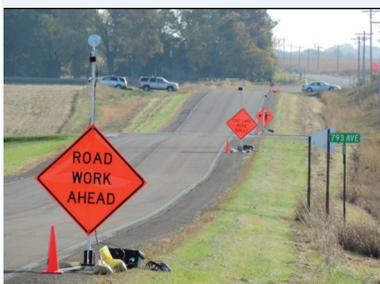
The standard work zone signage layout is not always effective at capturing driver attention.

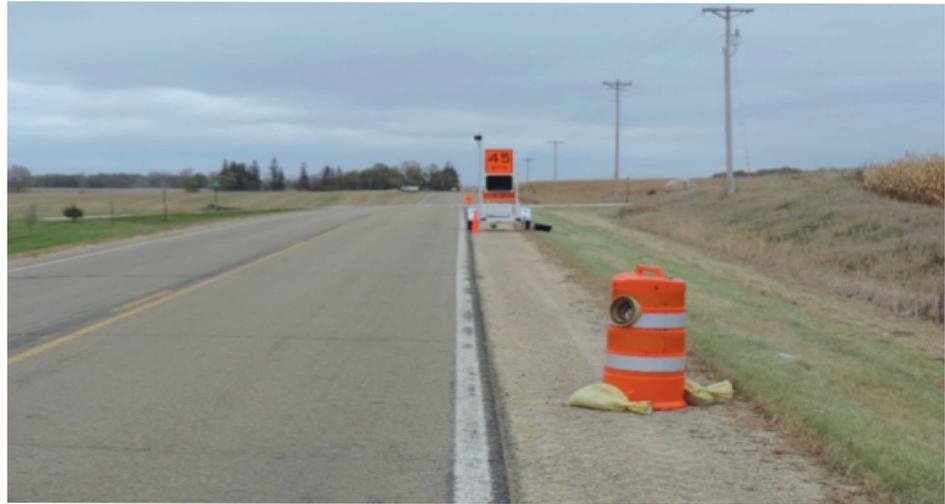
In field tests, the dynamic speed display trailer and warning horn reduced driver speed, particularly among the fastest and potentially most dangerous drivers.

The first field test (using the standard setup) did not collect enough data to be statistically valid due to short work zone working periods and low traffic volume. However, the data that were collected matched observations from the second field test (using the experimental setup), which found that the combination speed trailer and horn reduced average driver speeds approaching the work zone by about 5 mph relative to the standard layout. Perhaps more importantly, the distribution of speeds was narrower with the experimental layout, which had almost none of the high-speed outliers that the standard layout had. This suggests that the devices were effective at attracting the attention of the fastest and potentially most dangerous drivers as they approached the work zone.
